NOD_PGE_ELZ_20211214-01

NOTICE OF DEFECT

Energy Safety Inspection Report

Report Name: ELZ_PGE_20211214-01

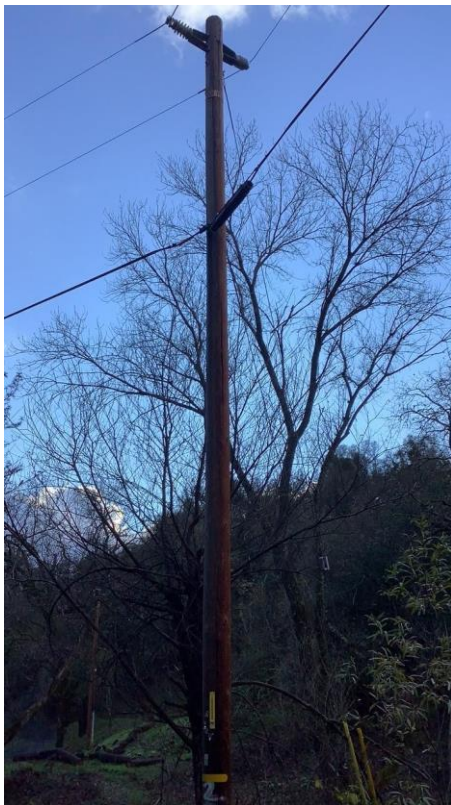
Structure ID: 101384818

1. Vegetation was found contacting guy wires above the insulator at structures numbered 101384818 and 101383904. Guy wires can become energized and pose an increased ignition risk if in contact with vegetation. Energy Safety considers this defect to be in the Minor risk category.

During the inspection, vegetation contacting down guy wires above insulators was discovered at structures numbered 101384818 and 101383904, as noted in Table 2 above. Guy wires are metallic and can become energized in some circumstances. Insulators break the current path and prevent electricity from reaching the ground where a down guy wire is anchored. However, the portion above the insulator may remain energized until the circuit is deenergized and may cause an ignition if energized while in contact with vegetation. Accordingly, Energy Safety considers vegetation in contact with down guy wires above the insulator a condition that increases an electrical corporation's ignition risk. See photos labeled Item9GW2Img1 and Item9GW2Img2 for structure 101384818, and Item13GW2Img1 and Item13GW2Img2 for structure 101383904 in Appendix A.

Figure 1 Item9GW2Img1: Picture of pole with Willow tree behind

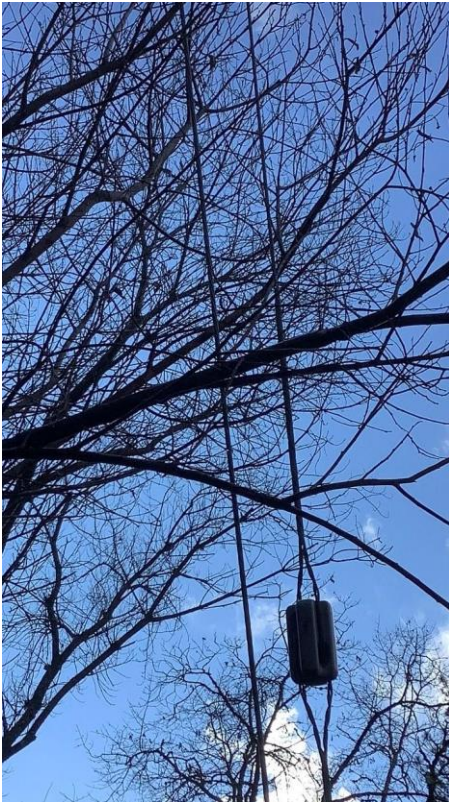
Figure 2 Item9GW2Img2: Photo of branches intertwined with guy wire above insulator

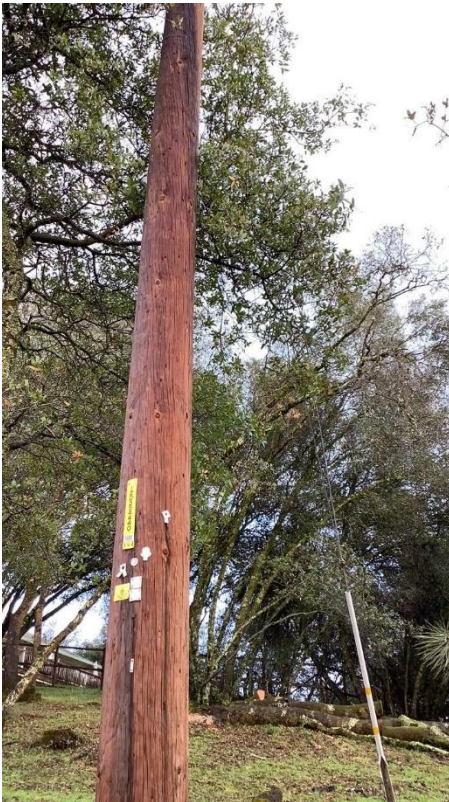
Structure ID: 101383904

Figure 3 Item13GW2Img1: Photo of pole tag with guy and guy insulator behind pole

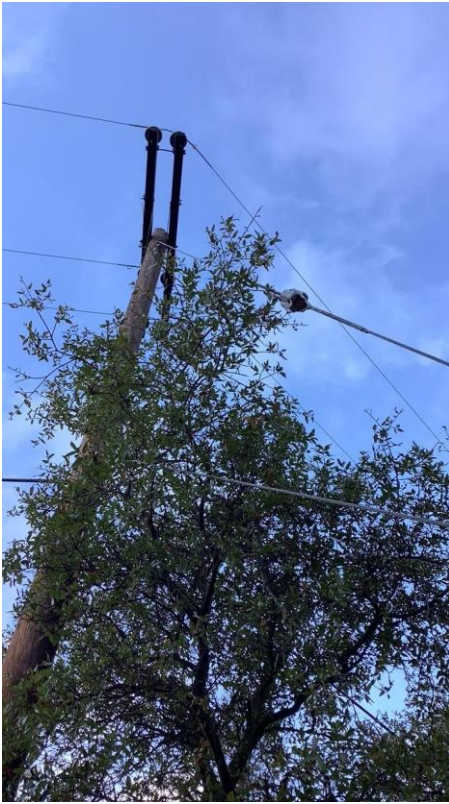
Figure 4 Item13GW2Img2: Photo of Interior Live Oak branches touching guy wire above insulator

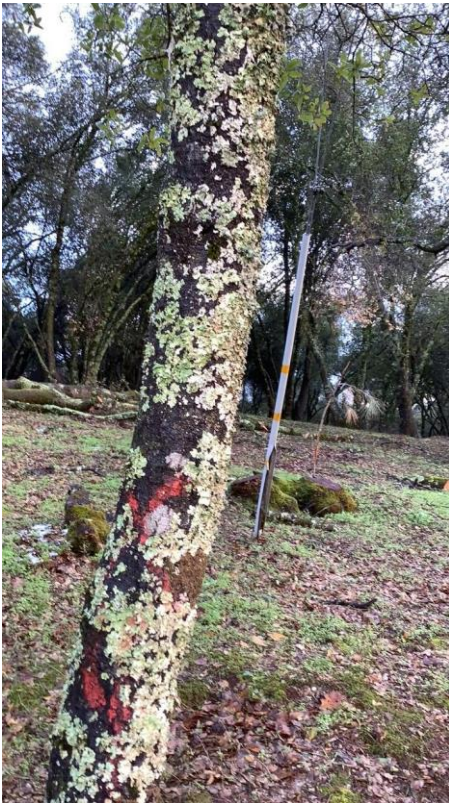
Figure 5 Item13GW2Img3: Red "X" on trunk of Interior Live Oak
