NOD_ MJ4_ PGE_ 20211203_ 01

NOTICE OF DEFECT

Energy Safety Inspection Report

On December 3, 2021, Energy Safety inspector Mahdi Jahami performed a walking inspection in Grass Valley in Nevada County. The goal of this inspection was to verify 1.3-line miles of covered conductor installed as part of PG&E’s system hardening initiative (2021 WMP initiative 7.3.3.17.1). Detailed findings from this field inspection are laid out in Section II below.

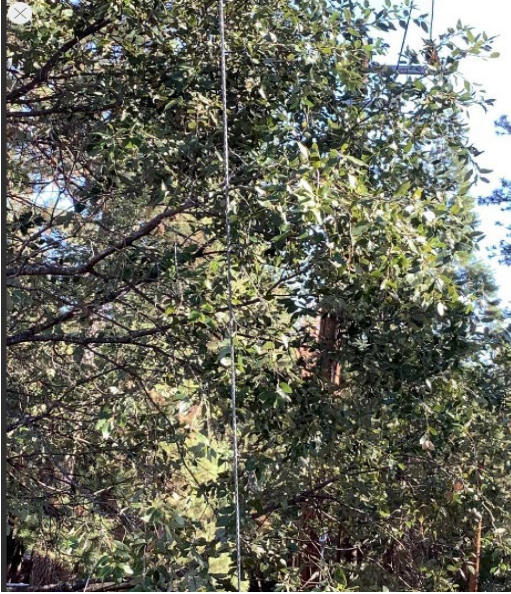
Structure ID: 120768666

1. Defect 1: Structures 120768666, 120798920, and 120851082 had vegetation contacting guy wires above the insulator. Guy wires can become energized and pose an increased ignition risk if in contact with vegetation. Energy Safety considers this defect to be in the Minor Risk category. Energy Safety inspector found three (3) defects of this type.

During the inspection, Energy Safety discovered several instances where vegetation was in contact with a guy wire above the insulator. Guy wires are metallic and can become energized in some circumstances. Insulators break the current path and prevent electricity from reaching the ground where a down guy wire is anchored. However, the portion above the insulator may remain energized until the circuit is deenergized and may cause an ignition if in contact with vegetation while energized. Accordingly, Energy Safety considers vegetation in contact with down guy wires above the insulator a condition that increases an electrical corporation's ignition risk. Structures where vegetation was in contact with the guy wire above the insulator are noted in Table 2.

Photo 1: Picture of vegetation contacting the guy wire

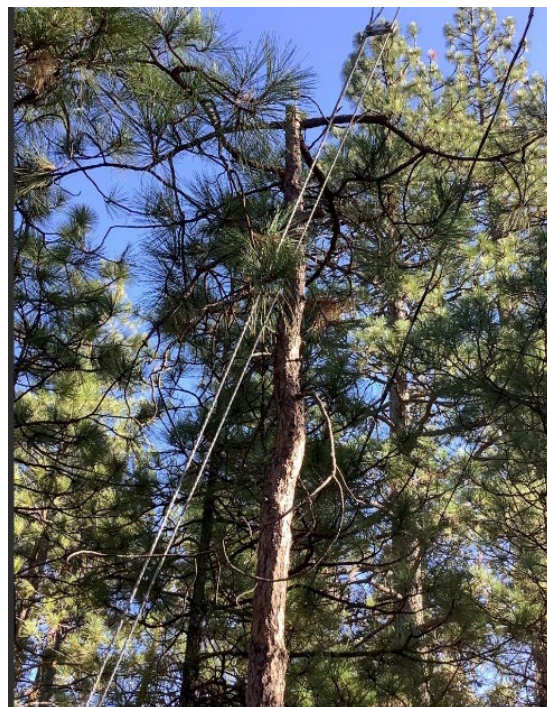
Structure ID: 120798920

Photo 3: Picture of vegetation contacting the guy wire

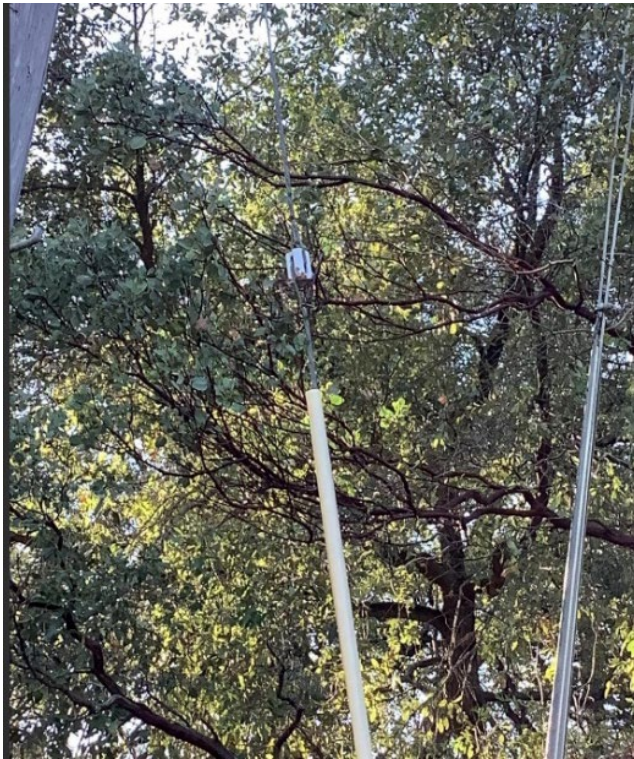
Structure ID: 120851082

Photo 3: Picture of vegetation contacting the guy wire
