NOTICE OF VIOLATION

Energy Safety Inspection Report

Report Name: SCE_EDC_20211116-01

On November 16, 2021, I performed a walking inspection of Southern California Edison (SCE) covered conductor installations, 2021 WMP initiative number 7.3.3.3.1, in the city of Simi Valley. I was accompanied by Energy Safety staff Gary Candelas, Ivan Garcia, and Anthony Trujillo. Detailed findings from this field inspection are laid out in Section II below.

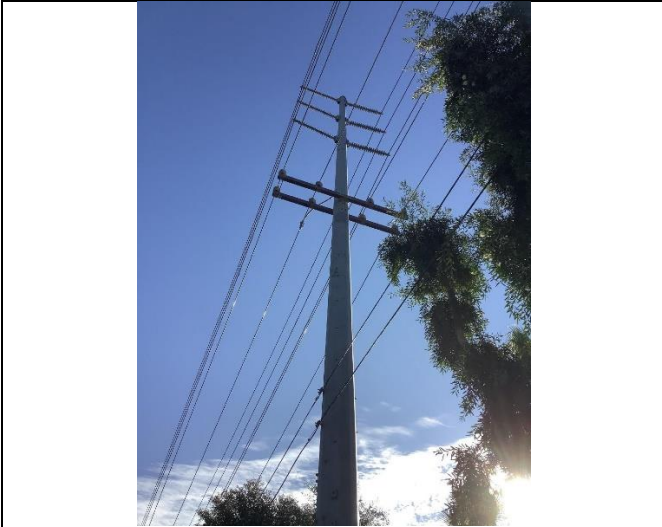
Structure ID: 4194273E

Item1IA1mg1: No vibration dampers installed

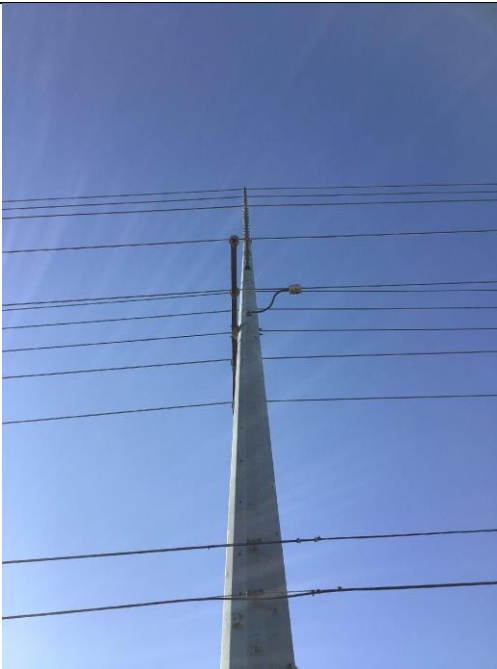
Structure ID: 4194270E

Item2IA1mg1: No vibration dampers installed

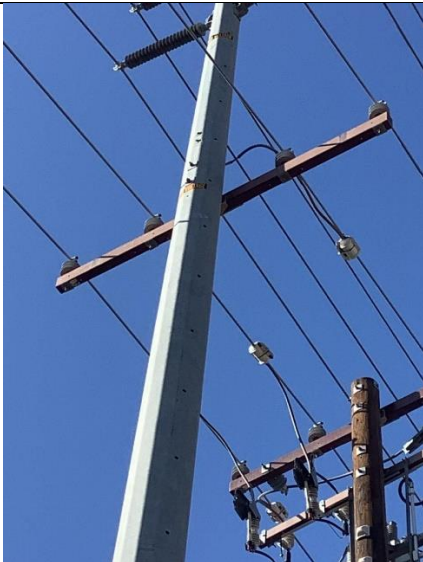
Structure ID: 1922869E

Item3IA1Img1: No vibration dampers installed

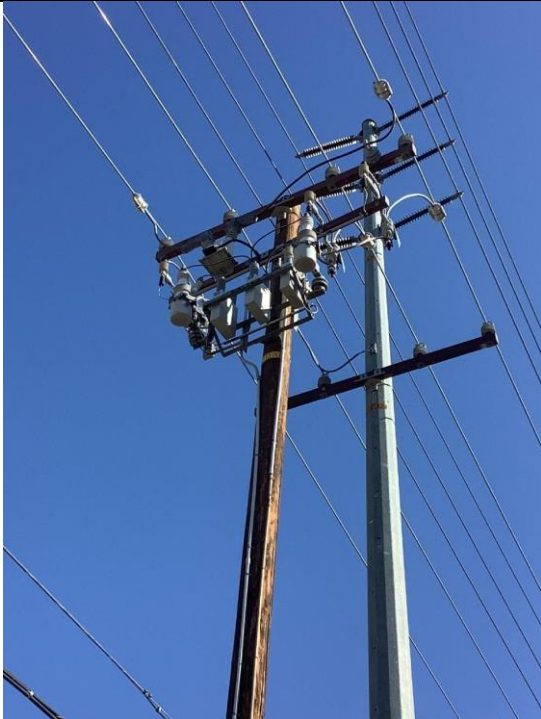
Structure ID: 4706494E

Item4IA1Img1: No vibration dampers installed

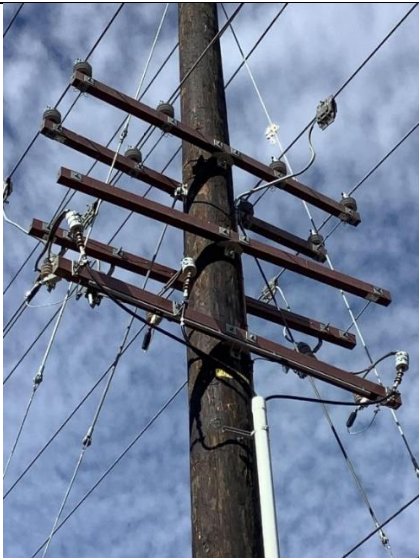
Structure ID: 1922867E

Item5IA1Img1: No vibration dampers installed

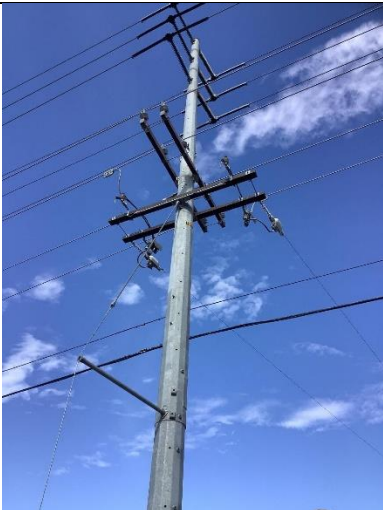
Structure ID: 1922864E

Item6IA1Img1: No vibration damper installed

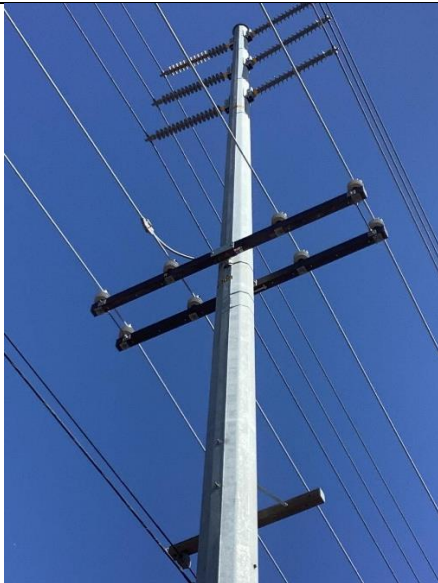
Structure ID: 4477212E

Item7IA1Img1: Vibration dampers not installed

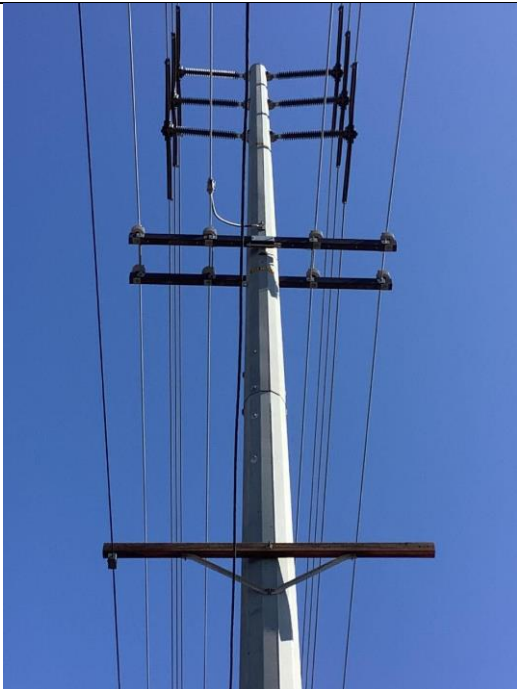
Structure ID: 4477225E

Item8IA1Img1: No vibration dampers installed

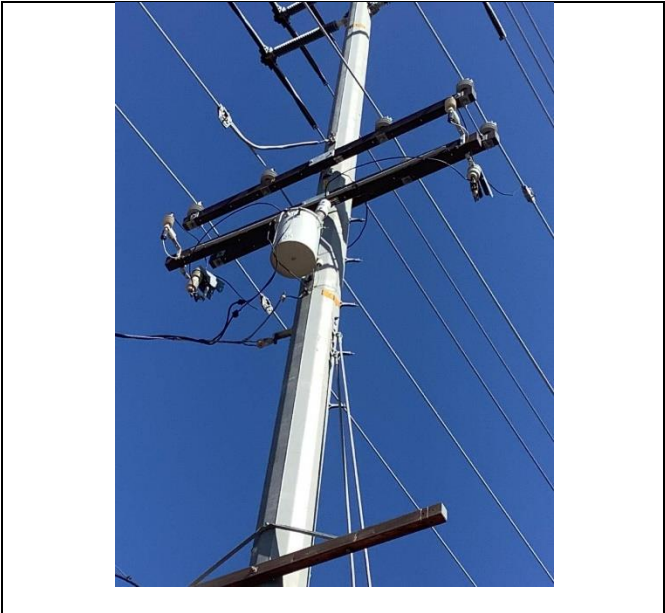
Structure ID: 1922664E

Item9IA1Img1: No vibration dampers installed

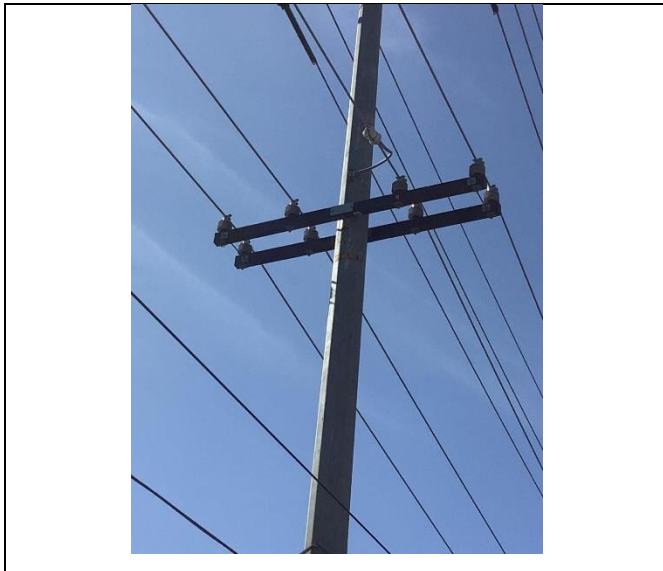
Structure ID: 447723E

Item10IA1Img1: No vibration dampers installed

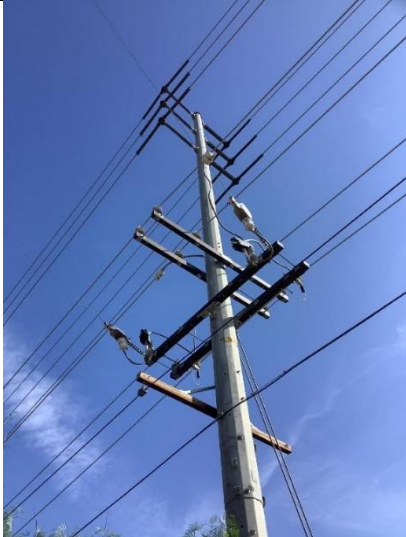
Structure ID: 4477222E

Item11IA1img1: No vibration dampers installed

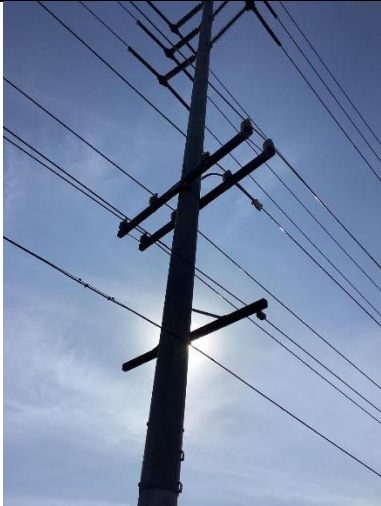
Structure ID: 4477218E

Item12IA1Img1: No vibration dampers installed

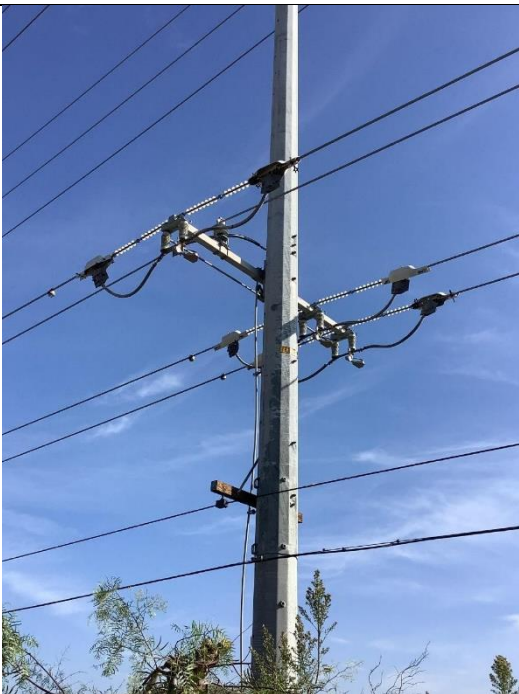
Structure ID: 4477214E

Item13IA1img1: No vibration dampers installed

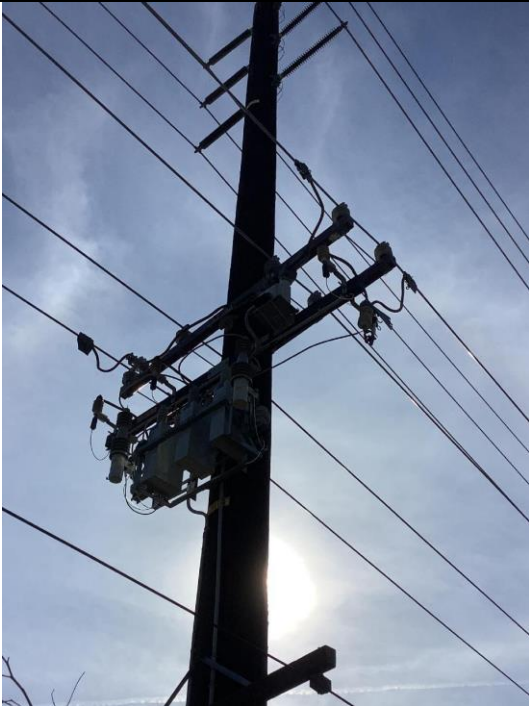
Structure ID: 4477211E

Item14IA1Img1: No vibration dampers installed

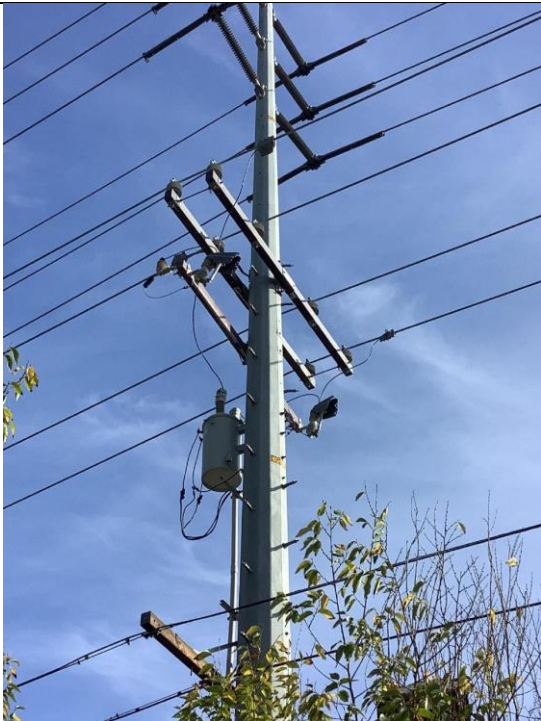
Structure ID: 1922653E

Item15IA1Img1: No vibration dampers installed

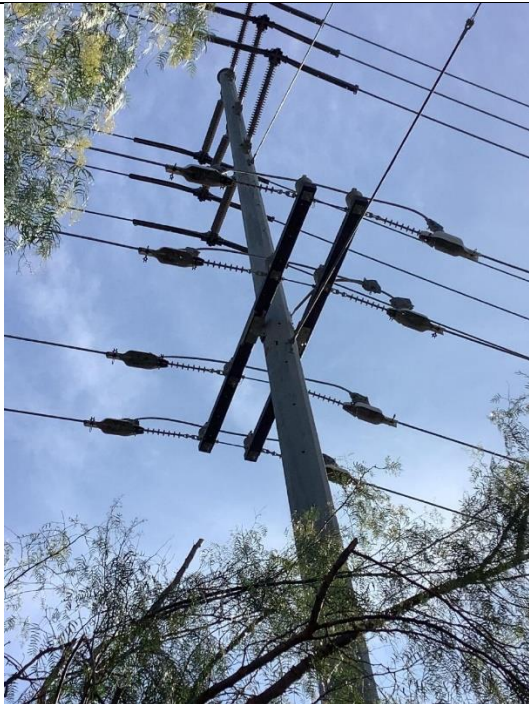
Structure ID: 4476901E

Item16IA1Img1: No vibration dampers installed
