NOV\_SCE\_EDC\_ 20211117-01

## **NOTICE OF VIOLATION**

# Energy Safety Inspection Report

On November 17, 2021, I performed a walking inspection of Southern California Edison (SCE) covered conductor installations, 2021 WMP initiative number 7.3.3.3.1 in the cities of Camarillo and Moorpark. I was accompanied by Energy Safety Utilities Engineers Anthony Trujillo, Ivan Garcia, and Environmental Scientist Gary Candellas. Detailed findings from this field inspection are laid out in Section II below.

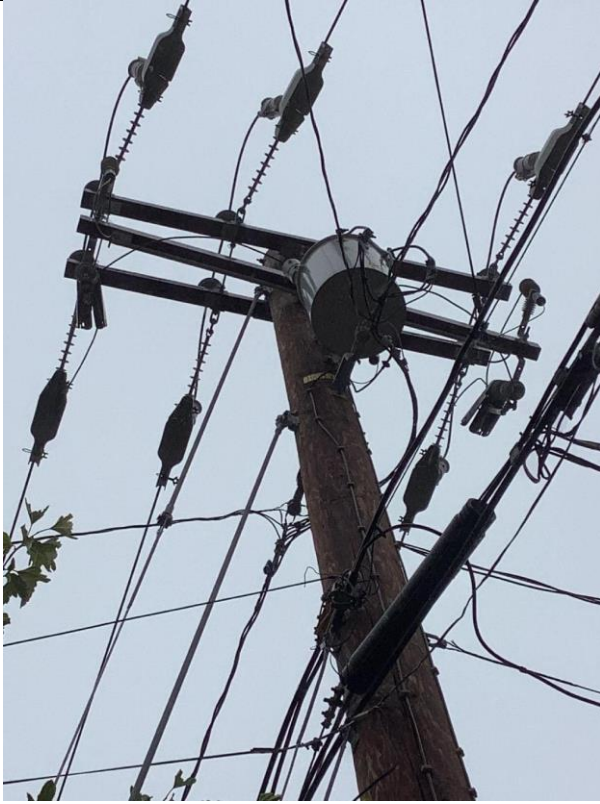
Structure ID: 382960E

1. Violation 1: Per SCE's Distribution Design Standards (DDS), Section DDS-10, page 10-82, "for the 336 (30/7) ACSR covered conductor, vibration dampers shall be installed on every span in both light loading and heavy loading areas," and SCE's Distribution Overhead Construction Standards (DOH), Section CC 190, page 1 of 11, vibration dampers are required when installing covered conductor. Poles numbered 382960E, 732562E, 4315280E, 1401817E, 1401818E, 1500596E, 2091458E, 1147448E, 4881031E, 1441491E, and 4434920E had covered conductor installed but failed to install vibration dampers. Energy Safety considers this violation for failure of adhering to protocol to be in the Minor risk category.

**Item1IA1mg1:** Vibration dampers are missing

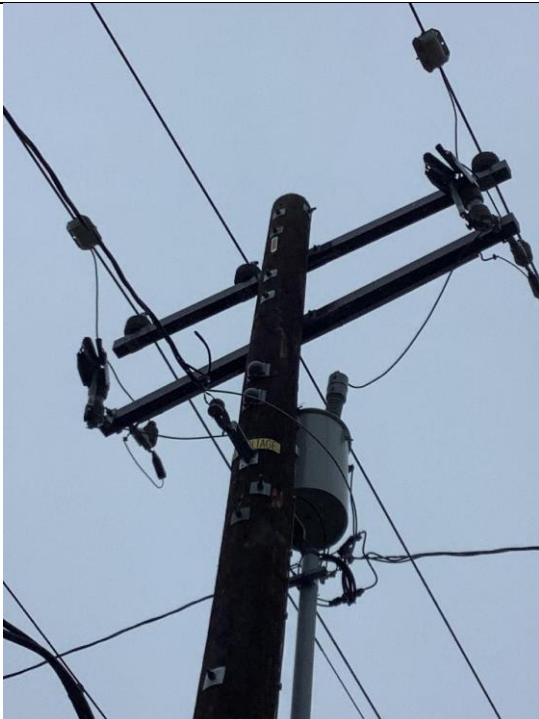
Structure ID: 732562E

Item2IA1Img1: Vibration dampers are missing

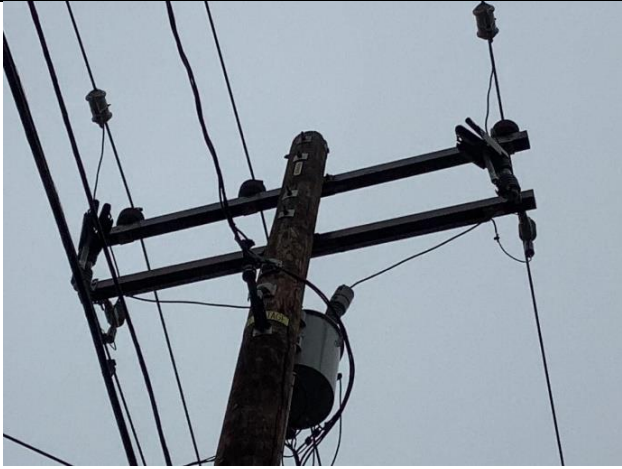
Structure ID: 4315280E

<p>Item3IA1img1: Vibration dampers are missing</p>

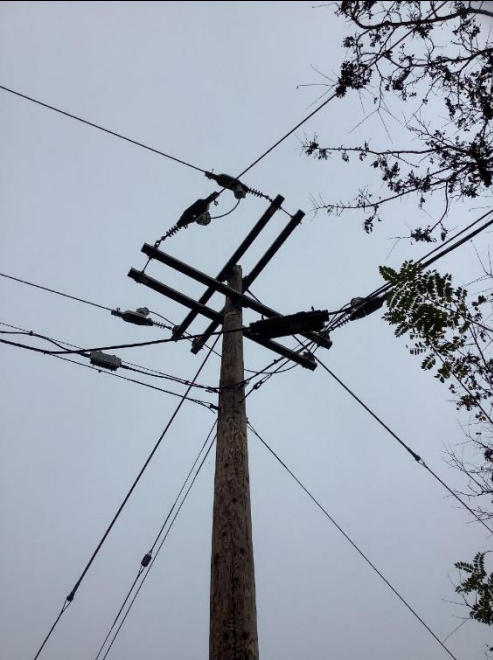
Structure ID: 1401817E

Item4IA1Img1: Vibration dampers are missing

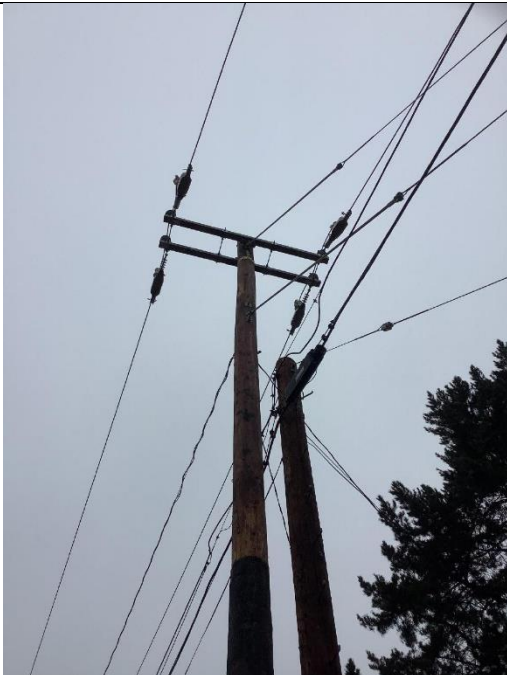
**Structure ID:** 1401818E

**Item5IA1Img1:** Vibration dampers are missing

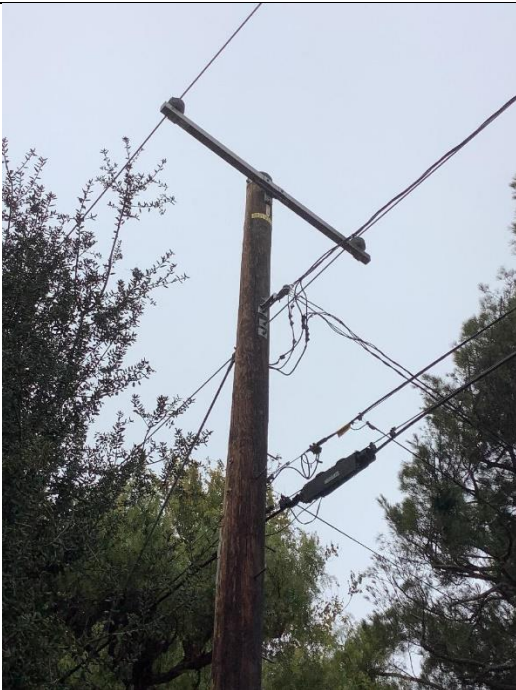
Structure ID: 1500596E

Item6IA1mg1: Vibration dampers are missing

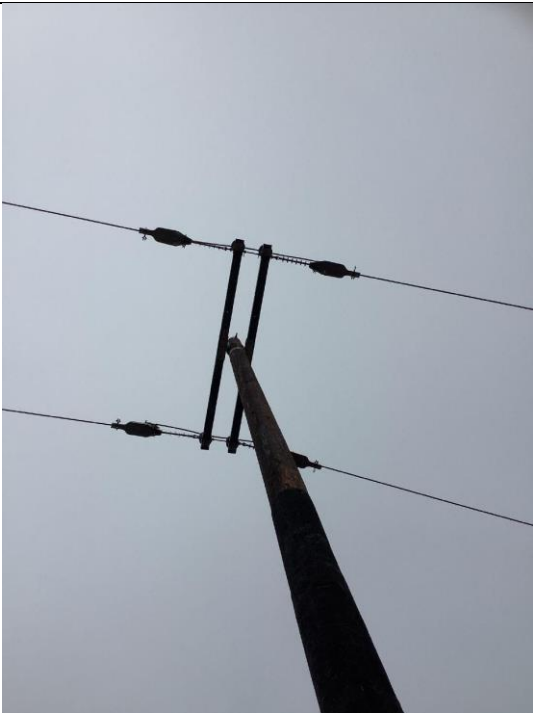
Structure ID: 2091458E

Item7IA1mg1: Vibration dampers are missing

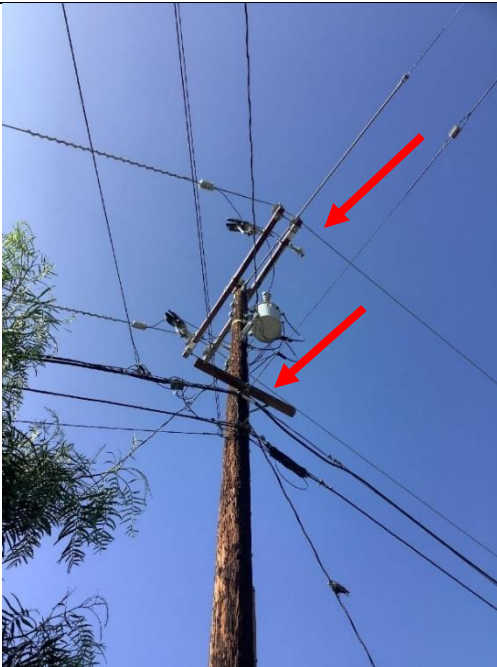
Structure ID: 1147448E

Item8IA1mg1: One side vibration dampers installed

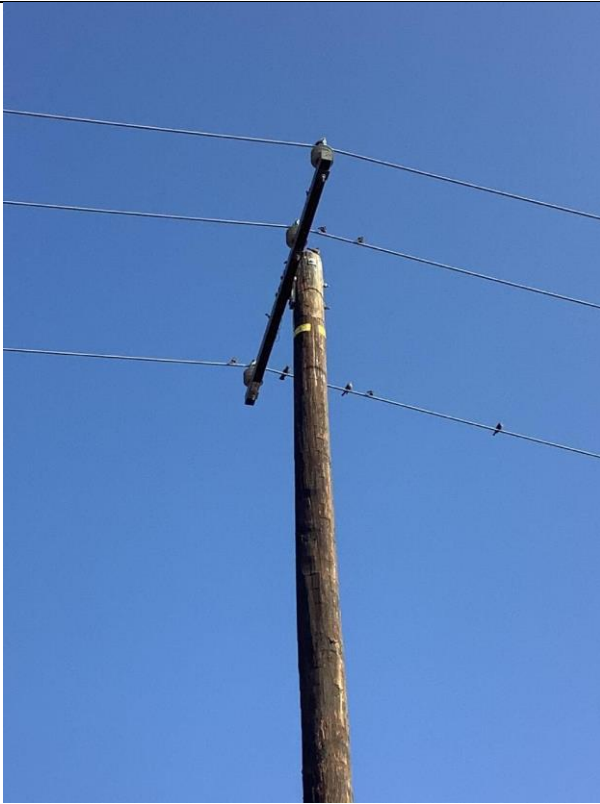
Structure ID: 4881031E

**Item10IA1mg1:** Vibration dampers are missing

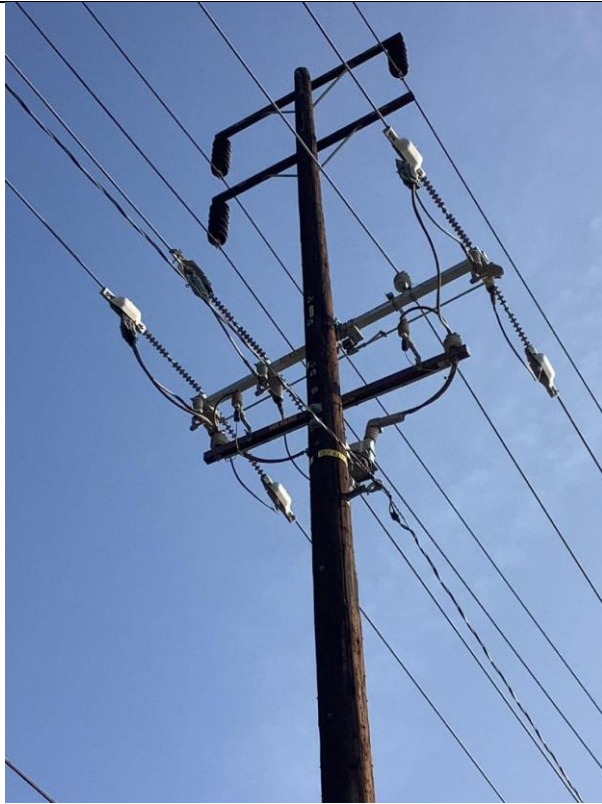
**Structure ID:** 1441491E

**Item11IA1mg1:** Vibration dampers are missing

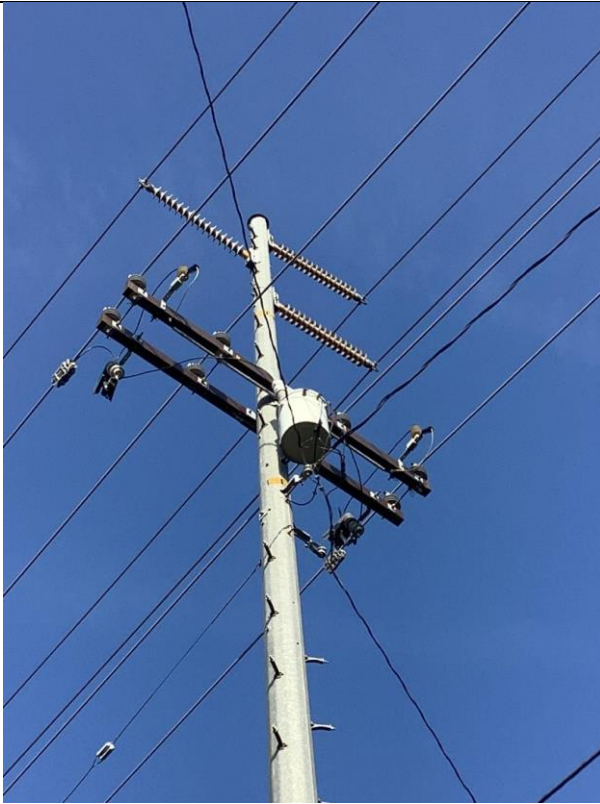
**Structure ID:** 4434920E

**Item12IA1mg1:** Vibration dampers are missing
