NOV_SCE_EDC_ 20211207-01

NOTICE OF VIOLATION

Energy Safety Inspection Report

Report Name: SCE_EDC_20211207-01

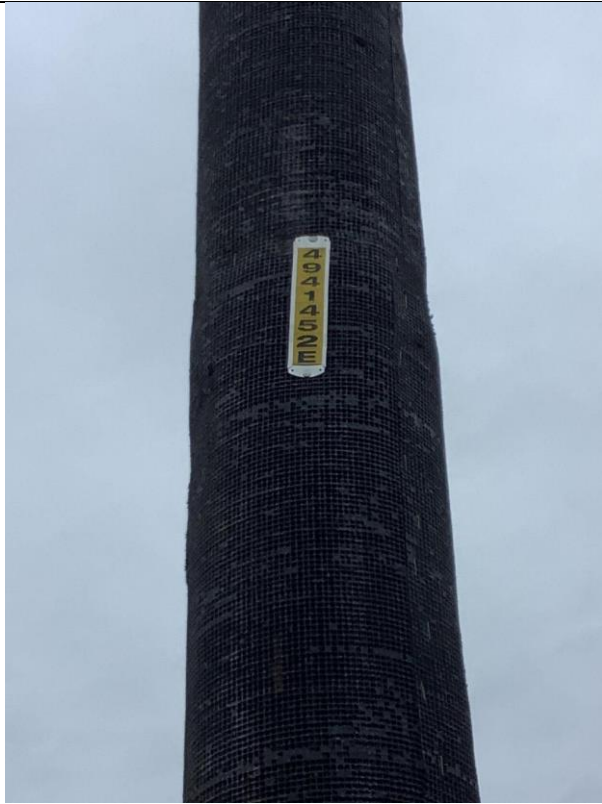
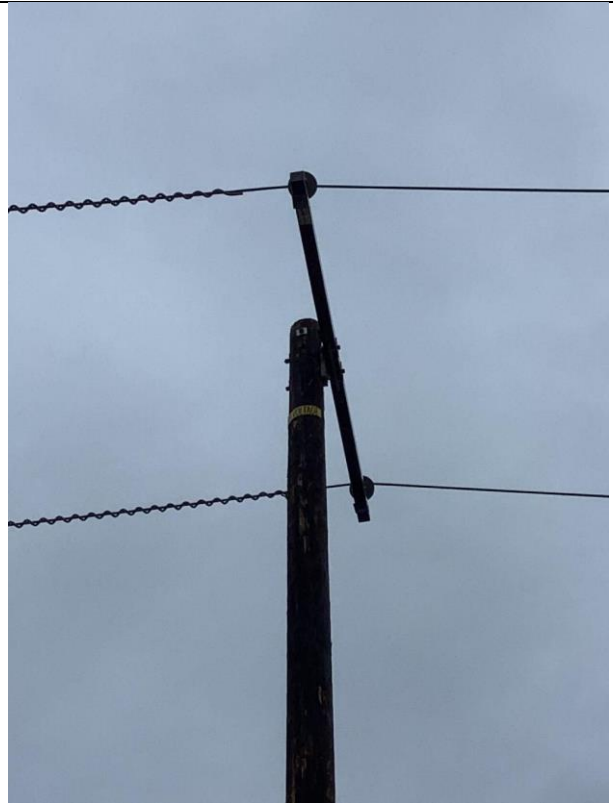
Structure ID: 4941452

1. Violation 1: At poles numbered 4941453, 4941452, and 4941454 the pole identification tag did not match the identification number provided by SCE in its Quarterly Data Report (QDR). Energy Safety considers this data accuracy violation to be in the Minor risk category.
2. Violation 2: Per SCE's Distribution Overhead Construction (DOH), Section CC 150, page 3 of 5, covered conductor double dead-end construction, "if conductor is exposed, install bolted wedge connector cover." Also, DDS, Section 10, 5.7.C.1.f. states, "Covered conductor systems shall be an all-covered system." Per SCE's DOH, Section CC 150.4, page 5 of 5, "All overhead equipment shall utilize appropriate wildlife covers." Pole numbered 4415240E did not have bolted wedge connector cover installed at a double dead end

Item2GImg1: Pole ID

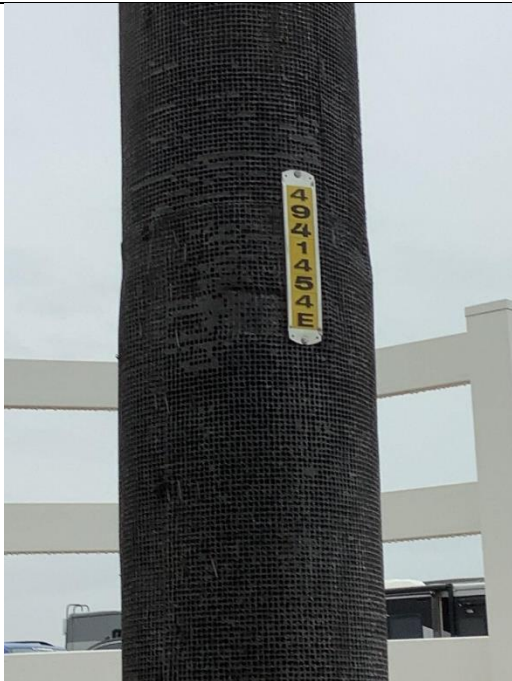
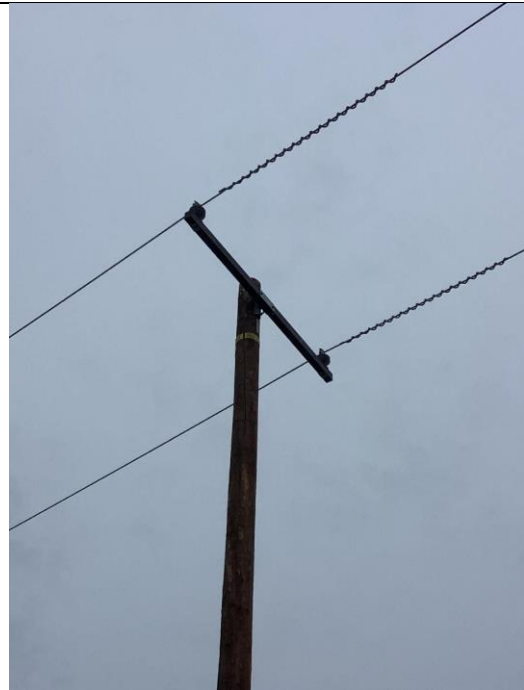
Structure ID: 4941454E

Item3GImg1: Pole ID

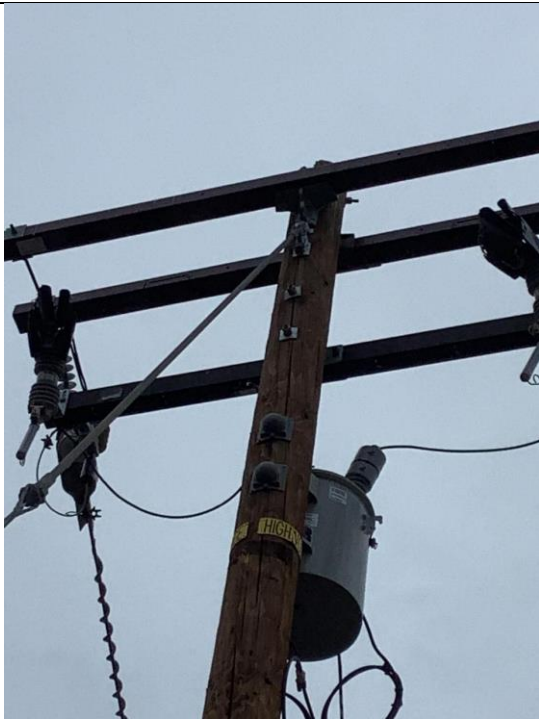
construction. Pole numbered 1289688E did not have a cover on the surge arrester clamp. Energy Safety considers this a violation for failure of adhering to protocol and in the Minor risk category.

Item4IA1Img1: Surge arrester clamp not covered

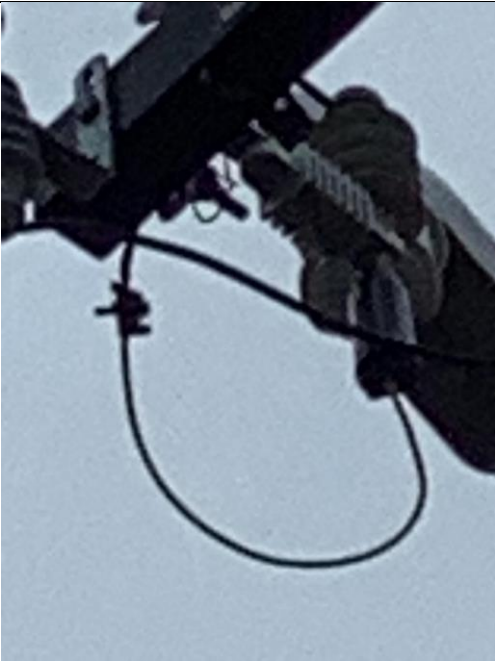
Item4IA2Img1: Close up of clamp not covered

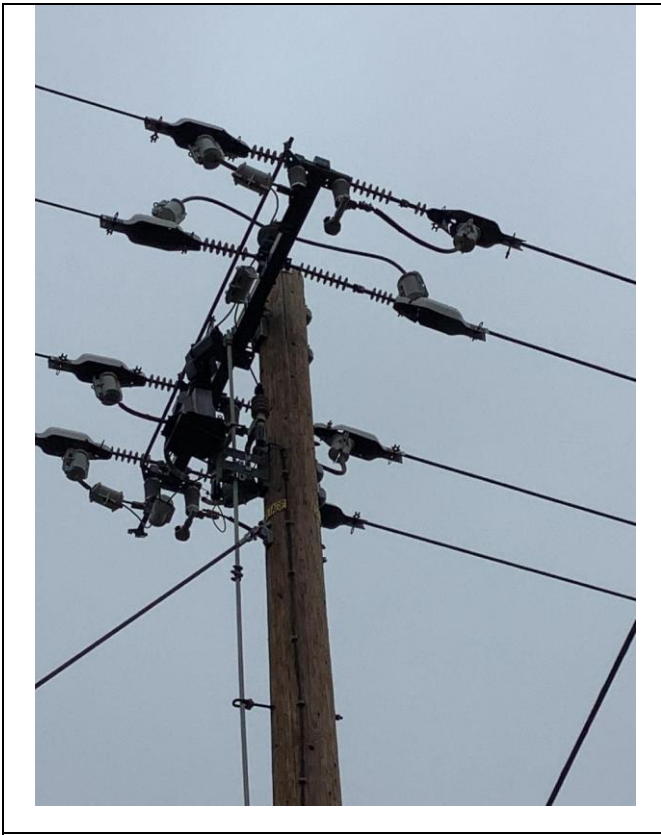
Per SCE's DDS and DOH, when installing covered conductor, vibration dampers must also be installed.² Energy Safety staff found that vibration dampers were not installed at multiple structures where covered conductor installation was completed. The structures missing vibration dampers where covered conductor was installed are identified in Table 2 above. On November 19, 2021, SCE submitted a memo to Energy Safety titled, "Interim Deviation from Standards on Vibration Damper for Covered Conductor" (hereafter, "Memo"). This Memo was dated August 18, 2021, and indicates that due to supply chain issues, SCE will suspend the installation of vibration dampers until December 31, 2021. In accordance with SCE's Q2 QDR submission, the covered conductor installations inspected by Energy Safety were completed prior to the issuance of the Memo. Also, SCE informed Energy Safety of this supply chain issue only after inspections commenced. Consequently, Energy Safety finds

Item5IA1Img1: No vibration dampers installed

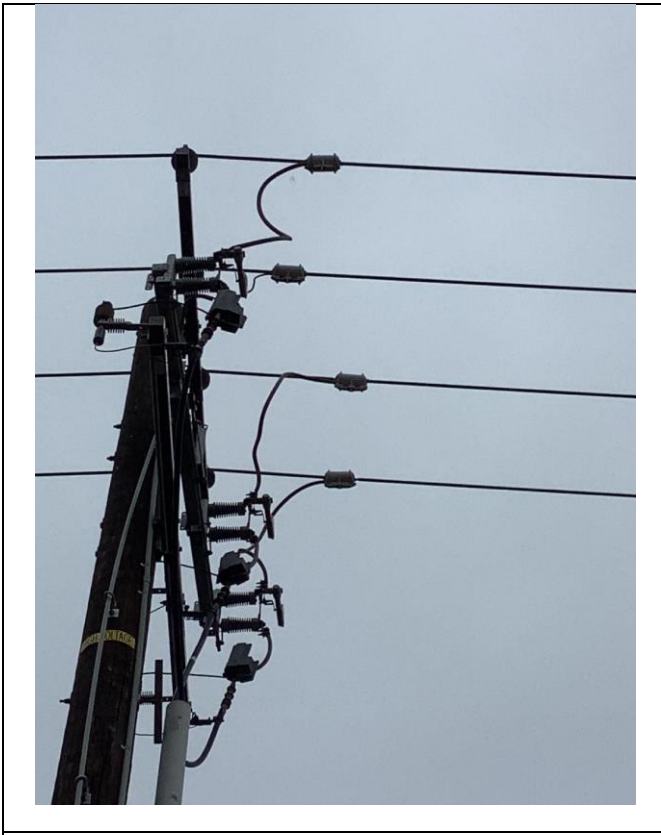
Item6IA1img1: No vibration dampers installed

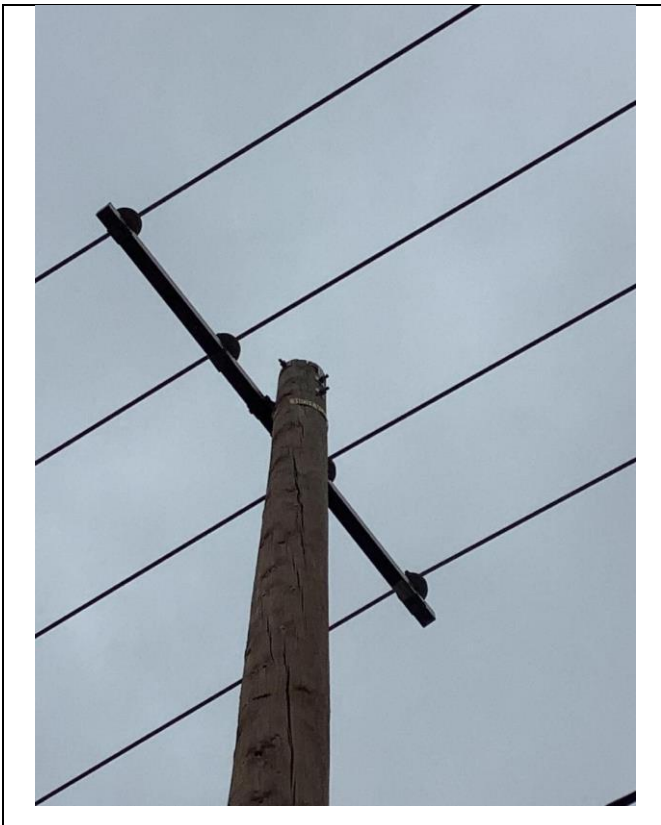
Item7IA1Img1: No vibration dampers installed

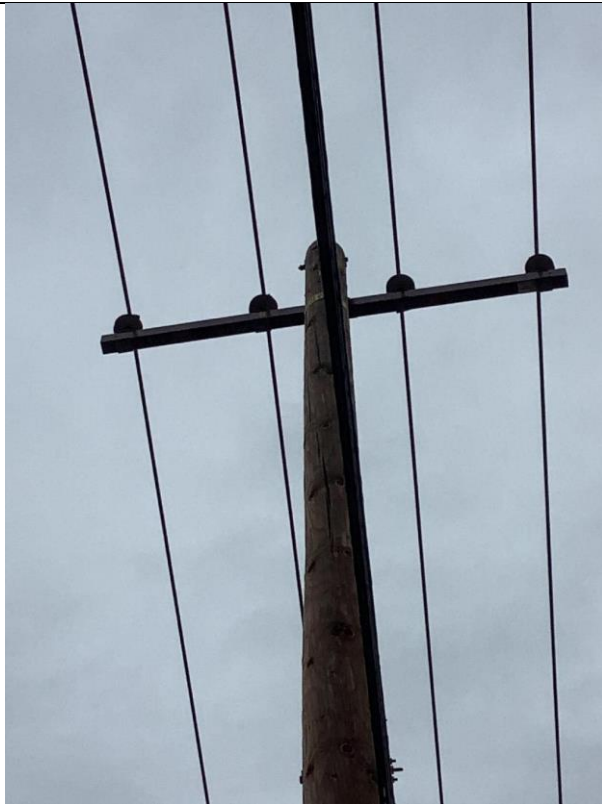
Item8IA1Img1: No vibration dampers installed

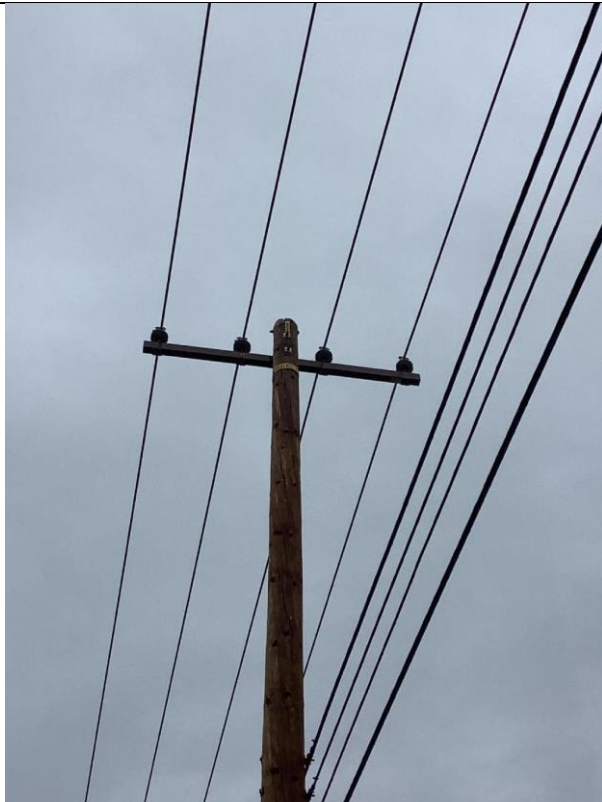
Item9IA1Img1: No vibration dampers installed

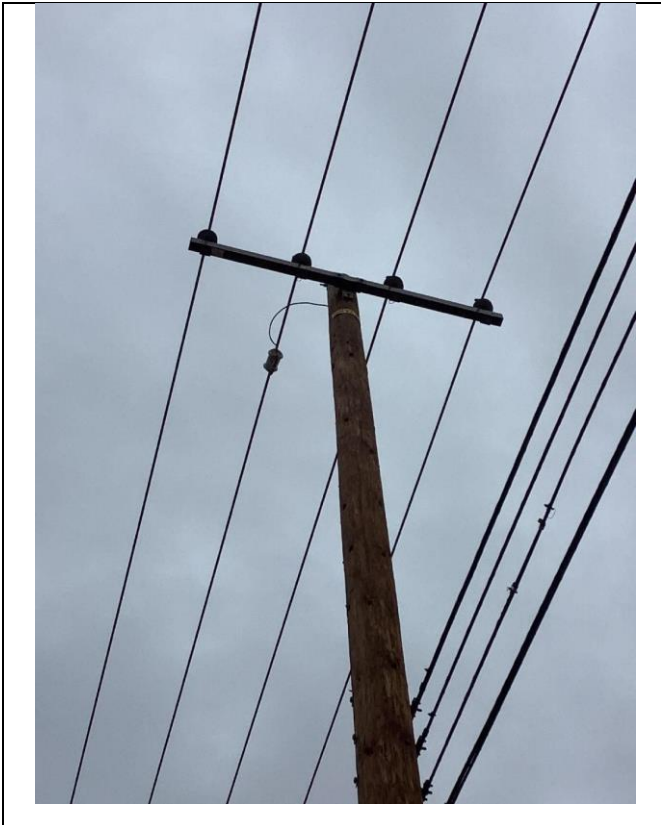
Item10IA1Img1: No vibration dampers installed

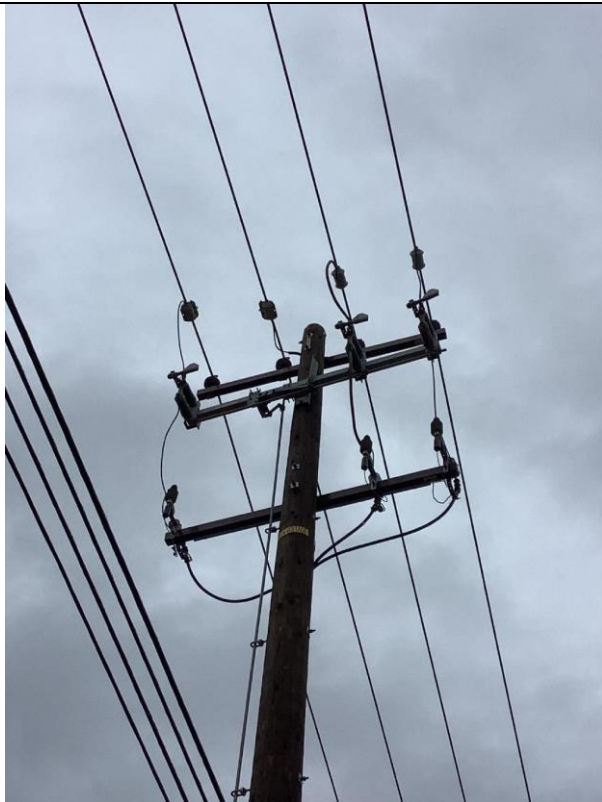
Item11IA1Img1: No vibration dampers installed

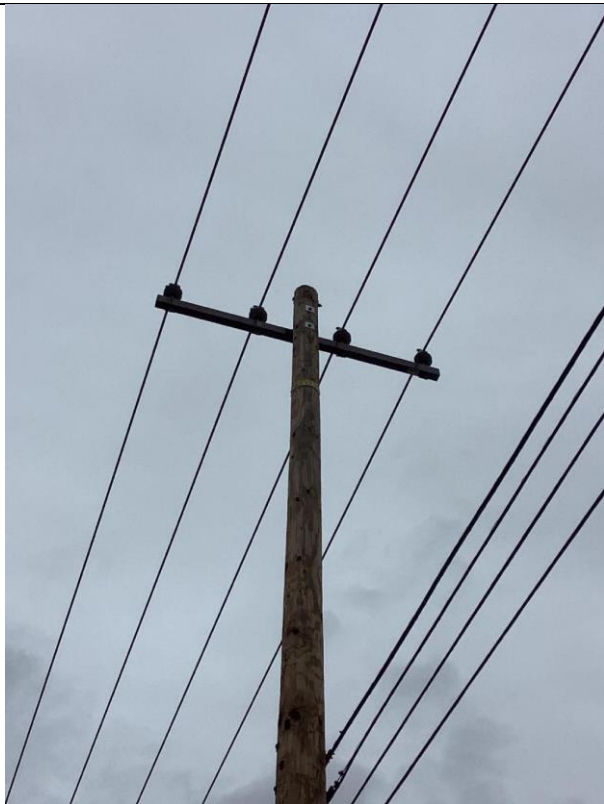
Item12IA1Img1: No vibration dampers installed

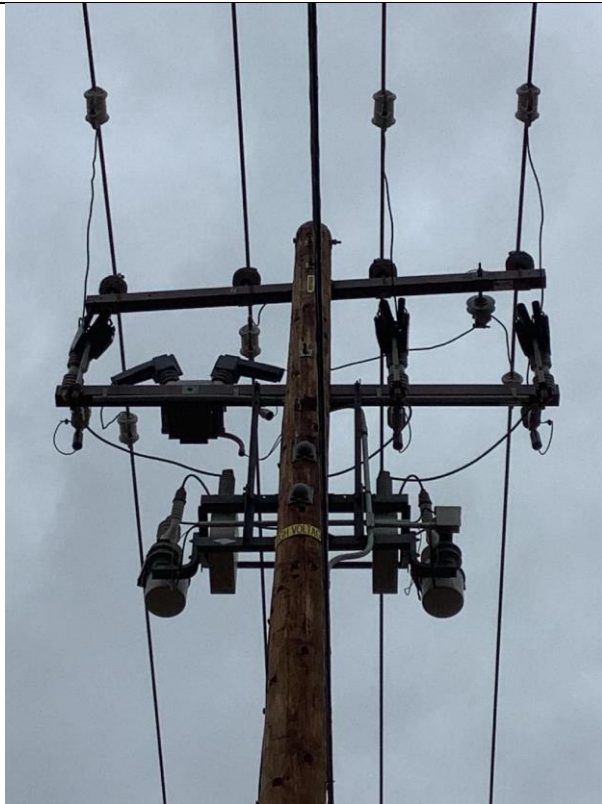
Item13IA1Img1: No vibration dampers installed

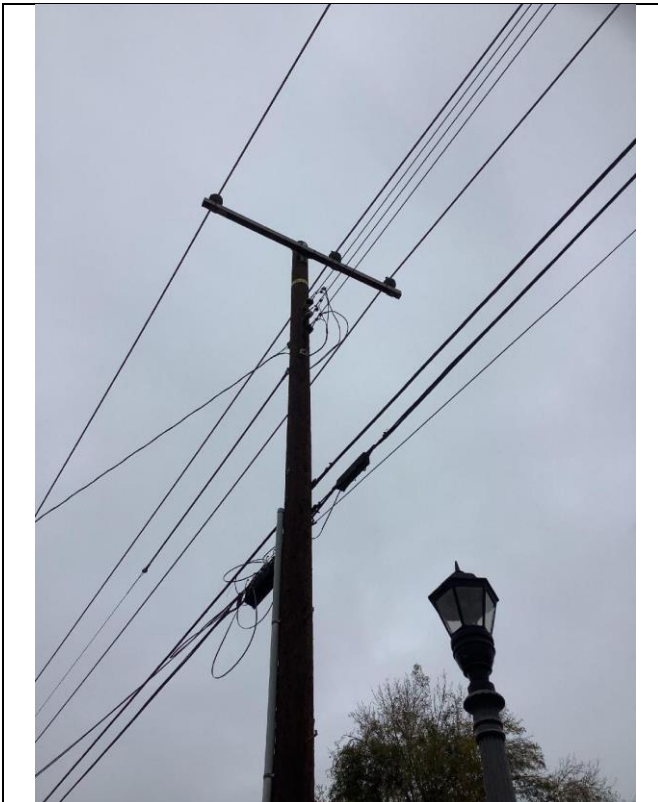
Item14IA1Img1: No vibration dampers installed

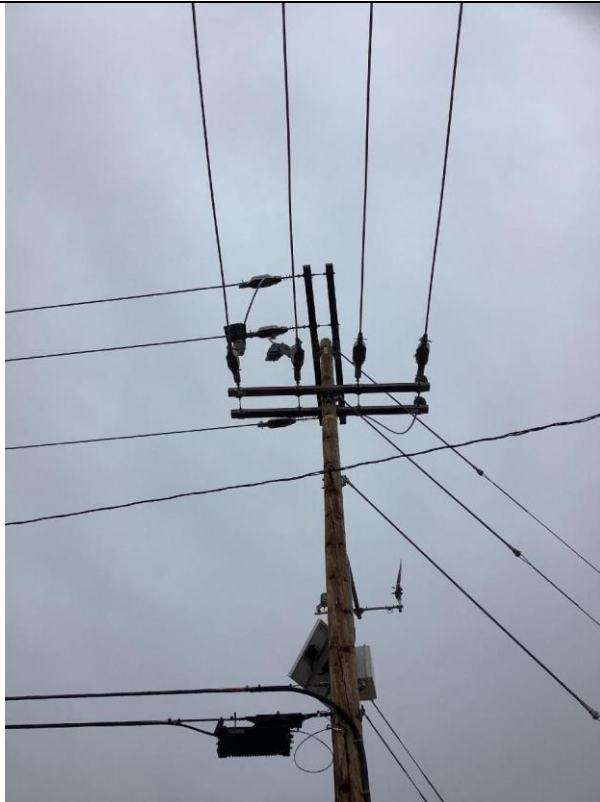
Item15IA1img1: No vibration dampers installed

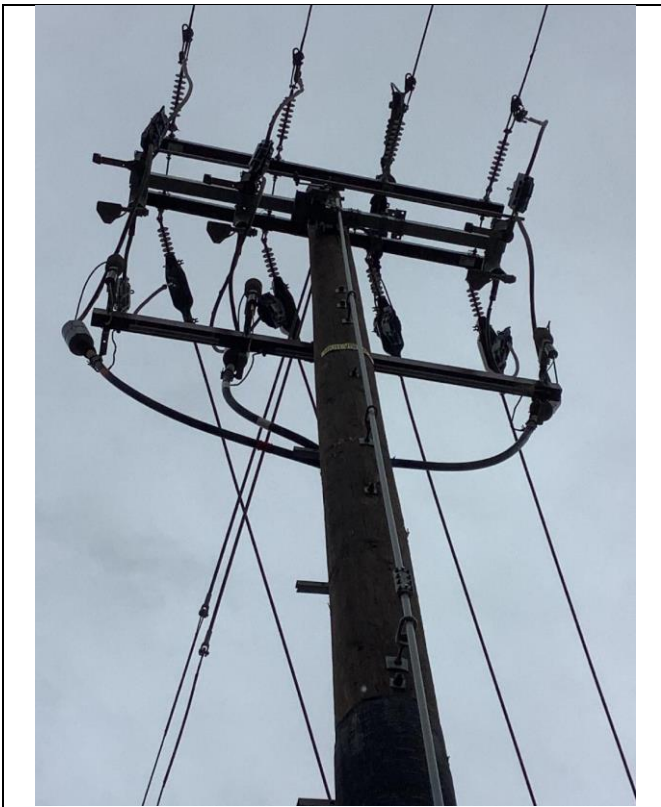
Item16IA1Img1: No vibration dampers installed

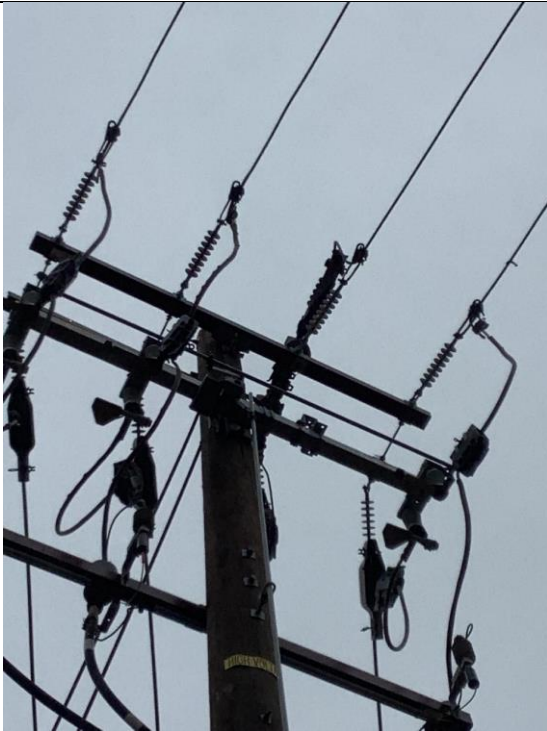
Per SCE's Distribution Overhead Construction Standards (DOH), in circumstances of double dead end construction on 4-wire covered conductor installations, if conductor is exposed, bolted wedge connector covers must be installed.¹ Also, SCE's Distribution Design Standards (DDS), Section 10, 5.7.C.1.f. states, "Covered conductor systems shall be an all-covered system." Per SCE's DOH, Section CC 150.4, page 5 of 5, "All overhead equipment shall utilize appropriate wildlife covers." This means that wildlife covers shall be installed on dead-ends, terminations, connectors, equipment bushings, and any partially covered exposed conductor. Energy Safety observed structures that did not have a wildlife cover on bolted wedge connectors nor on a surge arrestor. The structures where Energy Safety observed this violation of adherence to protocol are noted in Table 2 above.

Item16IA2Img1: Bolted wedge connector cover not installed

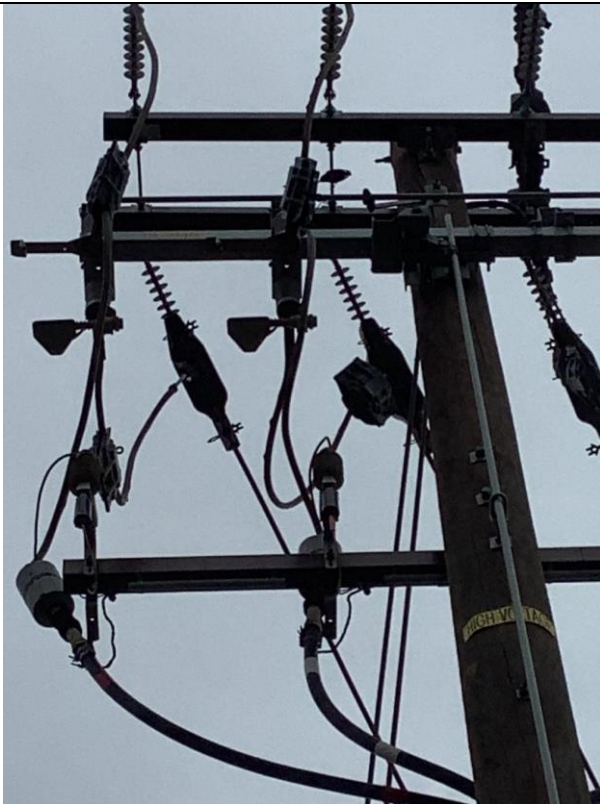
Item16IA3Img1: No cover on jumper wire

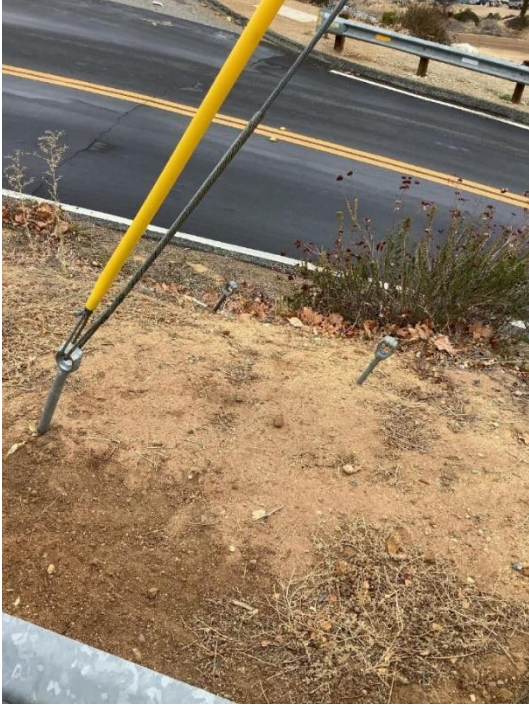
4. Violation 4: Per SCE's protocols for DOH, PO 300 page 9 of 9, “when an anchor location is abandoned, the rod and plate shall be removed if in a hazardous or potentially dangerous location. Otherwise, cut the rods off at least 12 inches below the ground line and abandon the remaining anchor. Screw anchor rods may be either unscrewed or cut off. Under no conditions should the rod be bent over or left exposed.” Energy Safety identified pole numbered 4415240E in violation of this protocol. The pole was replaced and the guy anchors were left in the ground unused. Energy Safety considers this violation to be in the Minor severity risk category.

Per SCE's DOH, PO 300 page 9 of 9, when a guy anchor location is abandoned, the rod and plate shall be removed if in a hazardous or potentially dangerous location. Otherwise, cut the rods off at least 12 inches below the ground line and abandon the remaining anchor. Screw anchor rods may be either unscrewed or cut off. Under no conditions should the rod be bent over or left exposed. Structures where this protocol was not followed are noted in Table 2 above. The pole was replaced, and there were two guy anchors left in the ground not being used. The potential for someone to trip and fall is due to the guy anchor being left in place and not used.

Item16IA4Img1: Guy anchors left in in the ground

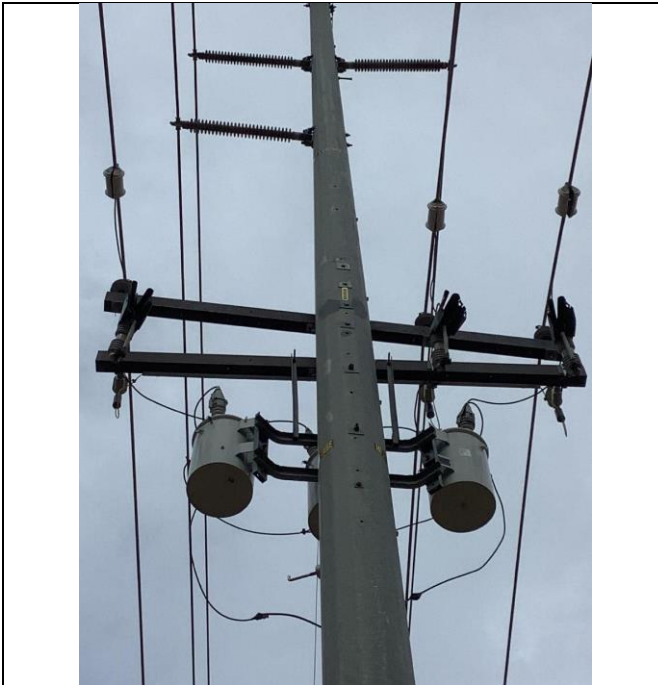
Item18IA1mg1: No vibration dampers installed

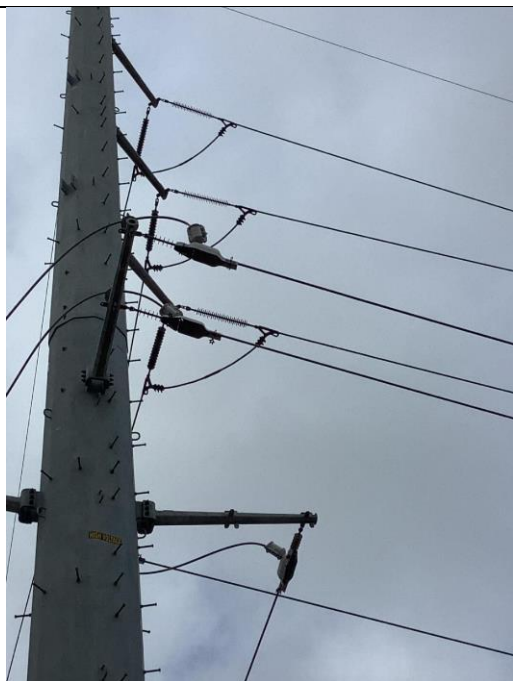
Item20IA1img1: No vibration dampers installed
