NOV_SCE_IAG_ 20211116-01

NOTICE OF VIOLATION

Energy Safety Inspection Report

Report Name: IAG_SCE_20211116-01

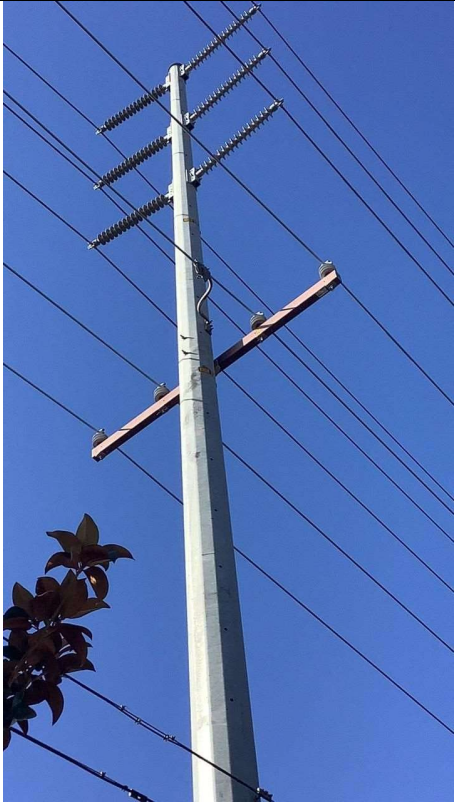
Item	Structure ID	HFTD	Initiative Number	Violation Type	Severity	Violation Description
1	4194272E	Tier 3	7.3.3.3.1	Adherence to Protocol	Minor	Failure to install vibration dampers on a span
2	4244431E	Tier 3	7.3.3.3.1	Adherence to Protocol	Minor	Failure to install vibration dampers on a span
3	1922868E	Tier 3	7.3.3.3.1	Adherence to Protocol	Minor	Failure to install vibration dampers on a span
4	1922865E	Tier 3	7.3.3.3.1	Data Accuracy	Minor	Pole type provided by SCE is incorrect. Reported pole type is a wood pole. The true pole type is a steel pole.
5	1922865E	Tier 3	7.3.3.3.1	Adherence to Protocol	Minor	Failure to install vibration dampers on a span
6	X11396E	Tier 3	7.3.3.3.1	Data Accuracy	Minor	Pole type provided by SCE is incorrect. Reported pole type is a wood pole. The true pole type is a steel pole.
7	X11396E	Tier 3	7.3.3.3.1	Adherence to Protocol	Minor	Failure to install vibration dampers on a span

Item1IA1Img1: No vibration dampers are installed

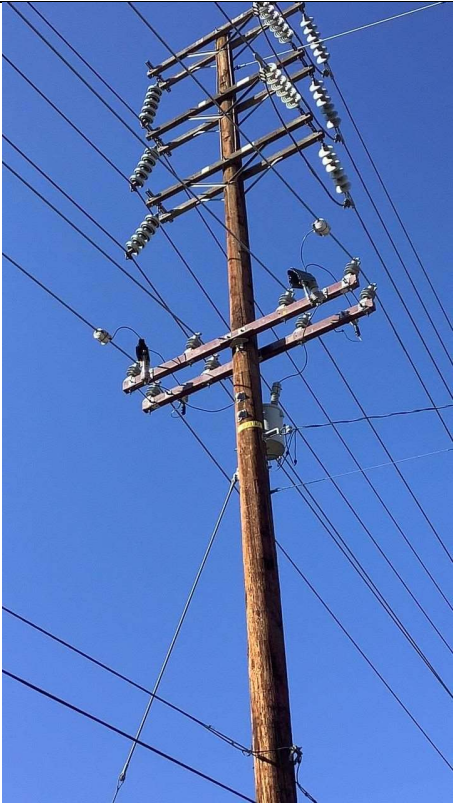
Item2IA1Img1: No vibration dampers are installed

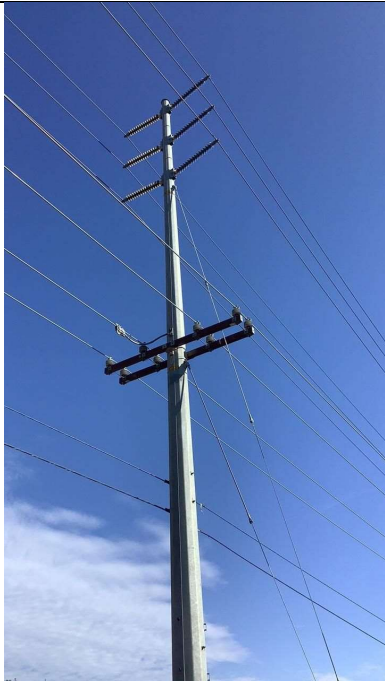
Item3IA1Img1: No vibration dampers are installed

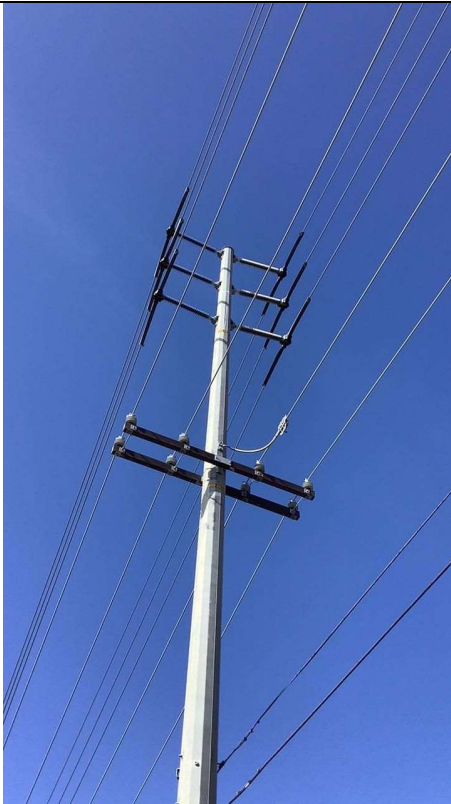
2. Violation 2: Energy Safety found three structures where the pole type (i.e., wood, steel, composite, etc.) provided by SCE did not match the pole type observed in the field. SCE reported poles 1922865E, X11396E, and 4477213E as wood. Energy Safety observed that

these were steel poles during inspections. Energy Safety considers this violation for providing inaccurate data to be in the Minor risk category.

Item4IA1img1: Steel pole observed in the field and no vibration dampers installed

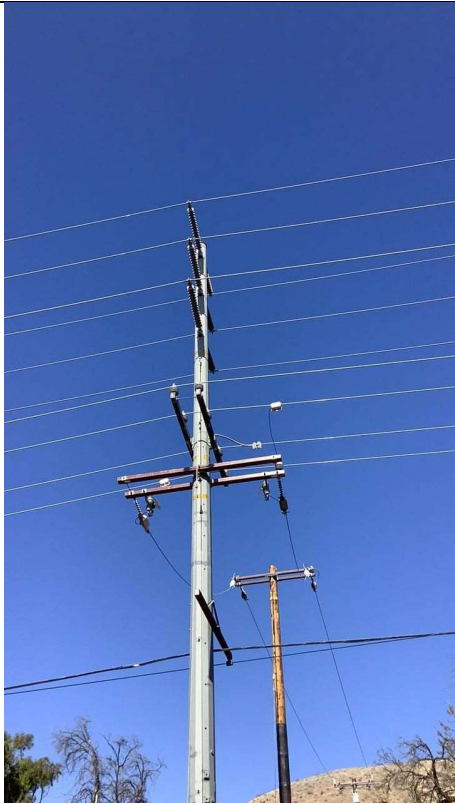
Item5IA1img1: Steel pole observed in the field and no vibration dampers are installed

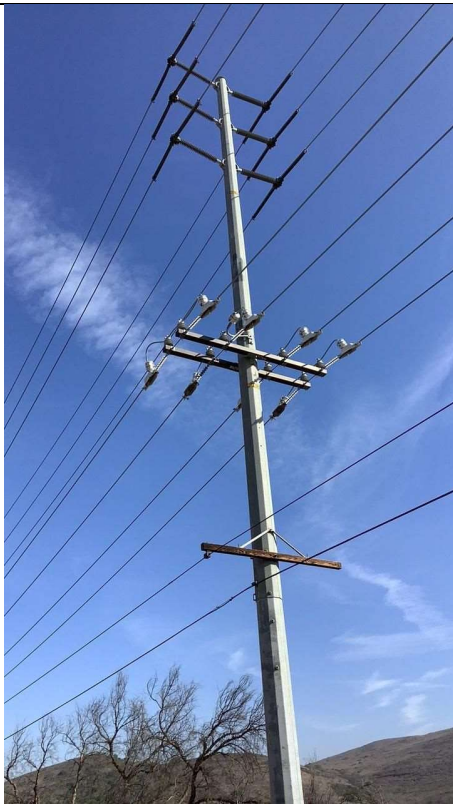
8	4477220E	Tier 3	7.3.3.3.1	Adherence to Protocol	Minor	Failure to install vibration dampers on a span
9	4477213E	Tier 3	7.3.3.3.1	Data Accuracy	Minor	Pole type provided by SCE is incorrect. Reported pole type is a wood pole. The true pole type is a steel pole.
10	4477213E	Tier 3	7.3.3.3.1	Adherence to Protocol	Minor	Failure to install vibration dampers on a span

Item8IA1Img1: No vibration dampers are installed

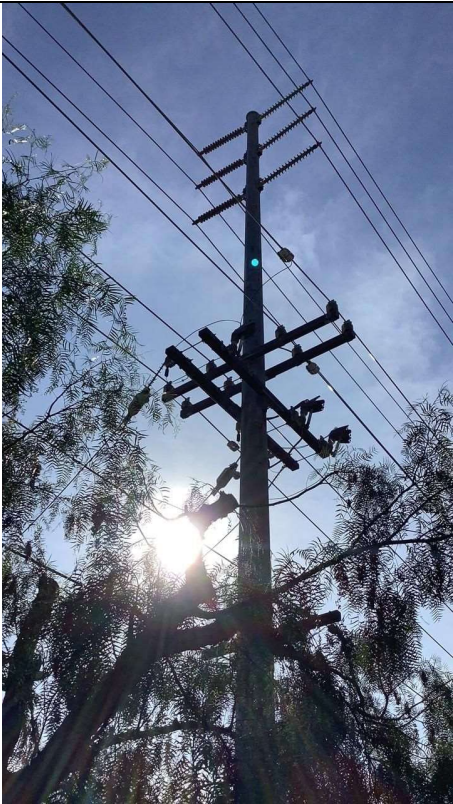
Item9IA1img1: Steel pole observed in the field and no vibration dampers are installed
