NOV_SCE_ATJ_ 20211117-01

NOTICE OF VIOLATION

Energy Safety Inspection Report

Report Name: ATJ_SCE_20211117-01

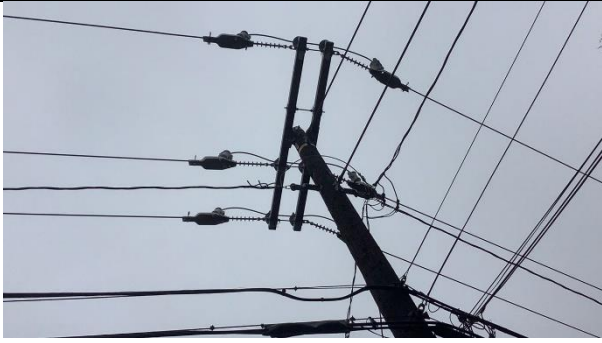
Structure ID: 732561H

Item1IA1mg1: Vibration dampers not installed

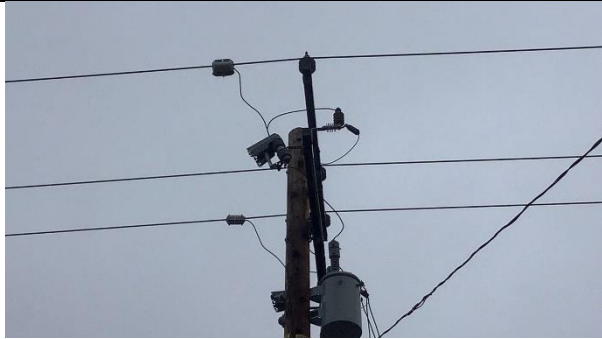
Structure ID: 984012E

Item2IA1Img1: Vibration dampers not installed

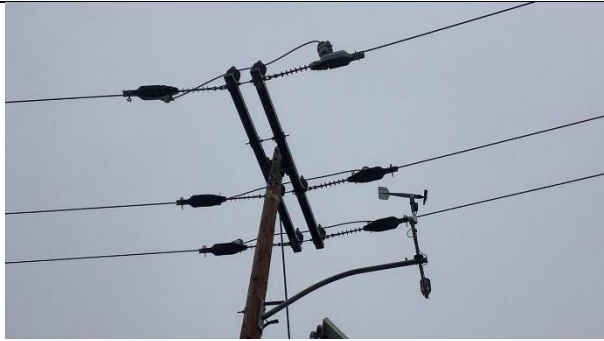
Structure ID: 4315279E

Item3IA2Img1: Vibration dampers not installed

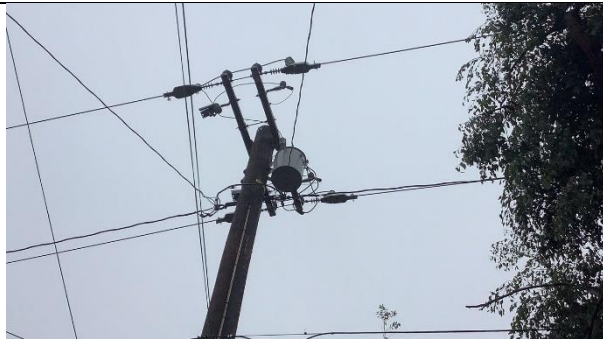
Structure ID: 1401819E

Item4IA1Img1: Vibration dampers not installed

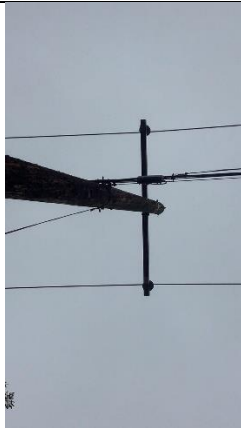
Structure ID: 2170090E

Item5IA1mg1: Failure to install vibration dampers

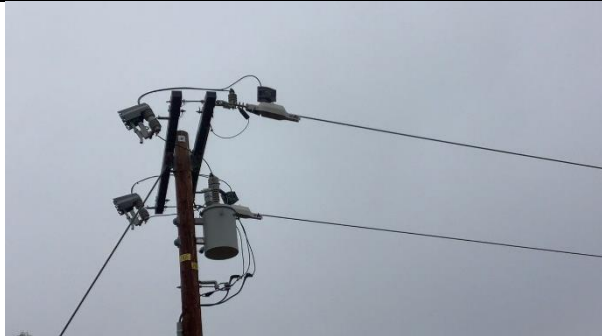
Structure ID: 4651152E

Item6IA1Img1: Vibration dampers not installed

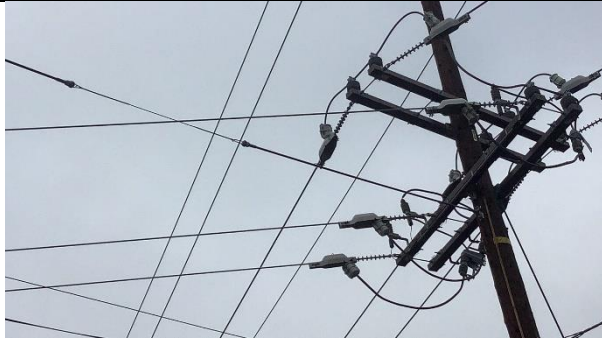
Structure ID: 1437878E

Item7IA1Img1: Vibration dampers not installed

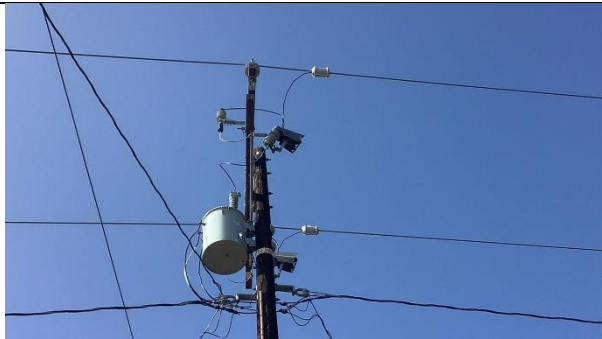
Structure ID: 1147445E

Item11IA1img1: Vibration dampers not installed

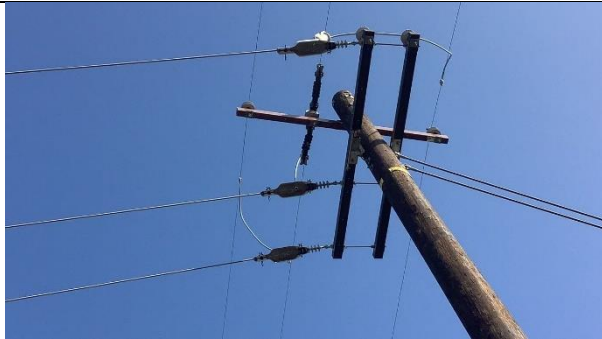
Structure ID: 1159657E

Item12IA1Img1: Vibration dampers not installed

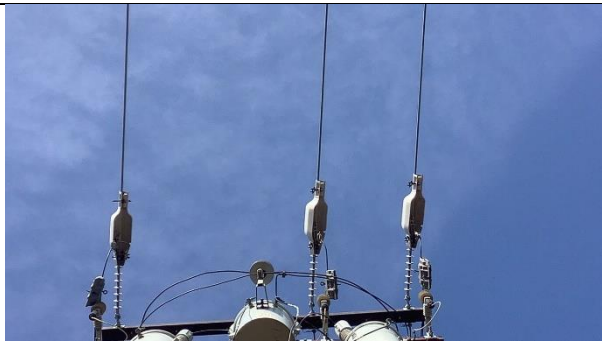
Structure ID: 2168563E

Item13IA1img1: Vibration dampers not installed

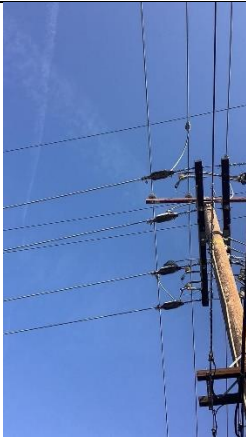
Structure ID: 4217177E

Item14IA1img1: Vibration dampers not installed
