## **NOTICE OF VIOLATION**

# Energy Safety Inspection Report

Report Name: ATJ\_SCE\_20211201-01

On December 1, 2021, I performed a walking inspection of Southern California Edison (SCE) covered conductor installations, 2021 WMP initiative number 7.3.3.3.1, in the cities of Acton and Lincoln Crest, California. Detailed findings from this field inspection are laid out in Section II below.

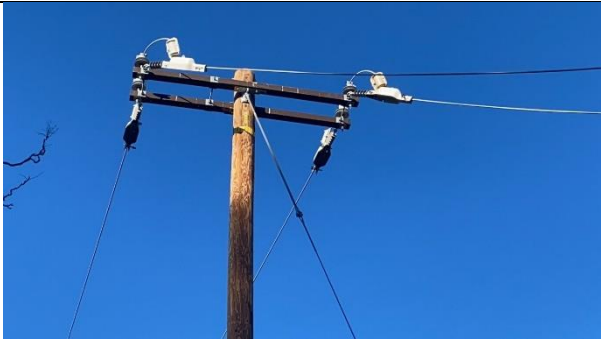
**Item2IA1Img1:** No vibration dampers

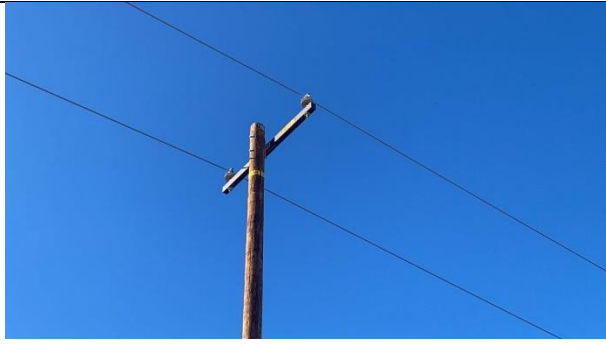
A photograph showing the top of the utility pole with cross-arms and power lines against a clear blue sky. No vibration dampers are visible on the cross-arms.
<p><b>Item3IA1Img1:</b> No vibration dampers</p>

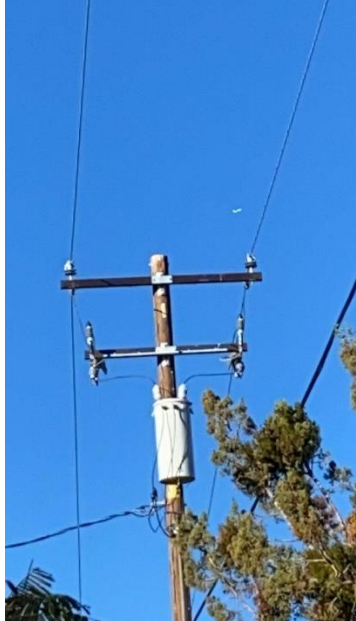
**Item4IA1img1:** Vibration dampers not installed

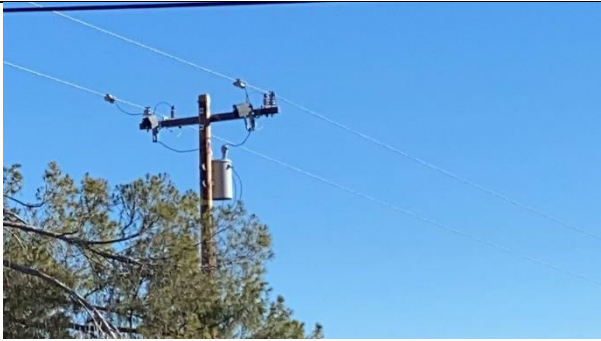
**Item5IA1img1:** No vibration dampers

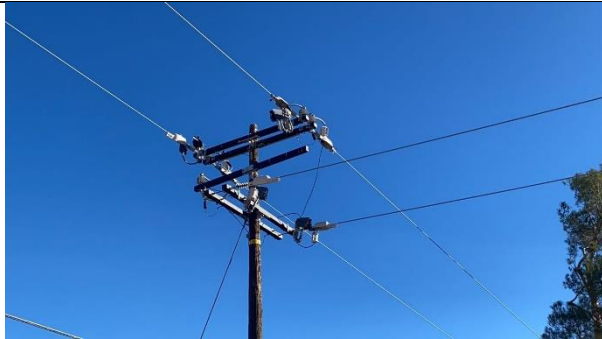
**Item6IA1Img1: No vibration dampers**

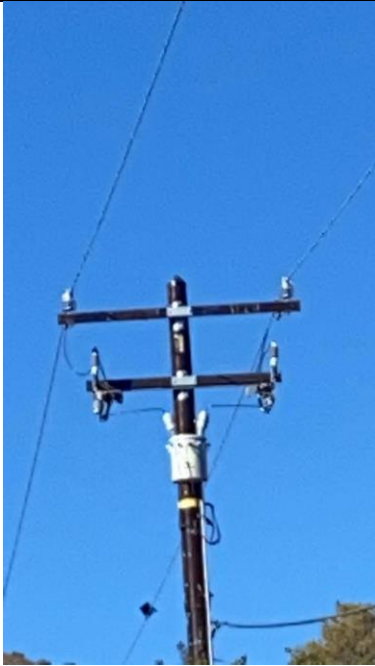
**Item7IA1Img1:** No vibration dampers

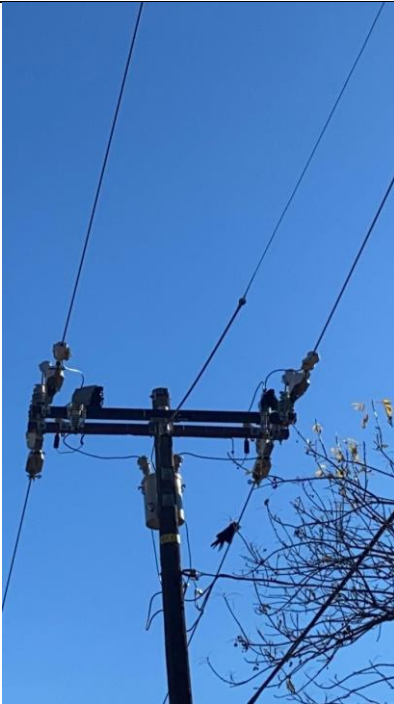
**Item8IA1Img1:** No vibration dampers

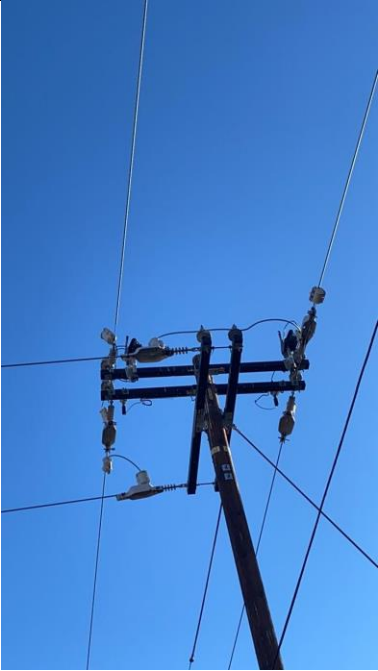
Item9IA1Img1: No vibration dampers

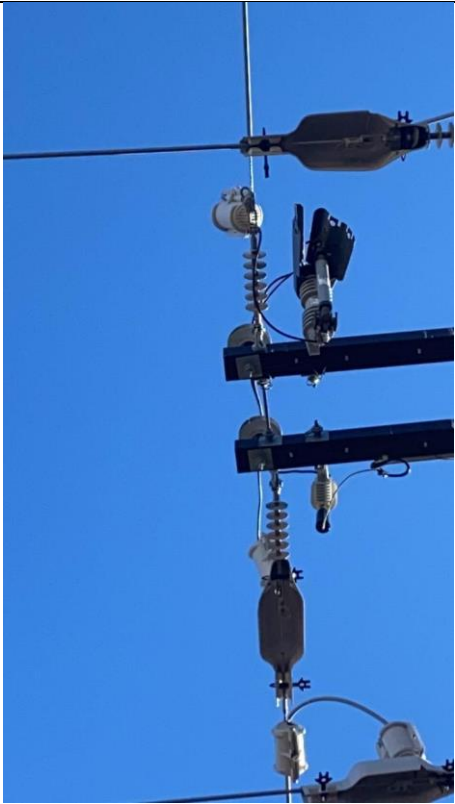
cover.” Per SCE’s DDS, Section 10, 5.7.C.1.f, “Covered conductor systems shall be an all-covered system. This means that wildlife covers shall be installed on dead-ends, terminations, connectors, equipment bushings, and any partially covered exposed conductor.” Poles numbered 4147040E and 4487750E did not have bolted wedge connector covers installed when transitioning from bare to covered conductor or at a double dead end. Energy Safety considers this a violation for failure of adhering to protocol and in the Minor risk category.

**Item9IA2img1:** No bolted wedge connector cover at double dead end

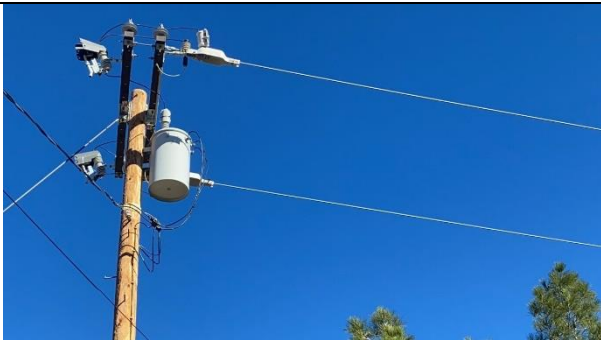
**Item10IA1img1: No vibration dampers**

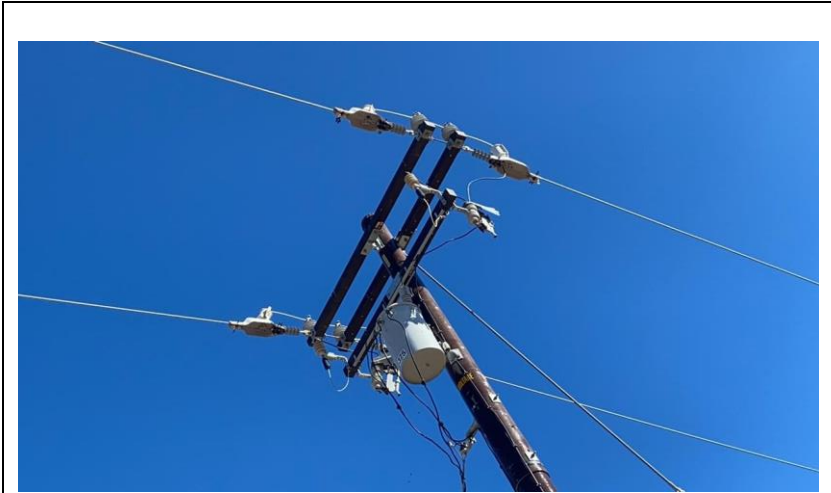
Item12IA1img1: No vibration dampers

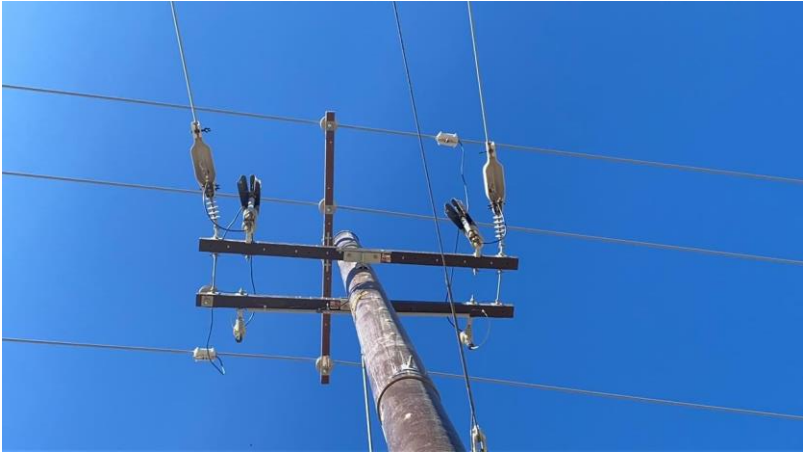
Item13IA1Img1: No vibration dampers

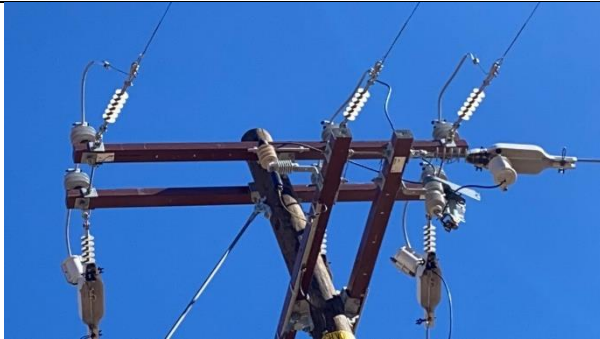
**Item15IA2Img2:** Bare to dead end with no bolted wedge connector covers

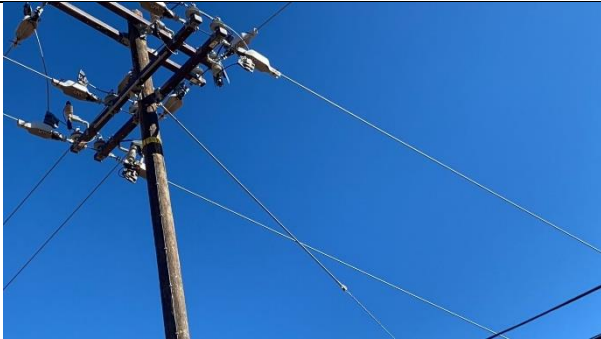
**Item16IA1Img1: No vibration dampers**

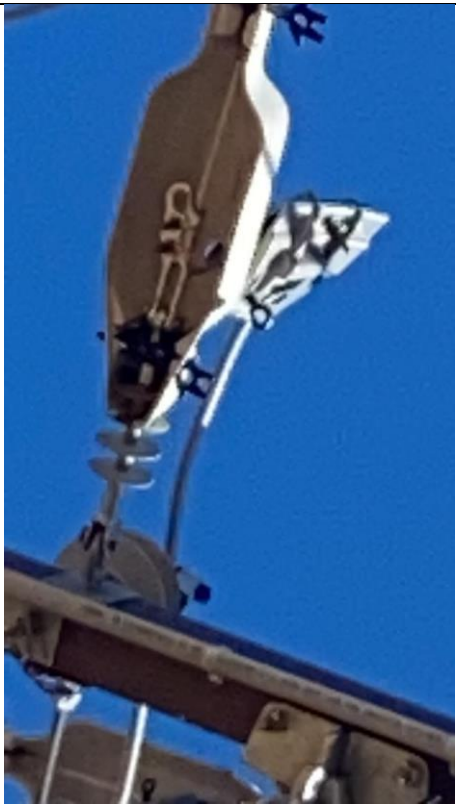
**Item16IA2Img1:** Loose center phase bolted wedge connector

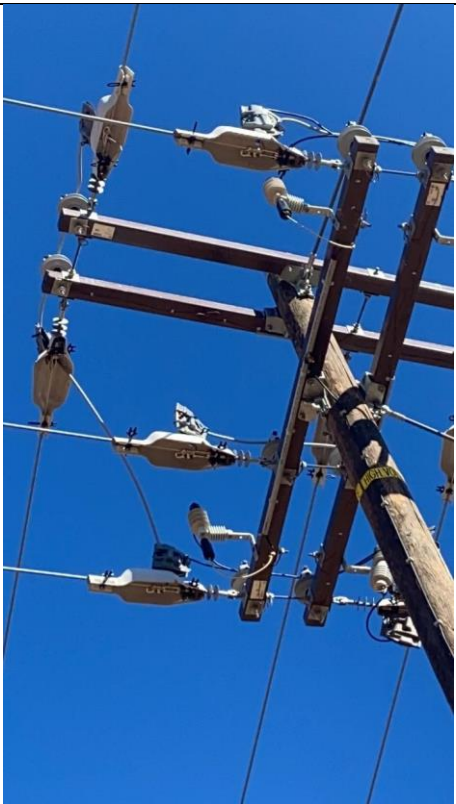
**Item16IA2Img2:** Overall loose center phase bolted wedge connector

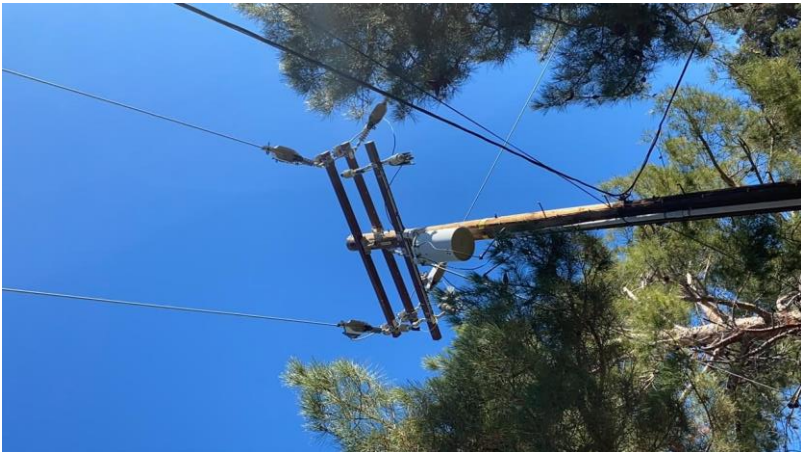
**Item17IA1img1: No vibration dampers**

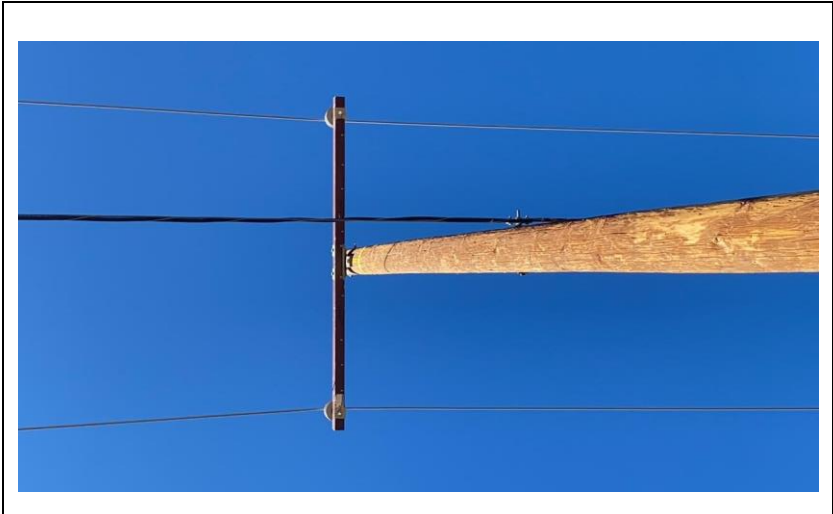
Item18IA1img1: No vibration dampers
