NOV_SCE_ATJ_ 20211202-01

NOTICE OF VIOLATION

Energy Safety Inspection Report

Report Name: ATJ_SCE_20221202-01

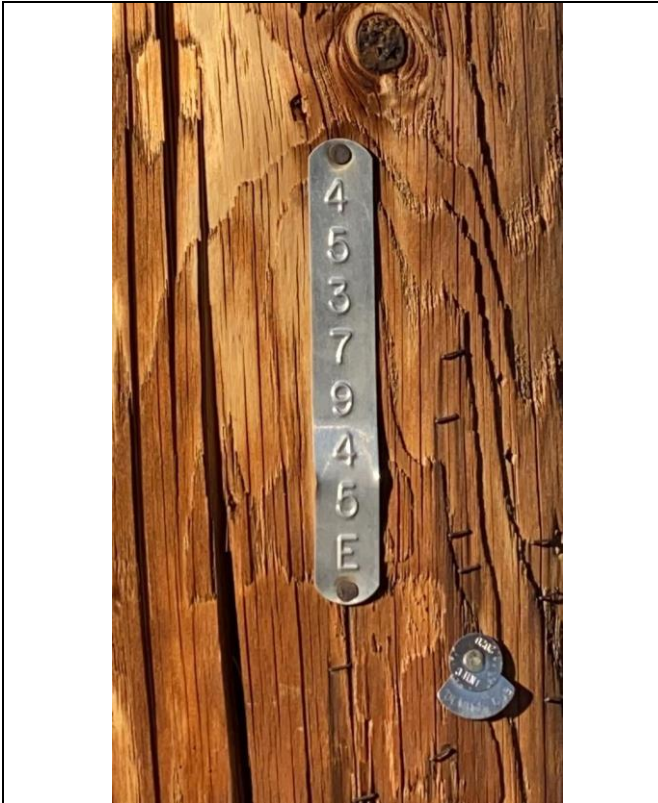
Item1IA1img1: Pole ID

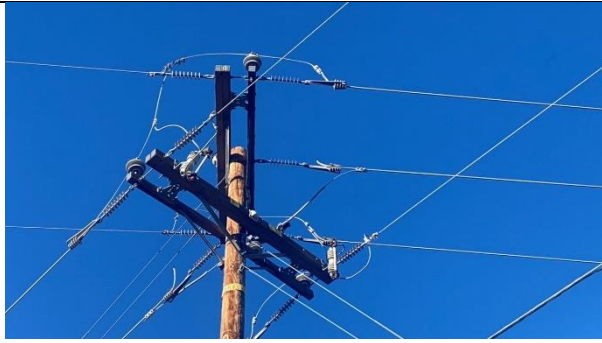
Item1IA2Img1: Overall pole phases

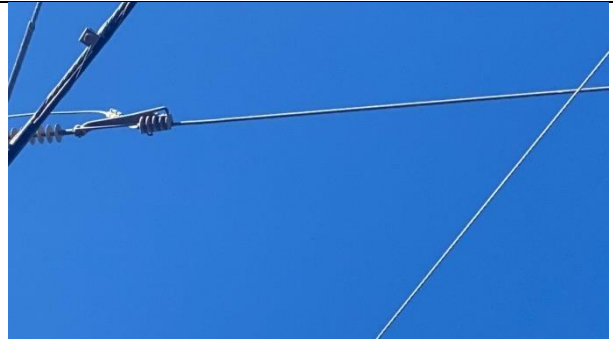
Item1IA2Img3: Bare conductors

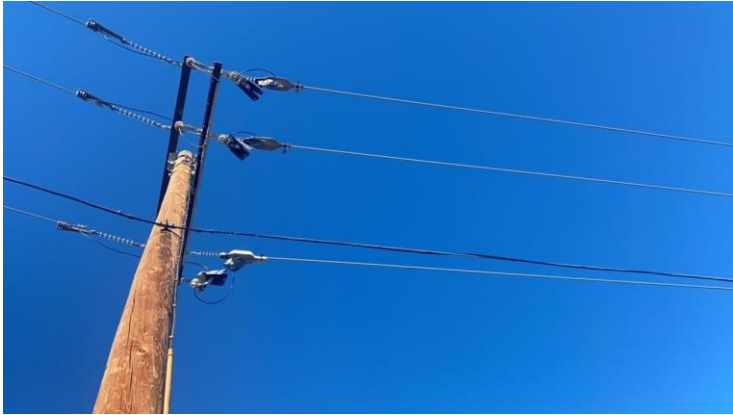
Per SCE's DDS and DOH, when installing covered conductor, vibration dampers must also be installed.⁴ Energy Safety staff found that vibration dampers were not installed at multiple structures where covered conductor installation was completed. The structures missing vibration dampers where covered conductor was installed are identified in Table 2 above. On November 19, 2021, SCE submitted a memo to Energy Safety titled, "Interim Deviation from Standards on Vibration Damper for Covered Conductor"⁵ (hereafter, "Memo"). This Memo was dated August 18, 2021, and indicates that due to supply chain issues, SCE will suspend the installation of vibration dampers until December 31, 2021. In accordance with SCE's Q2 QDR submission, the covered conductor installations inspected by Energy Safety were completed prior to the issuance of the Memo. Also, SCE informed Energy Safety of this supply chain issue only after inspections commenced. Consequently, Energy Safety finds that SCE is still in violation of its protocols requiring the installation of vibration dampers as part of covered conductor installations.

Item2IA1Img1: No vibration dampers

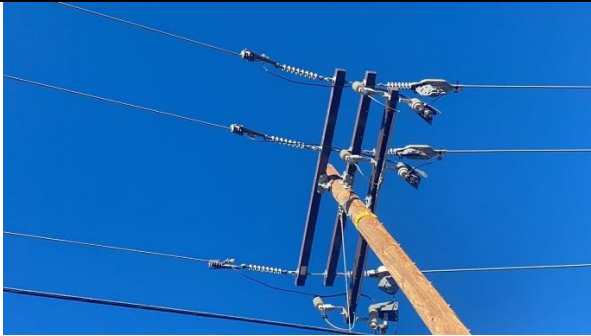
Per SCE's DOH, Section CC 180, Sheet 1 of 1, when transitioning from covered conductor to bare wire, "dead-end clamps" and "if conductor is exposed, install bolted wedge connector cover" are required. Also, DDS, Section 10, 5.7.C.1.f., "Covered conductor systems shall be an all-covered system. This means that wildlife covers shall be installed on dead-ends, terminations, connectors, equipment bushings, and any partially covered exposed conductor. Further covering other equipment with wildlife protection covers will increase the covered conductor system's overall effectiveness at preventing contact-with-object faults." Energy Safety observed a structure that did not have bolted wedge connector covers when transitioning from bare to covered conductor. The structure is noted in Table 2 above.

Item2IA3Img1: No bolted wedge connector covers when transitioning from bare to covered conductor

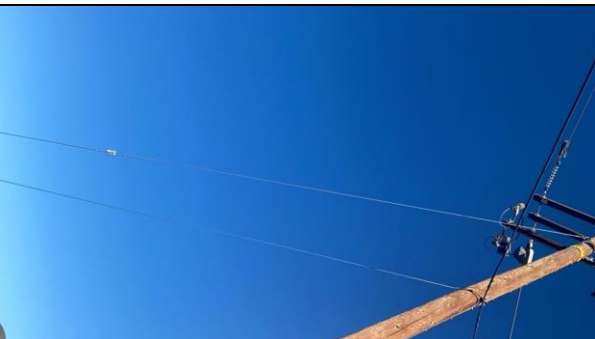
In accordance with SCE's protocols for covered conductor installation, Distribution Overhead Construction Standards (DOH) PO section 300, SCE states, "In HFRA installations of covered conductor it is required to upgrade down guy/span guy insulation to include Fiberglass Guy Strain Insulators."¹ In addition, SCE's Distribution Design Standards (DDS), section DDS-10 indicates that, "[b]eginning July 2020, SCE has transitioned to a standard requirement in guying to utilize the fiberglass guy strain insulators where traditional porcelain guy strain insulators have been applied."² Further, in response to an Energy Safety Data Request (DR-030), SCE stated that, "[i]n HFRA installations of covered conductor it is required to... upgrade down guy/span guy installation to include Fiberglass Guy Strain Insulators."³ During the inspection, Energy Safety found several instances where fiberglass guy wire strain insulators were not installed where covered conductor work was completed, per SCE's protocols. Structures where this protocol was not followed are noted in Table 2 above.

Item2IA4Img1: Porcelain down guy

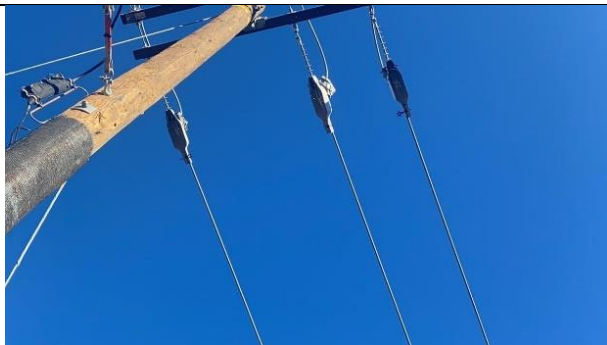
Item3IA1Img1: No vibration dampers

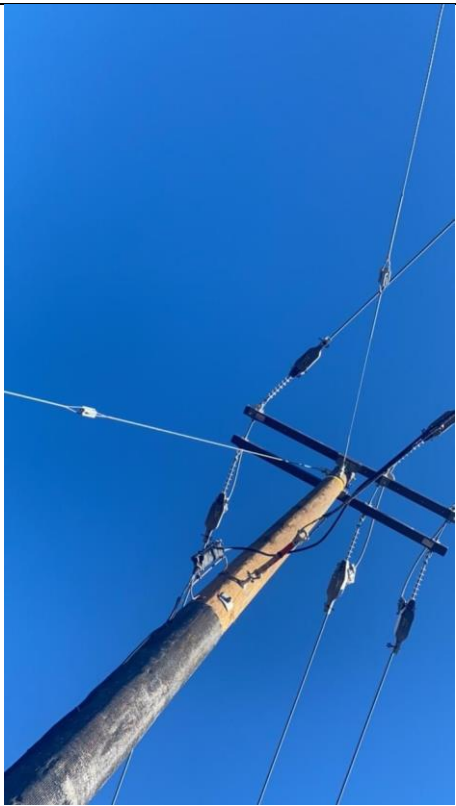
Item3IA2Img1: Porcelain guy insulators

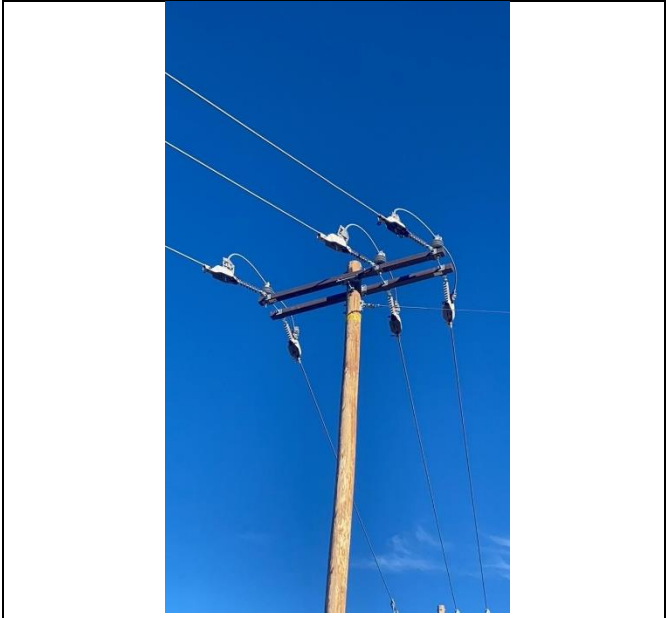
Item4IA1Img1: No vibration dampers

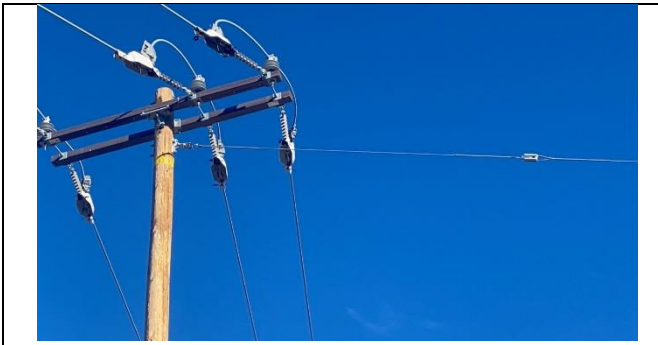
Item4IA2Img1: Porcelain guy insulator

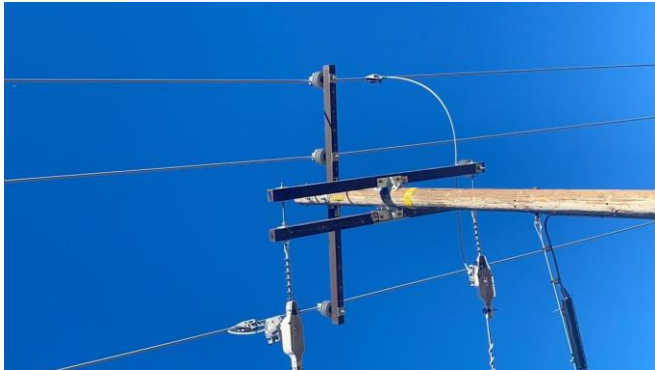
Item5IA1Img1: No vibration dampers

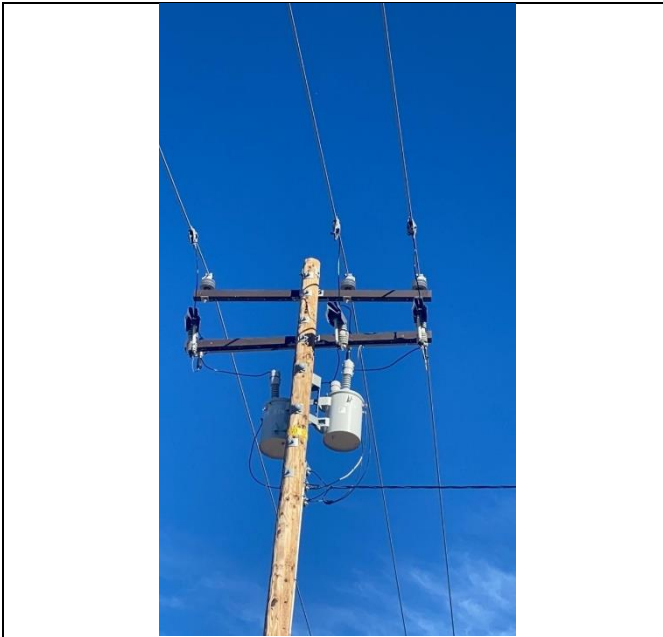
Item6IA1img1: No vibration dampers

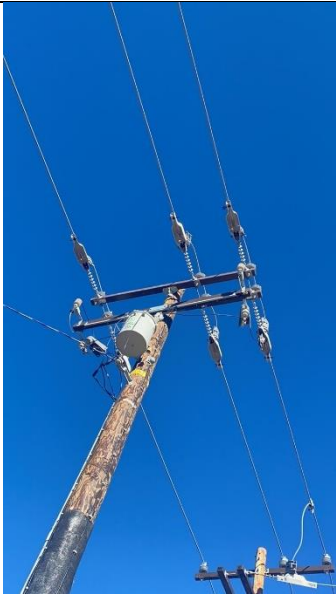
Item7IA1Img1: No vibration dampers

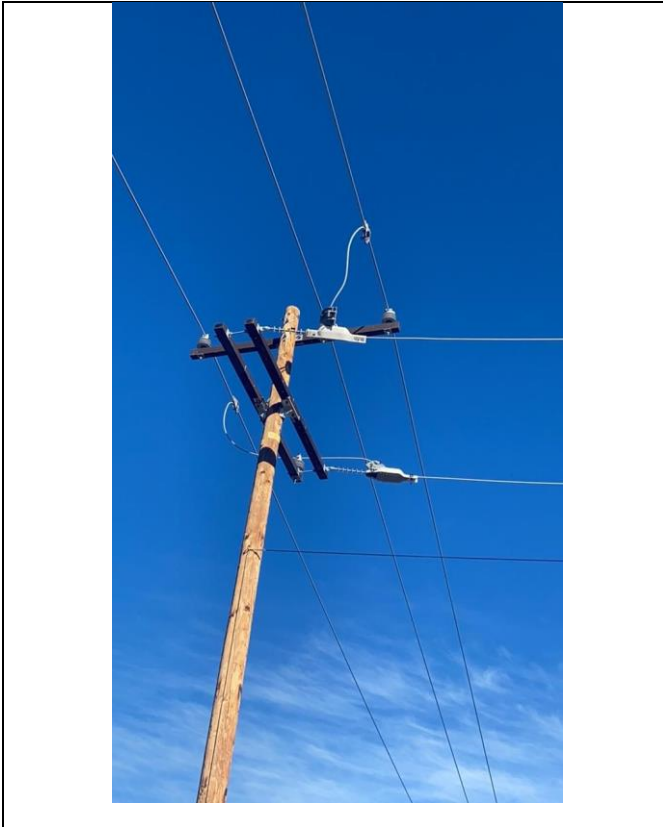
Item8IA1Img1: No vibration dampers

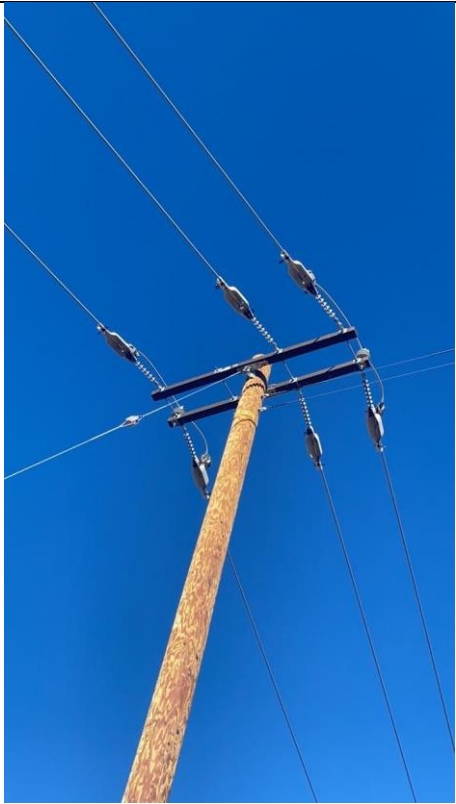
Item9IA1Img1: No vibration dampers

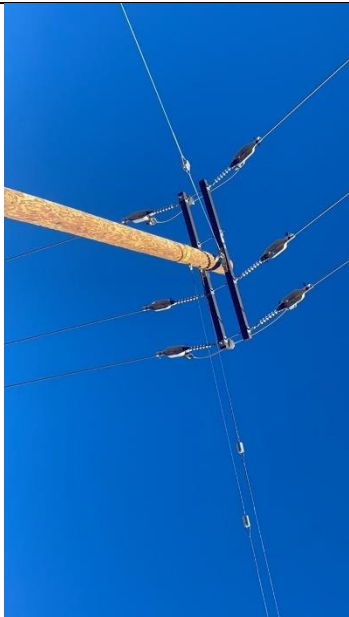
Item9IA2Img1: Three guy wires with porcelain insulators

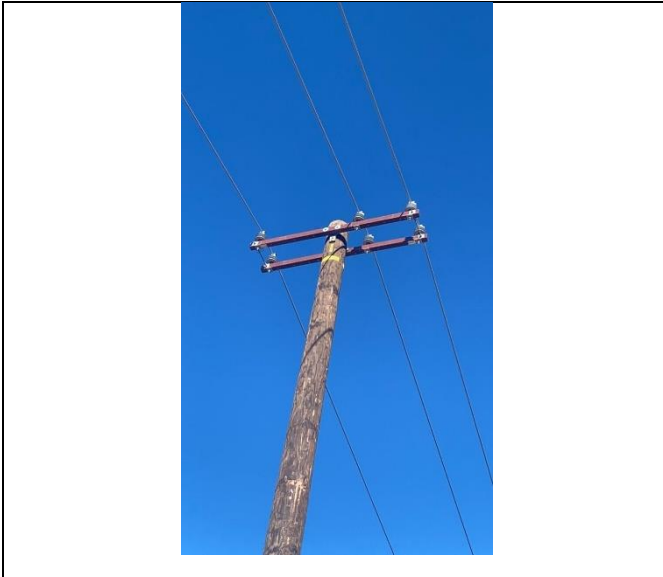
Item10IA1img1: No vibration dampers

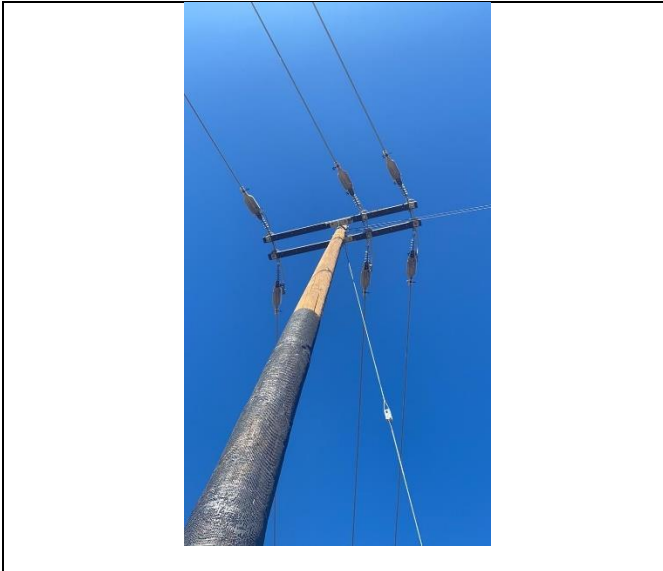
Item11IA1Img1: No vibration dampers

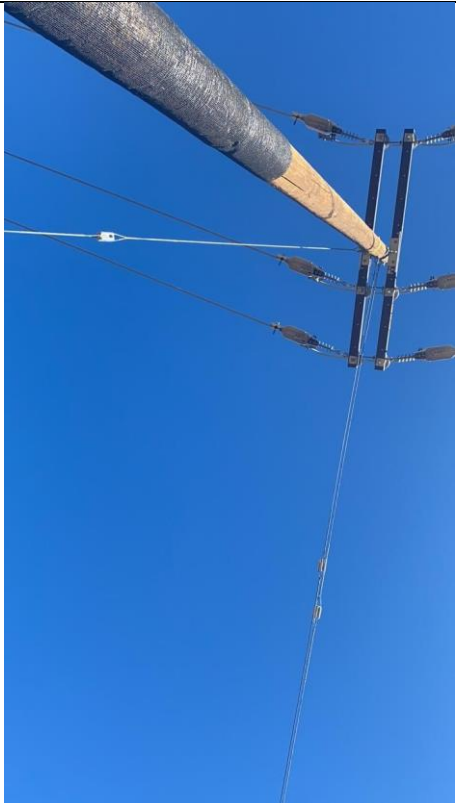
Item11IA2Img1: Porcelain guy insulators on three guys

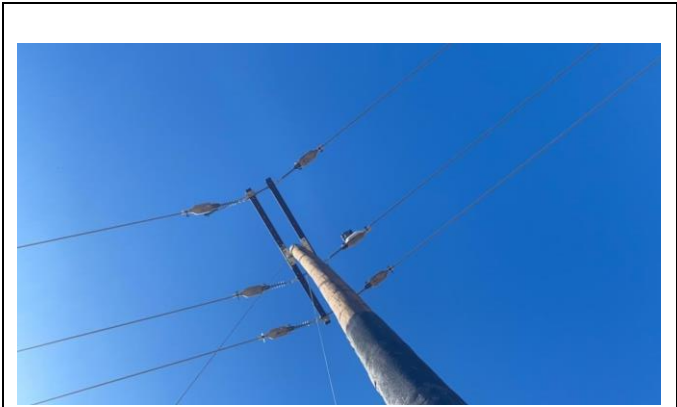
Item12IA1Img1: No vibration dampers

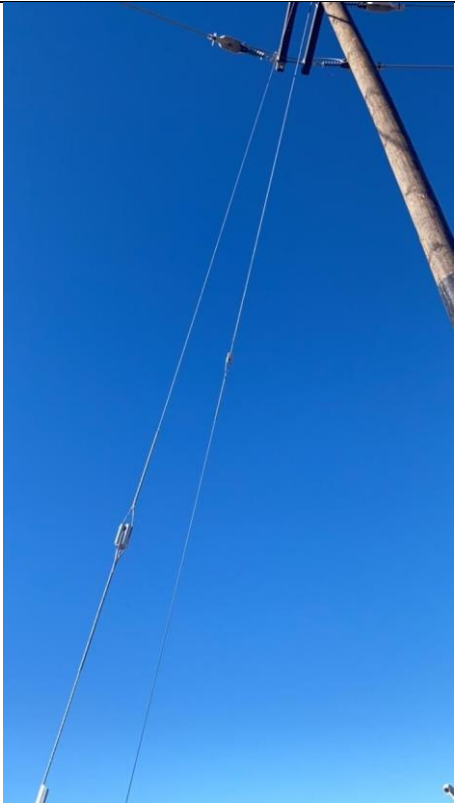
Item12IA2Img1: Porcelain guy insulators on two guy wires

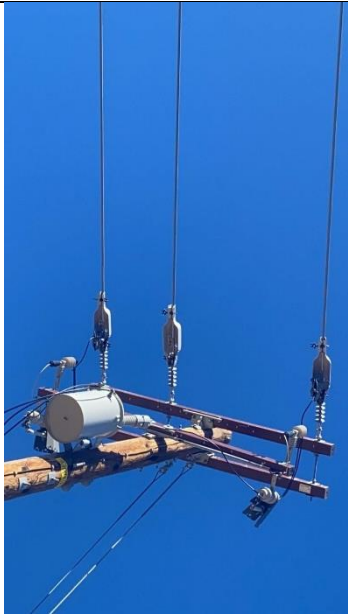
Item14IA1img1: No vibration dampers

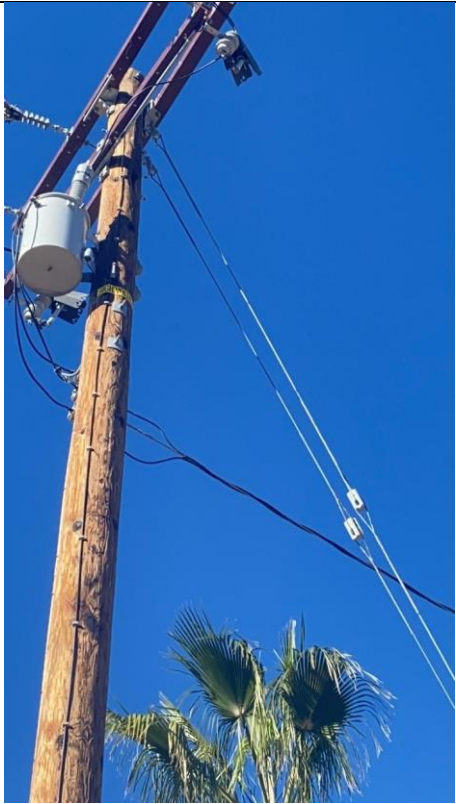
Item14IA2Img1: Porcelain insulators

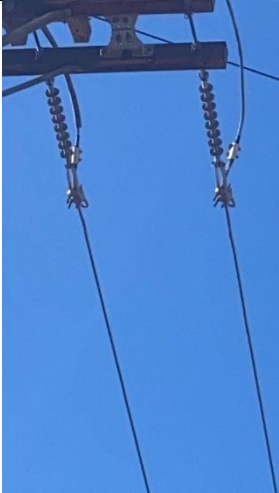
Item15GImg3: Bare wire on all phases closeup

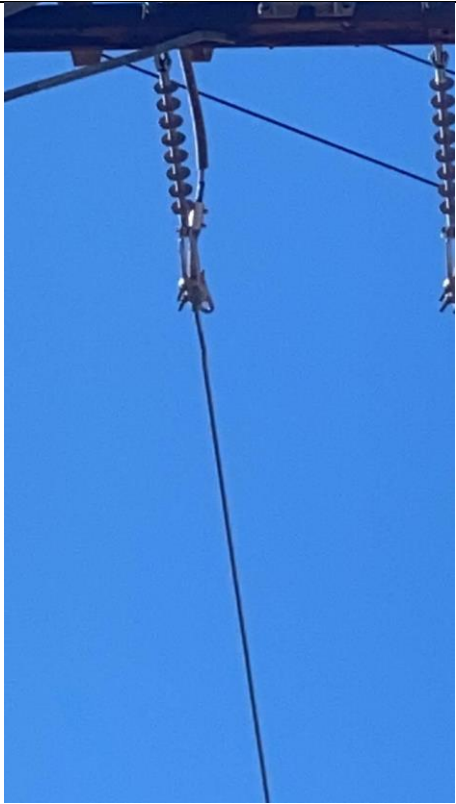
Item15IA1img1: Bare conductor

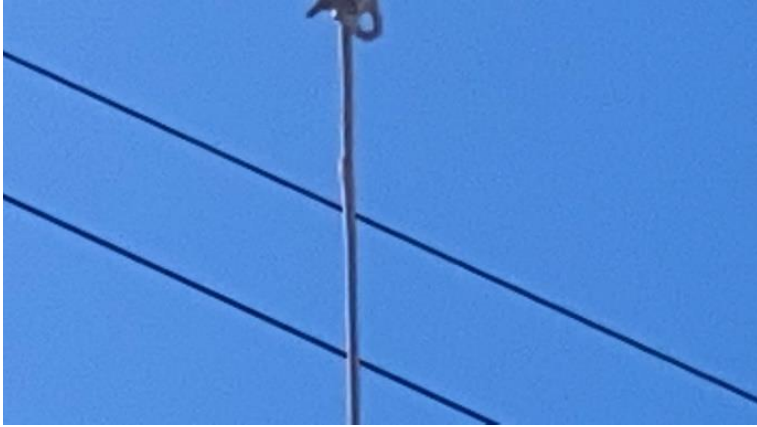
In addition to the violations discovered during WMP inspections of SCE's covered conductor installations, Energy Safety discovered one conductor that showed evidence of bird caging. Energy Safety considers bird caging as a condition that increases an electrical corporation's ignition risk because bird caging is a potential indicator of degradation in a conductor and compromises its structural integrity. Bird caging on a supply conductor can weaken its strength and lead to a wire down event and ignition, thus increasing the risk of conductor failure and potential ignition. The span where bird caging was observed is identified in Table 3.

Item15CD5Img1: Close up of phase bird caging

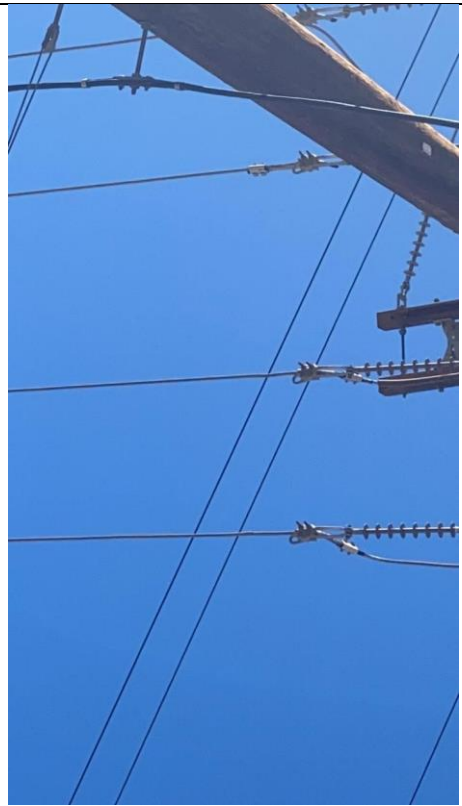
Item15CD5Img2: Overall view, bird caging on bottom phase

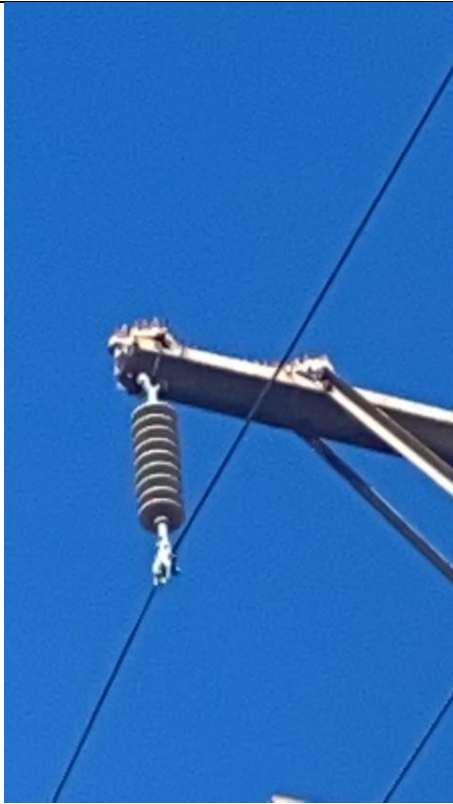
Item16IA1Img1: Bare conductor

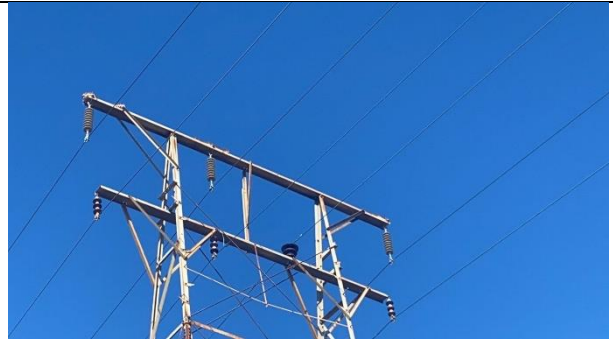
Item16IA1Img2: Overall view of bare conductor

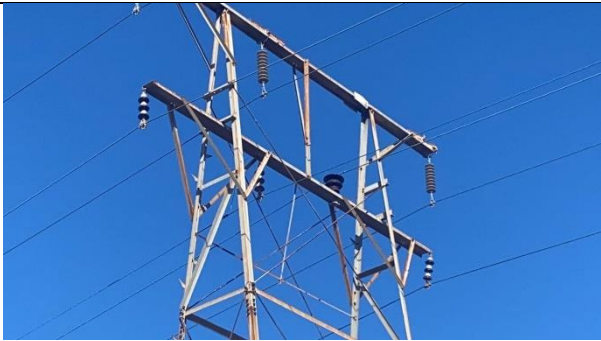
Item17IA1Img1: Bare phases
