NOV_SCE_ATJ_ 20211208-01

NOTICE OF VIOLATION

Energy Safety Inspection Report

Report Name: ATJ_SCE_20211208-01

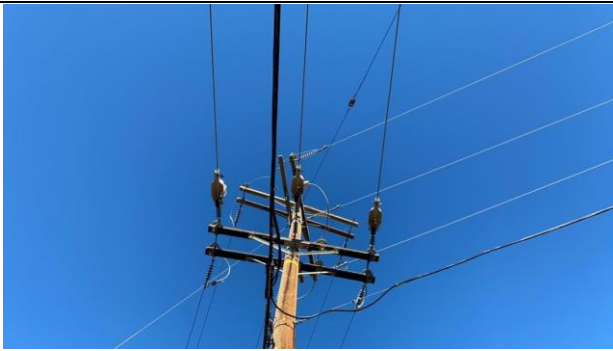
Per SCE's DDS and DOH, when installing covered conductor, vibration dampers must also be installed.⁴ Energy Safety staff found that vibration dampers were not installed at multiple structures

where covered conductor was completed. The structures missing vibration dampers where covered conductor was installed are identified in Table 2 above. On November 19, 2021, SCE submitted a memo to Energy Safety titled, "Interim Deviation from Standards on Vibration Damper for Covered Conductor"⁵ (hereafter, "Memo"). This Memo was dated August 18, 2021, and indicates that due to supply chain issues, SCE will suspend the installation of vibration dampers until December 31, 2021. In accordance with SCE's Q2 QDR submission, the covered conductor installations inspected by Energy Safety were completed prior to the issuance of the Memo. Also, SCE informed Energy Safety of this supply chain issue only after inspections commenced. Consequently, Energy Safety finds that SCE is still in violation of its protocols requiring the installation of vibration dampers as part of covered conductor installations.

Item1IA1Img1: No vibration dampers

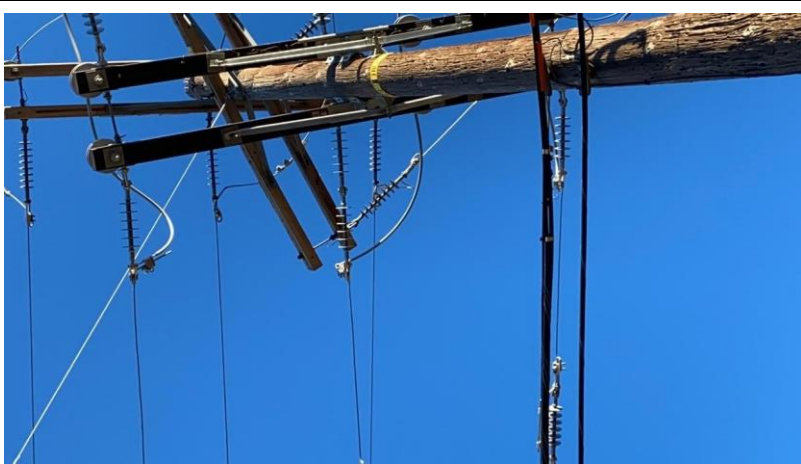
Finally, Energy Safety discovered a guy wire that was within six inches of a 12kV primary conductor. Energy Safety considers energized conductors that are in close proximity of a guy wire a potential ignition driver. Guy wires that may slap energized conductors may cause arcing, increasing an electrical corporation's ignition risk. The structure where Energy Safety observed a down guy wire in close proximity of bare conductor is identified in Table 3.

Item1IA2Img1: Guy wire is within 6 inches of bare conductor (top of photo, guy wire coming out of the picture)

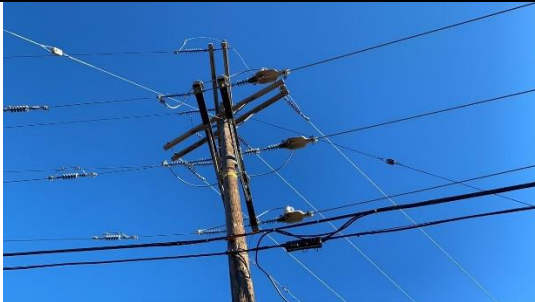
3. Violation 3: Per SCE’s Distribution Overhead Construction Standards (DOH), section PO 300, page 3 of 9, and Distribution Design Standards (DDS), section DDS-10, page 10-26, installation of a fiberglass guy strain insulator is required for distribution guying applications and repairs in high fire risk areas (HFRAs) and shall be installed in conjunction with covered conductor installation.¹ Poles numbered 1008927E and 1513760E had covered conductor installed but failed to install fiberglass guy strain insulators, in accordance with SCE protocol. Energy Safety considers this violation for failure of adhering to protocol to be in the Minor risk category.

Item1IA3Img1: Porcelain guy wire insulator

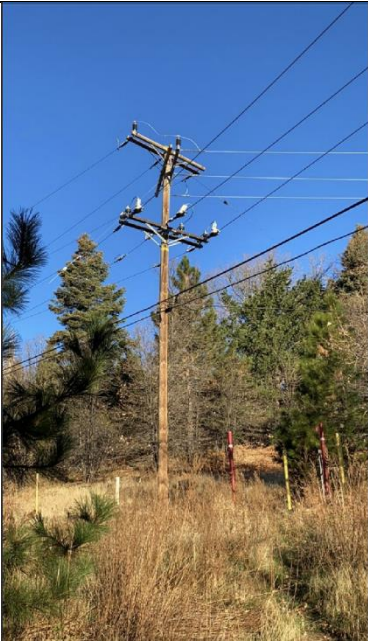
5. Violation 5: Per SCE’s DOH, when transitioning from covered conductor to bare wire, “if conductor is exposed, install bolted wedge connector cover.” Per SCE’s DDS, Section 10, 5.7.C.1.f, “Covered conductor systems shall be an all-covered system. This means that wildlife covers shall be installed on dead-ends, terminations, connectors, equipment bushings, and any partially covered exposed conductor.” Pole 1008927E did not have bolted wedge connector covers when transitioning from bare to covered conductor. Energy Safety considers this failure to follow protocol violation to be in the Minor risk category.

Per SCE's DOH, Section CC 150, page 3 of 5, in circumstances of 4-wire covered conductor double dead-end construction, if conductor is exposed, bolted wedge connector covers must be installed. Also, DDS, Section 10, 5.7.C.1.f. states, "Covered conductor systems shall be an all-covered system." Per SCE's DOH, Section CC 150.4, page 5 of 5, "All overhead equipment shall utilize appropriate wildlife covers. This means that wildlife covers shall be installed on dead-ends, terminations, connectors, equipment bushings, and any partially covered exposed conductor." Energy Safety observed structure numbered 4487750E that did not have bolted wedge connector cover installed when transitioning from bare to covered conductor. This structure is noted in Table 2 above.

Item1CD2Img1: No wildlife covers at transition from bare to covered conductor

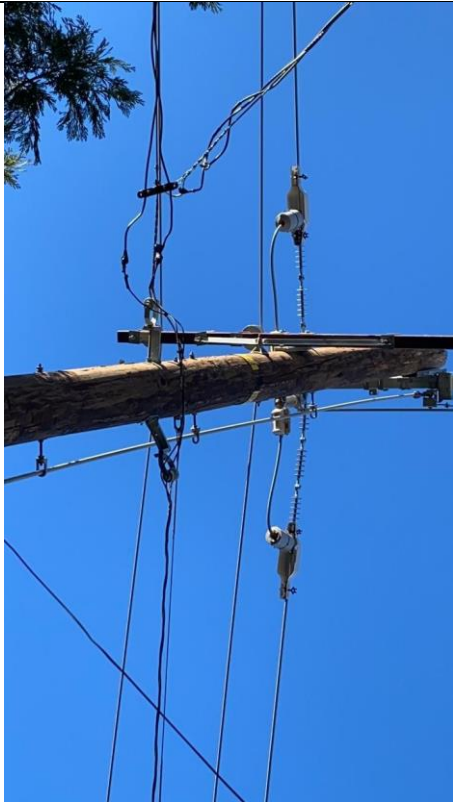
Item3IA1Img1: No vibration dampers

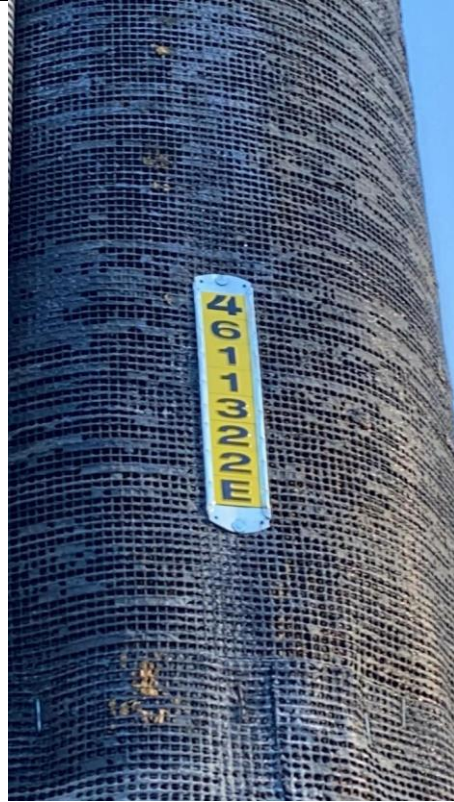
Item4GImg2: Pole ID

6. Violation 6: At pole numbered 4621322E, the pole identification number on the structure did not match the identification number provided by SCE in its QDR. Energy Safety considers this data accuracy violation to be in the Minor risk category.

During the inspections, Energy Safety also found one structure where the structure identification number provided by SCE did not match the structure identification number observed in the field. The structure where Energy Safety observed this data accuracy issue is noted in Table 2 above.

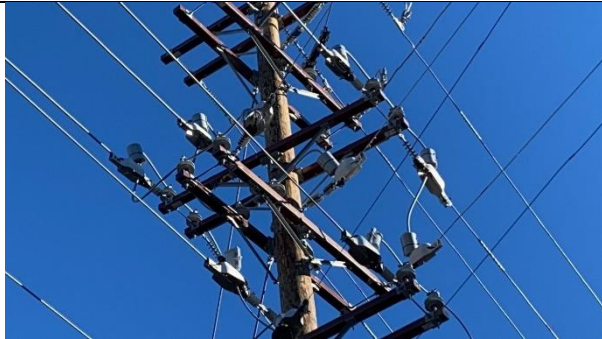
Item4IA2Img1: No vibration dampers

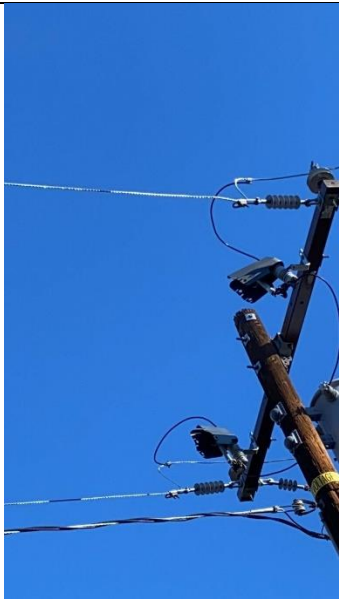
1. Violation 1: Per SCE’s 2021-Q1 and Q2 quarterly data report (QDR), covered conductor was installed on poles numbered 453043E, and 4920022E. These structures reported covered conductor initiative (2021 WMP initiative number 7.3.3.3.1) with a status of “complete.” However, upon inspection, SCE has not even begun covered conductor installation at these locations. Energy Safety considers this data accuracy violation to be in the Moderate risk category.

2. Violation 2: Per SCE’s 2021-Q1 and Q2 QDR, covered conductor was installed on poles numbered 453043E, and 4920022E. Upon inspection, Energy Safety staff found no covered conductor installed at the above-mentioned structures. Given SCE’s focus on covered conductor as one of its flagship wildfire mitigation programs and the scope of this mitigation program, Energy Safety is greatly concerned about how much covered conductor work is completed and how prevalent this issue may be. Energy Safety

Item5IA1Img1: Bare wire

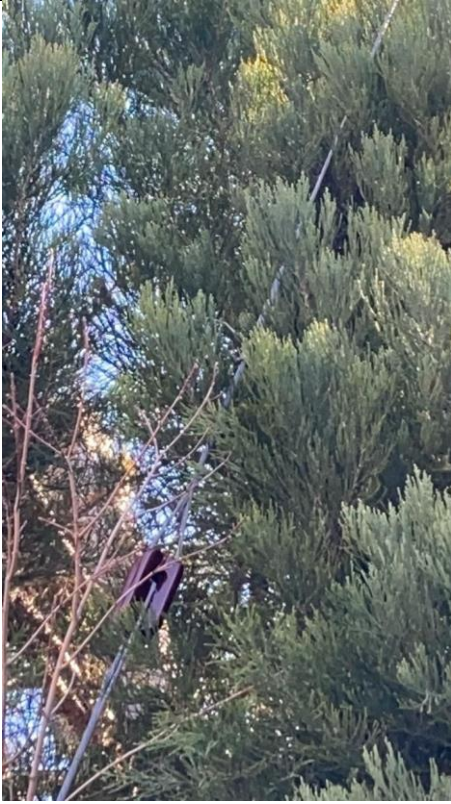
In addition to the violations discovered during WMP inspections of SCE's covered conductor installations, Energy Safety discovered vegetation contacting a guy wire above the insulator. Guy wires are metallic and can become energized in some circumstances. Insulators break the current path and prevent electricity from reaching the ground where a down guy wire is anchored. However, the portion above the insulator can remain energized until the circuit is deenergized and may cause an ignition if energized while in contact with vegetation. Accordingly, Energy Safety considers vegetation in contact with down guy wires above the insulator a condition that increases an electrical corporation's ignition risk. The structure where Energy Safety observed vegetation in contact with the guy wire above the insulator is noted in Table 3.

Item5GW2Img1: Vegetation touching guy wire above insulator

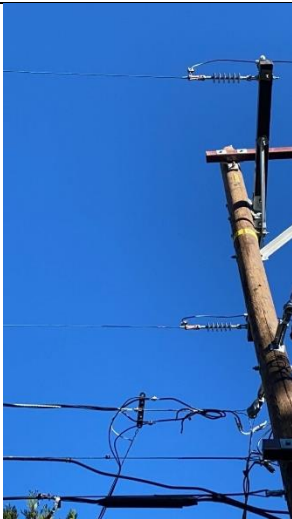
Item6IA1Img1: Bare wire

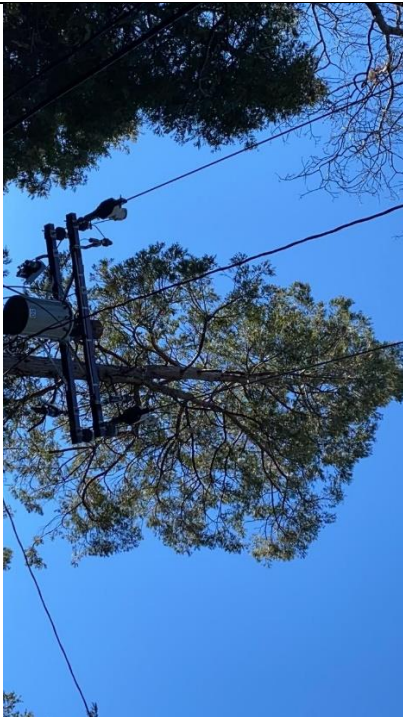
Item7IA1img1: No vibration dampers

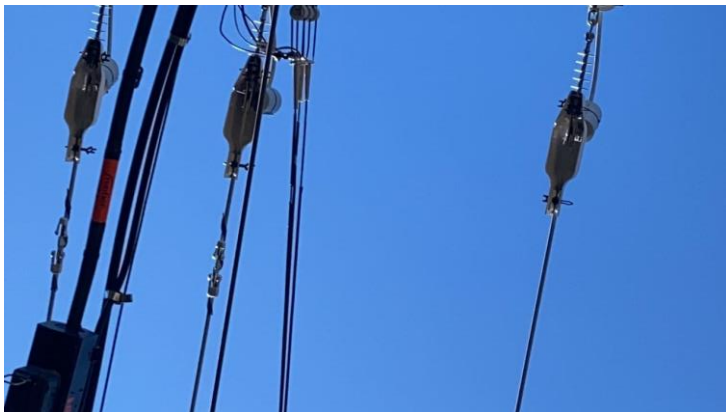
Item16IA1Img1: In photo, right phase missing vibration damper

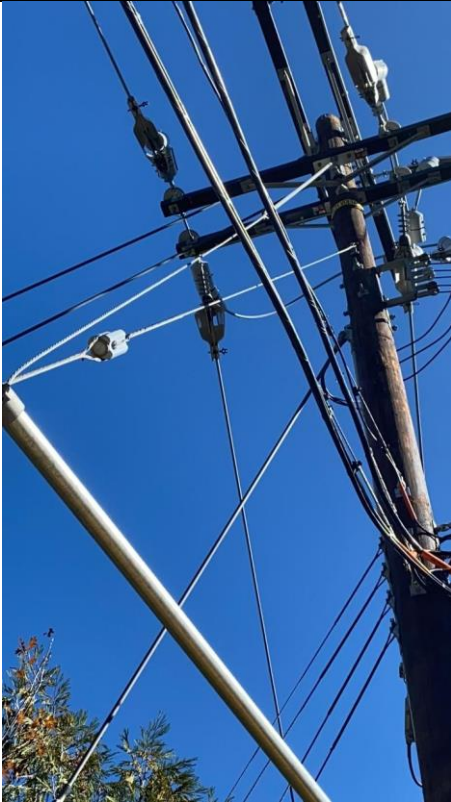
Item19IA1Img1: Missing fiberglass guy wire insulator
