NOD_SCE_ATJ_20211202-01

NOTICE OF DEFECT

Energy Safety Inspection Report

Report Name: ATJ_SCE_20221202-01

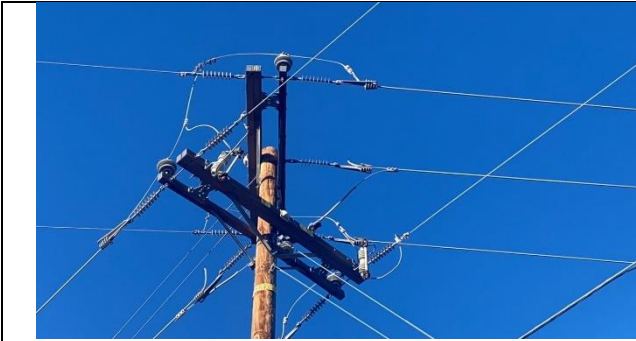
Item1IA2Img1: Overall pole phases

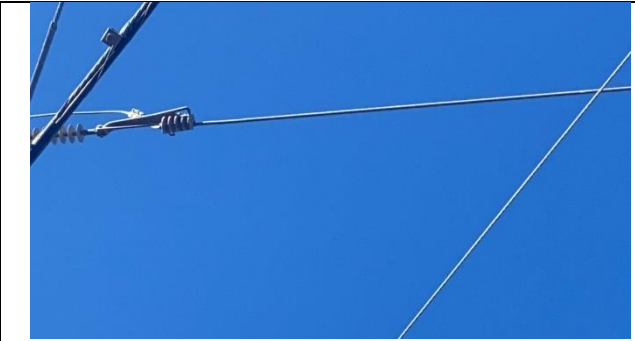
Item1IA2Img3: Bare conductors

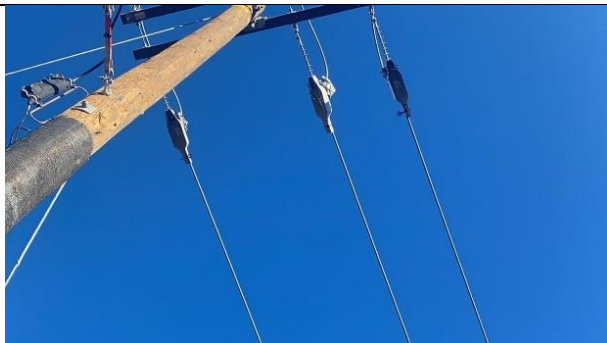
Per SCE's DDS and DOH, when installing covered conductor, vibration dampers must also be installed.⁴ Energy Safety staff found that vibration dampers were not installed at multiple structures where covered conductor installation was completed. The structures missing vibration dampers where covered conductor was installed are identified in Table 2 above. On November 19, 2021, SCE submitted a memo to Energy Safety titled, "Interim Deviation from Standards on Vibration Damper for Covered Conductor"⁵ (hereafter, "Memo"). This Memo was dated August 18, 2021, and indicates that due to supply chain issues, SCE will suspend the installation of vibration dampers until December 31, 2021. In accordance with SCE's Q2 QDR submission, the covered conductor installations inspected by Energy Safety were completed prior to the issuance of the Memo. Also, SCE informed Energy Safety of this supply chain issue only after inspections commenced. Consequently, Energy Safety finds that SCE is still in violation of its protocols requiring the installation of vibration dampers as part of covered conductor installations.

Item3IA1Img1: No vibration dampers

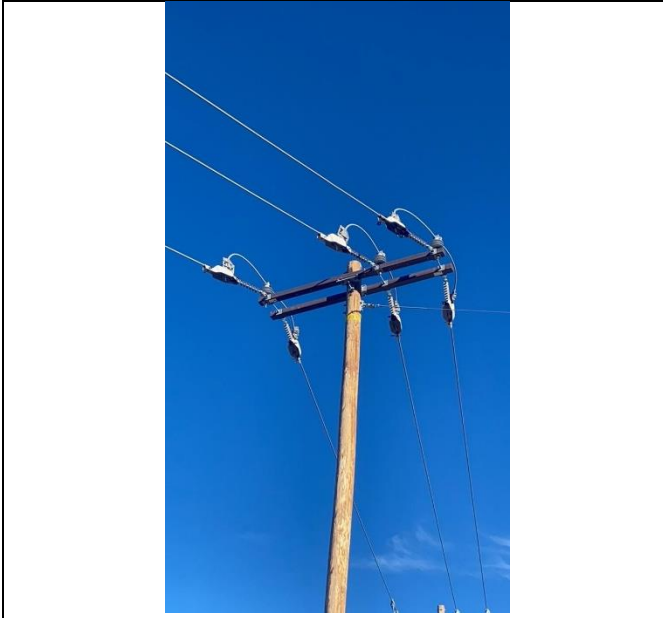
Item4IA1Img1: No vibration dampers

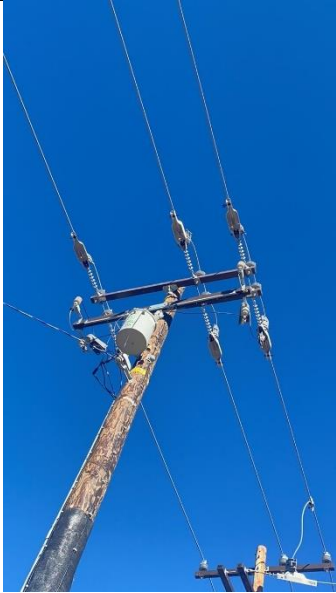
Item7IA1Img1: No vibration dampers

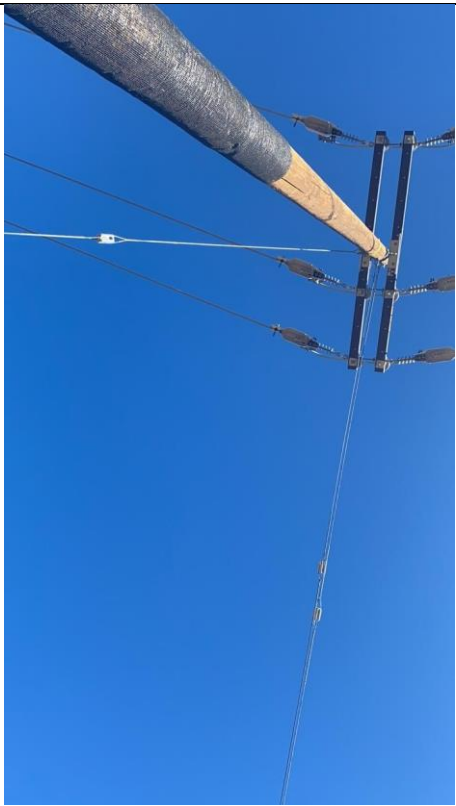
In accordance with SCE's protocols for covered conductor installation, Distribution Overhead Construction Standards (DOH) PO section 300, SCE states, "In HFRA installations of covered conductor it is required to upgrade down guy/span guy insulation to include Fiberglass Guy Strain Insulators."¹ In addition, SCE's Distribution Design Standards (DDS), section DDS-10 indicates that, "[b]eginning July 2020, SCE has transitioned to a standard requirement in guying to utilize the fiberglass guy strain insulators where traditional porcelain guy strain insulators have been applied."² Further, in response to an Energy Safety Data Request (DR-030), SCE stated that, "[i]n HFRA installations of covered conductor it is required to... upgrade down guy/span guy installation to include Fiberglass Guy Strain Insulators."³ During the inspection, Energy Safety found several instances where fiberglass guy wire strain insulators were not installed where covered conductor work was completed, per SCE's protocols. Structures where this protocol was not followed are noted in Table 2 above.

Item11IA2Img1: Porcelain guy insulators on three guys

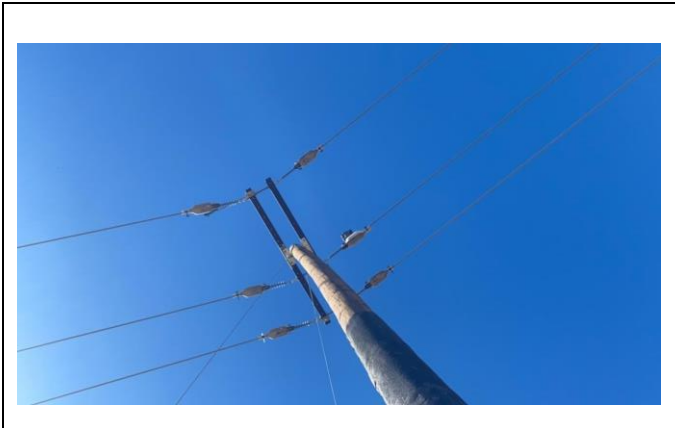
Item12IA1Img1: No vibration dampers

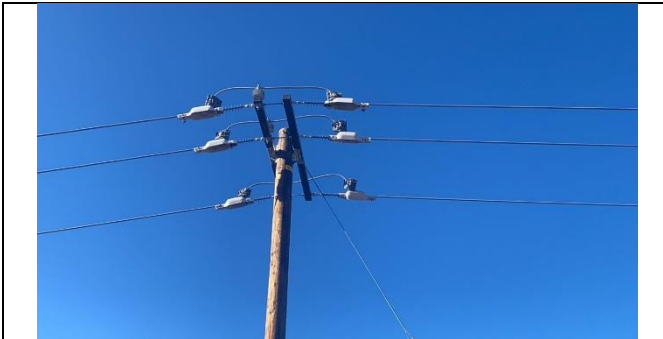
Item13IA1Img1: No vibration dampers

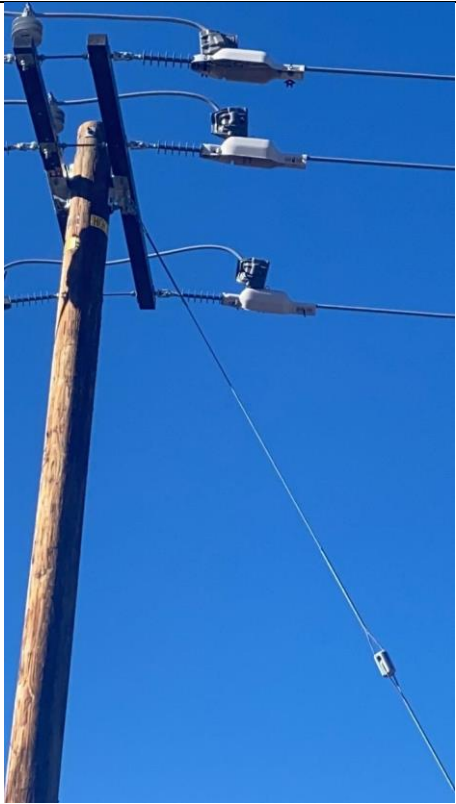
Item13IA2Img1: Porcelain guy insulator

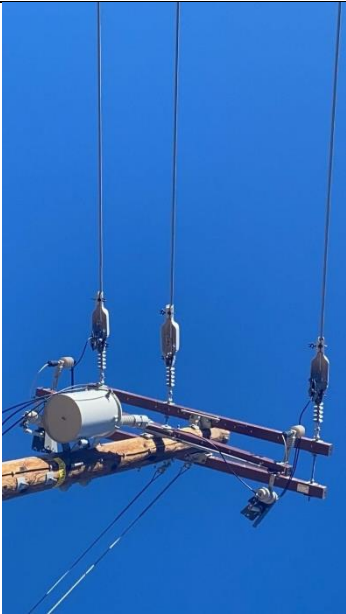
Item14IA1img1: No vibration dampers

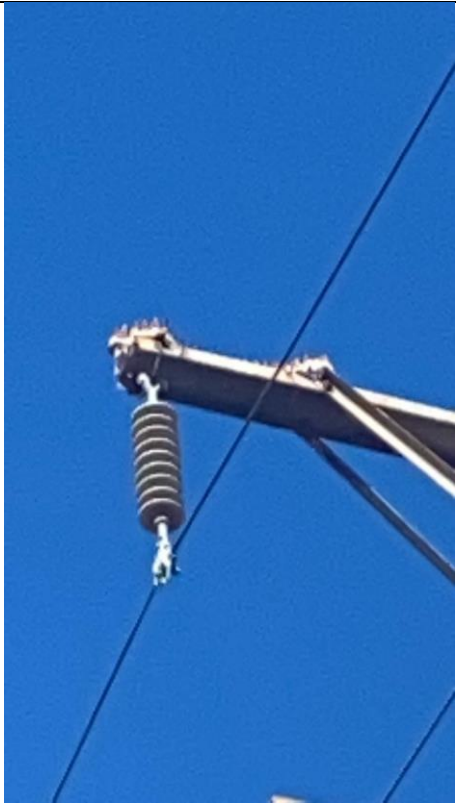
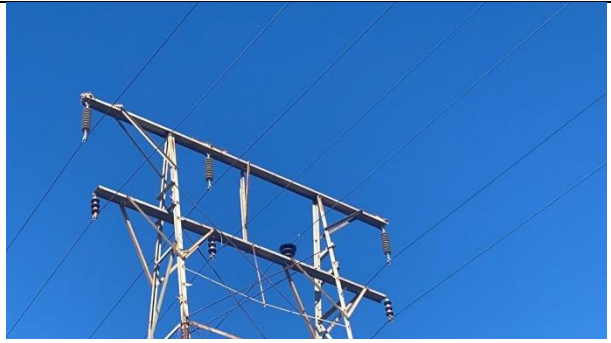
Item16IA1Img1: Bare conductor

Item16IA1Img2: Overall view of bare conductor

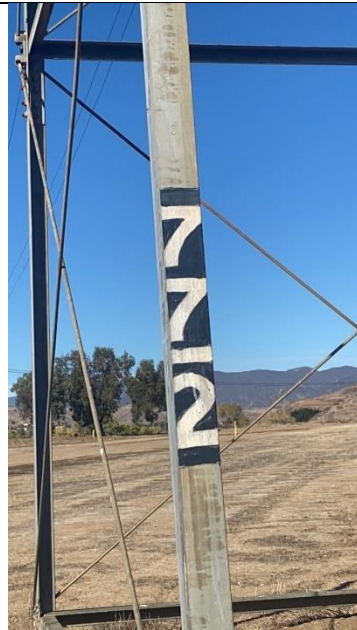
During inspections, Energy Safety found three structures where the structure ID provided by SCE did not match the structure ID observed in the field. Structures where Energy Safety observed this data accuracy violation are noted in Table 2 above.

Item16IA2Img1: Correct structure ID

Item16IA2Img2: Other structure ID

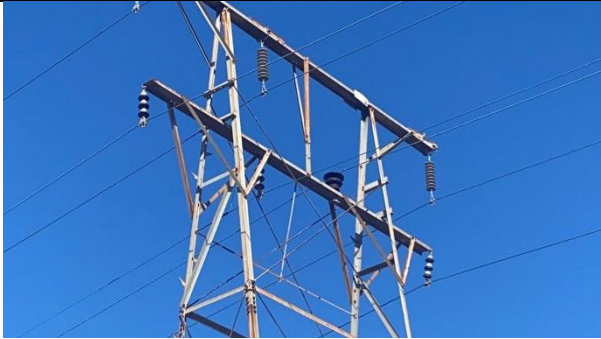
Item17IA1Img1: Bare phases
