NOTICE OF DEFECT

Energy Safety Inspection Report

Report Name: ATJ_SCE_20211208-01

Date(s): December 8, 2021

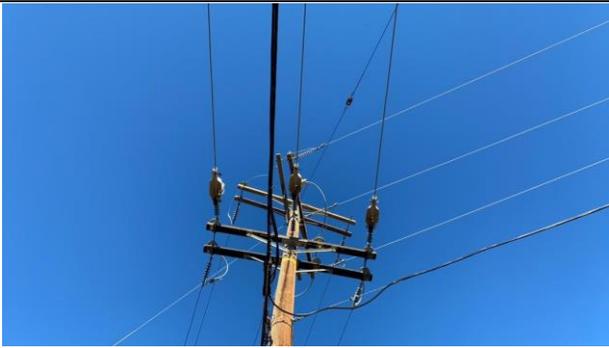
Item1IA1Img1: No vibration dampers

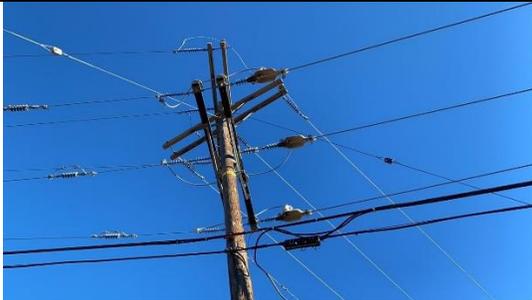
Item1IA3Img1: Porcelain guy wire insulator

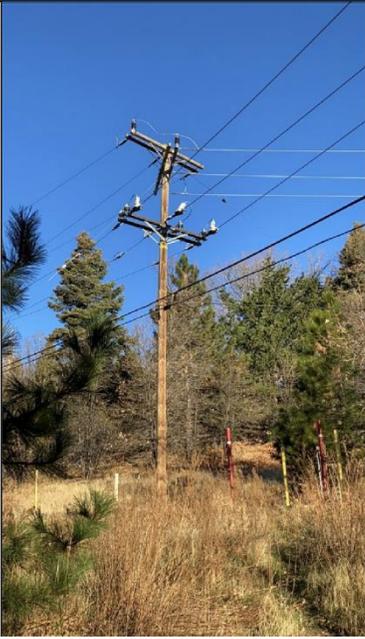
Item1CD2Img1: No wildlife covers at transition from bare to covered conductor

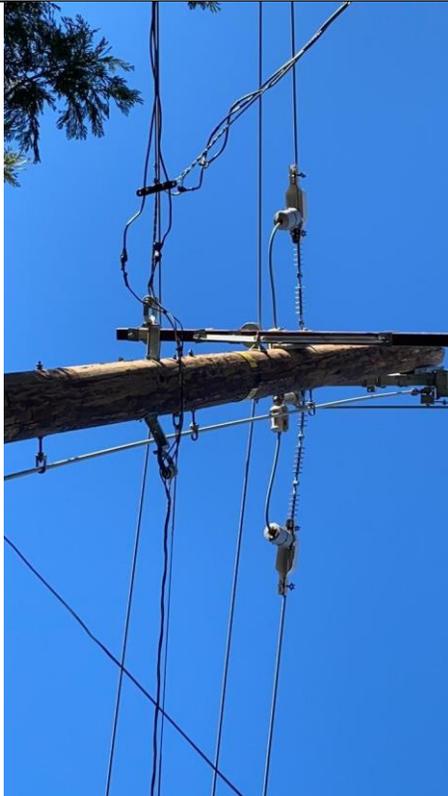
Item3IA1Img1: No vibration dampers

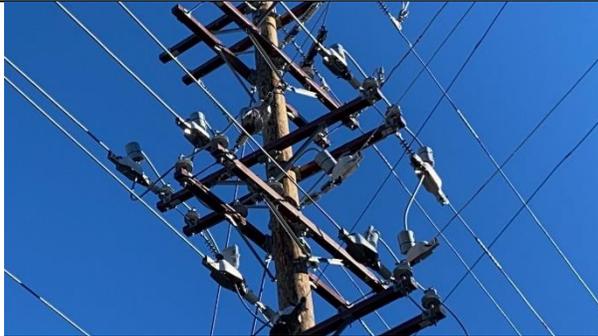
Item4IA2Img1: No vibration dampers

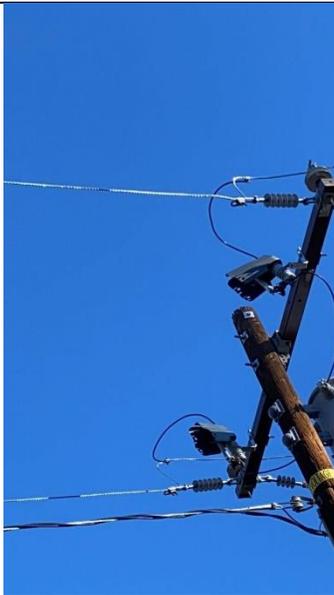
Item5IA1Img1: Bare wire

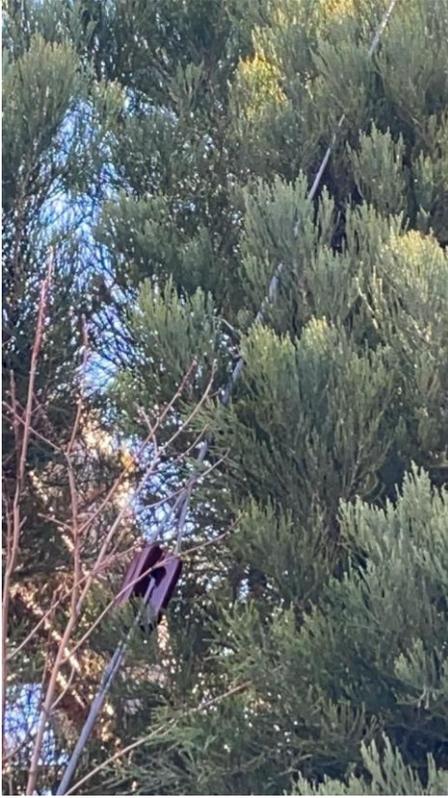
In addition to the violations discovered during WMP inspections of SCE's covered conductor installations, Energy Safety discovered vegetation contacting a guy wire above the insulator. Guy wires are metallic and can become energized in some circumstances. Insulators break the current path and prevent electricity from reaching the ground where a down guy wire is anchored. However, the portion above the insulator can remain energized until the circuit is deenergized and may cause an ignition if energized while in contact with vegetation. Accordingly, Energy Safety considers vegetation in contact with down guy wires above the insulator a condition that increases an electrical corporation's ignition risk. The structure where Energy Safety observed vegetation in contact with the guy wire above the insulator is noted in Table 3.

Item5GW2Img1: Vegetation touching guy wire above insulator

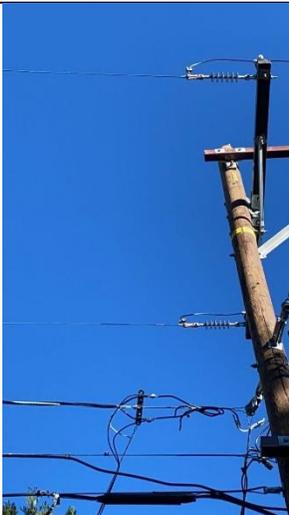
Item6IA1Img1: Bare wire

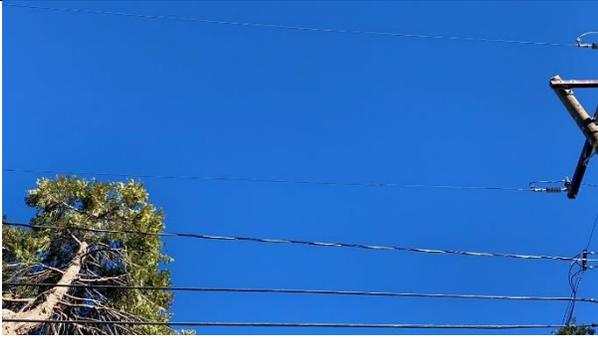
Energy Safety also discovered a conductor that had an excessive number of splices along a single phase. Energy Safety considers the presence of three or more splices along a single-phase conductor to be an indicator of potential issues with electrical loading or physical weakening of the line. The weakening of conductors can result in heightened risk of conductor failure or of arcing that could

result in an ignition. The structure where Energy Safety observed excessive splices observed along a single phase is identified in Table 3.

Item6CD9Img1: 3 splices on one phase

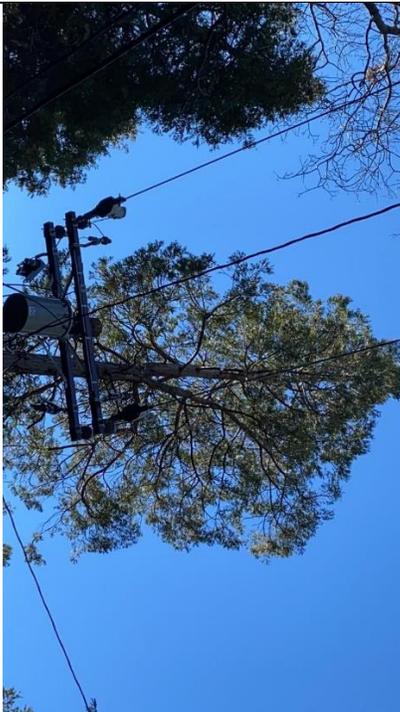
Item7IA1img1: No vibration dampers

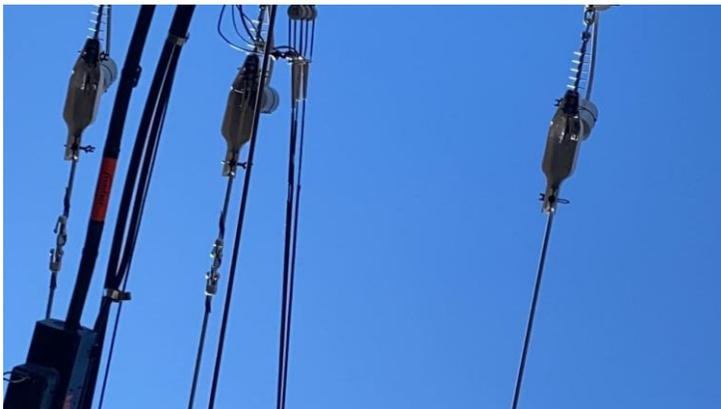
Item16IA1Img1: In photo, right phase missing vibration damper

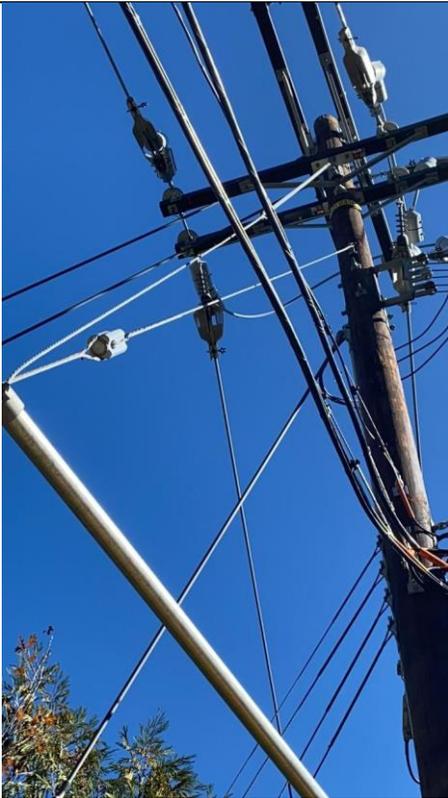
Item19IA1Img1: Missing fiberglass guy wire insulator
