NOTICE OF DEFECT

Energy Safety Inspection Report

Report Name: ATJ_SCE_20211116

On November 16, 2021, I performed a walking inspection of Southern California Edison (SCE) covered conductor installations, 2021 WMP initiative number 7.3.3.3.1, along Tierra Rejada Road near the city of Simi Valley. Detailed findings from this field inspection are laid out in Section II below.

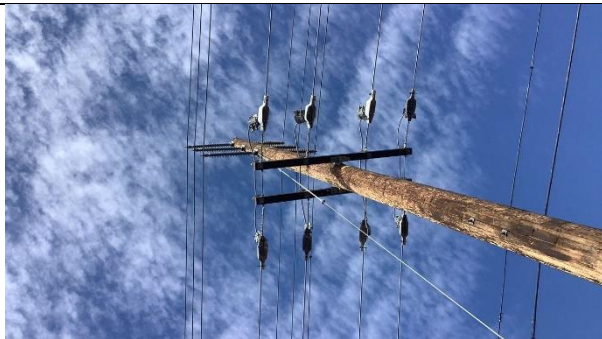
Item1IA1Img1: No vibration dampers installed

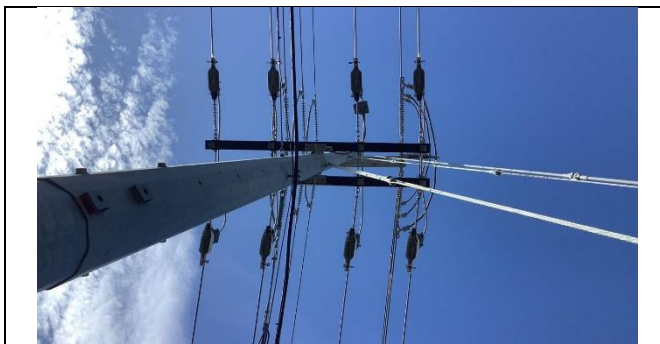
Item2IA1Img1: No vibration dampers installed

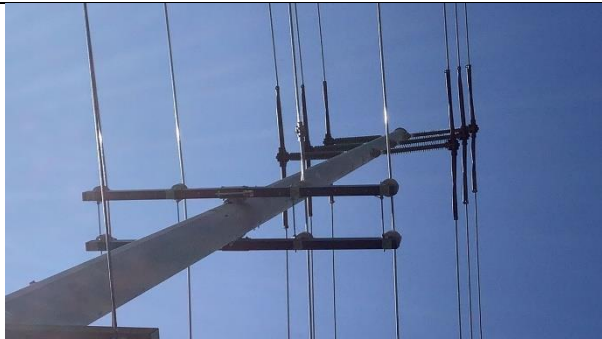
Item4IA1Img1: No vibration dampers installed

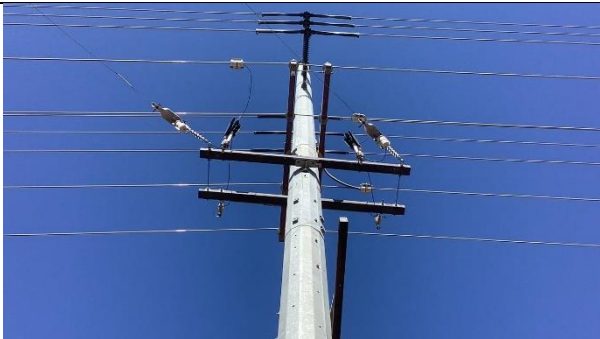
Item5IA1img1: No vibration dampers installed

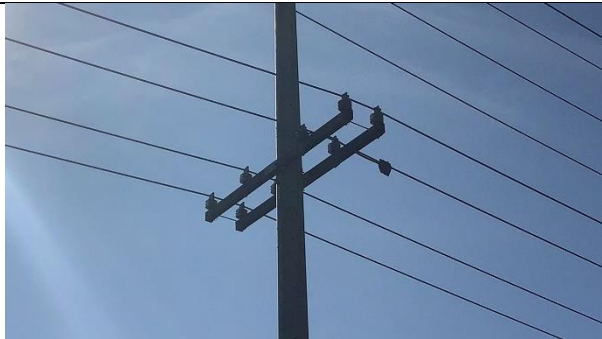
Item6IA1Img1: Vibration dampers not installed

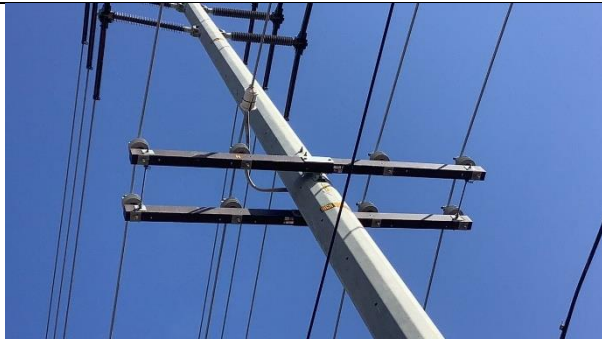
Item7IA1img1: Vibration dampers not installed

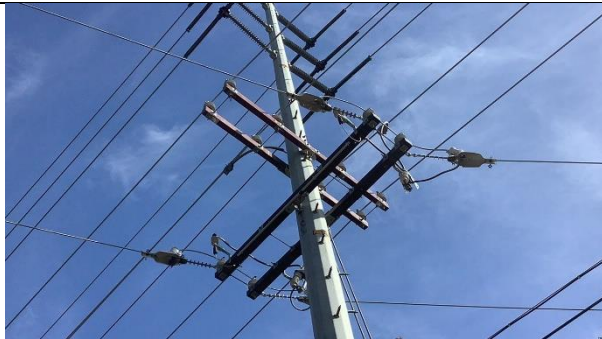
Item9IA1img1: No vibration dampers installed

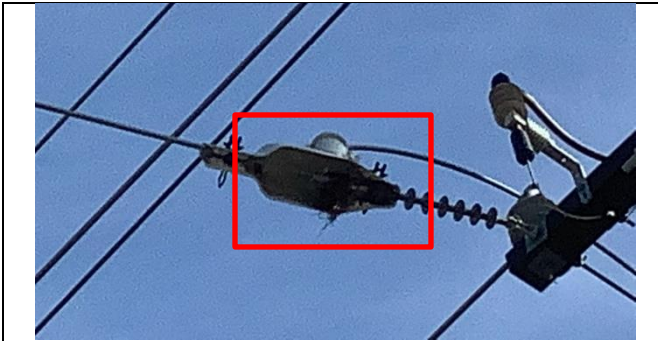
1. Defect 1: Pole numbered 1922654E has a bird nest within a dead-end bolted wedge connector cover. The primary purpose of an equipment cover is to prevent contact between the equipment and foreign objects. The presence of wildlife and nests inside a cover increases the risk of ignition if wildlife or wildlife-related debris contacts an energized portion of the circuit. This situation will also shorten the lifespan of the covered conductor installation. Energy Safety considers this defect to be in the Minor risk category.

Item	Structure ID	HFTD	Defect Type	Severity	Defect Description
1	1922654E	Tier 3	Vegetation touching supply conductors	Moderate	There is a bird nest within a dead-end bolted wedge connector cover

In addition to the violations discovered during WMP inspections of SCE’s covered conductor installations, Energy Safety discovered a bird nest within a bolted wedge connector cover. Energy Safety considers the presence of nests within a connector cover a condition that increases an electrical corporation's ignition risk because of the high probability that nesting materials or nest-related debris may contact energized portions of the electrical infrastructure. The purpose of the cover is to protect external objects from making contact and resulting in a potential ignition. A bird nest made of dry brush, debris, and other flammable materials within the surface of a bolted wedge connector cover increases the electrical corporation’s ignition and wildfire risk. The structure where the nest was observed is identified in Table 3.

Item9VG2Img1: Bird nest close-up view

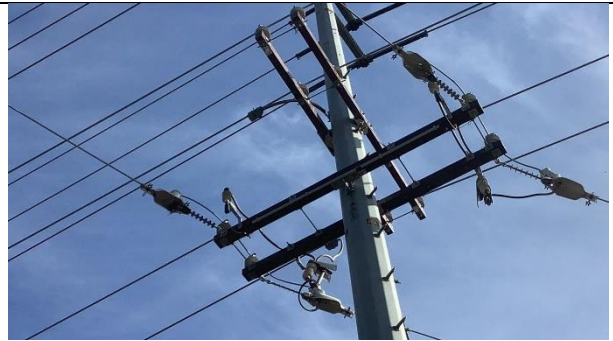
Item9VG2Img2: Bird nest in end cap to left of photo

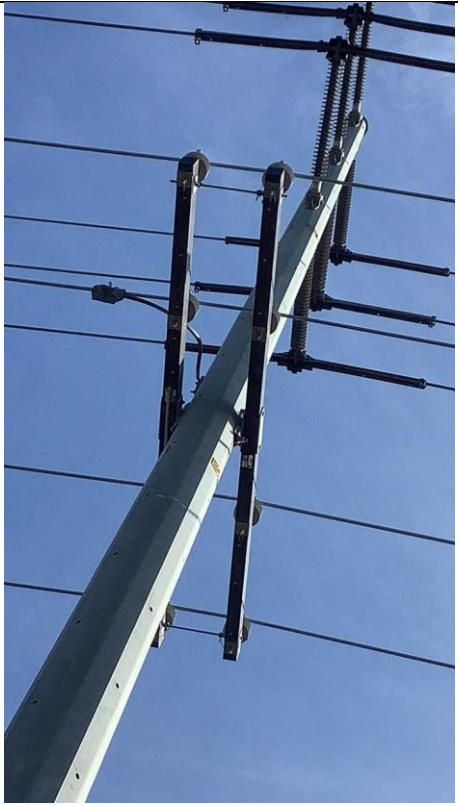
Item10IA1mg1: Vibration dampers not installed

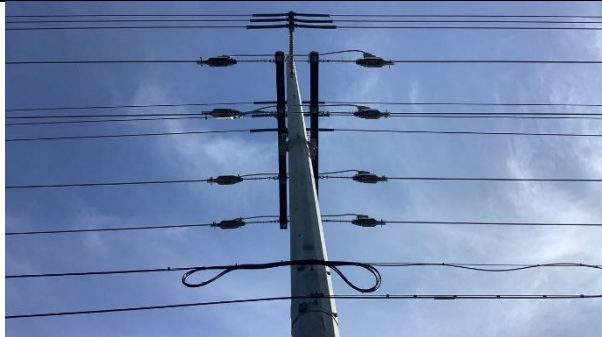
Item11IA1img1: Vibration dampers not installed

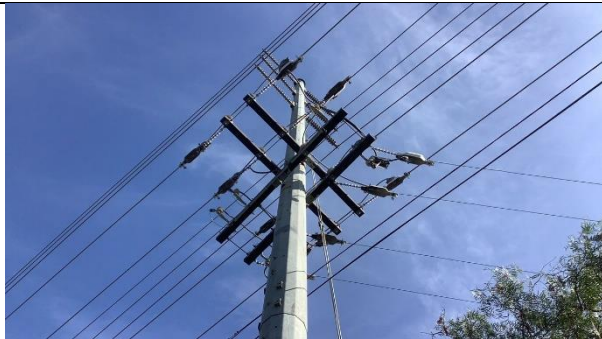
Item12IA1mg1: No vibration dampers installed
