NOV\_SCE\_ATJ\_ 20211116-01

# NOTICE OF VIOLATION

# Energy Safety Inspection Report

Report Name: ATJ\_SCE\_20211116

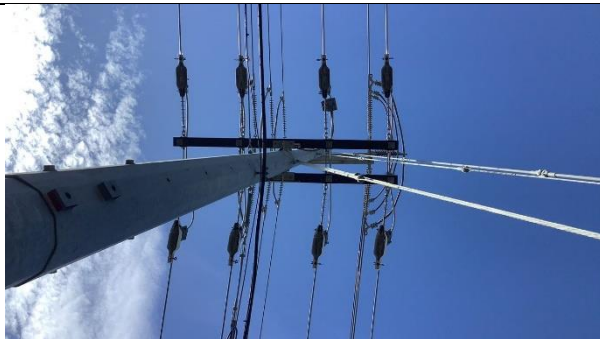
Item2IA1Img1: No vibration dampers installed

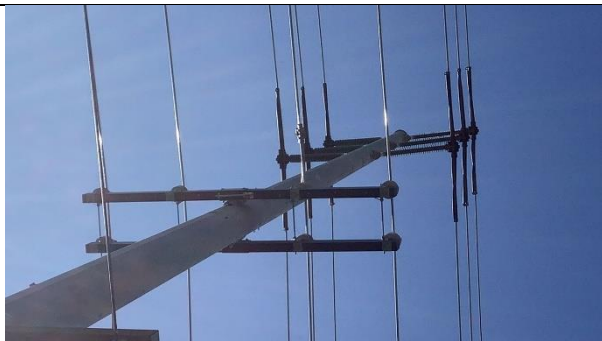
Item4IA1img1: No vibration dampers installed

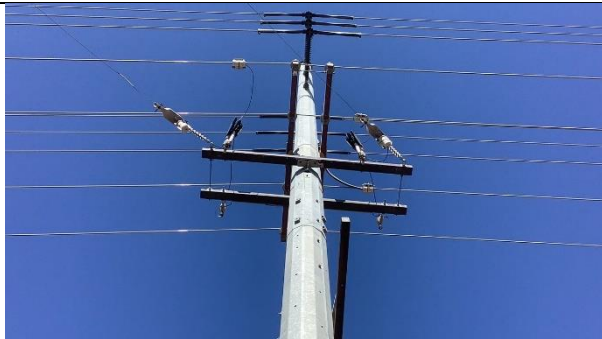
Item5IA1img1: No vibration dampers installed

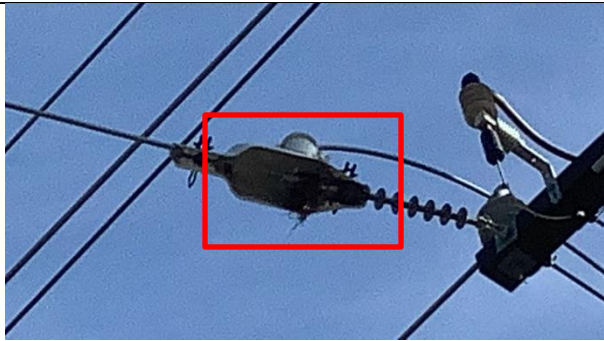
Item	Structure ID	HFTD	Defect Type	Severity	Defect Description
1	1922654E	Tier 3	Vegetation touching supply conductors	Moderate	There is a bird nest within a dead-end bolted wedge connector cover

**Item9VG2Img1:** Bird nest close-up view

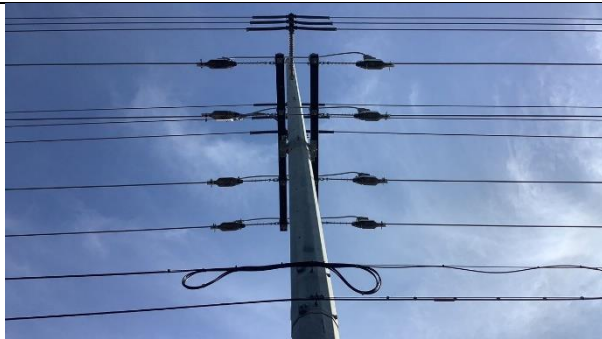
Item11IA1img1: Vibration dampers not installed
