**CALIFORNIA UNDERGROUND FACILITIES SAFE EXCAVATION BOARD
INVESTIGATION DIVISION
INVESTIGATION REPORT**

CASE No.: 21LA01481

INCIDENT: Contractor struck a marked natural gas service line with a mini excavator causing a leak and evacuation of nearby residents.

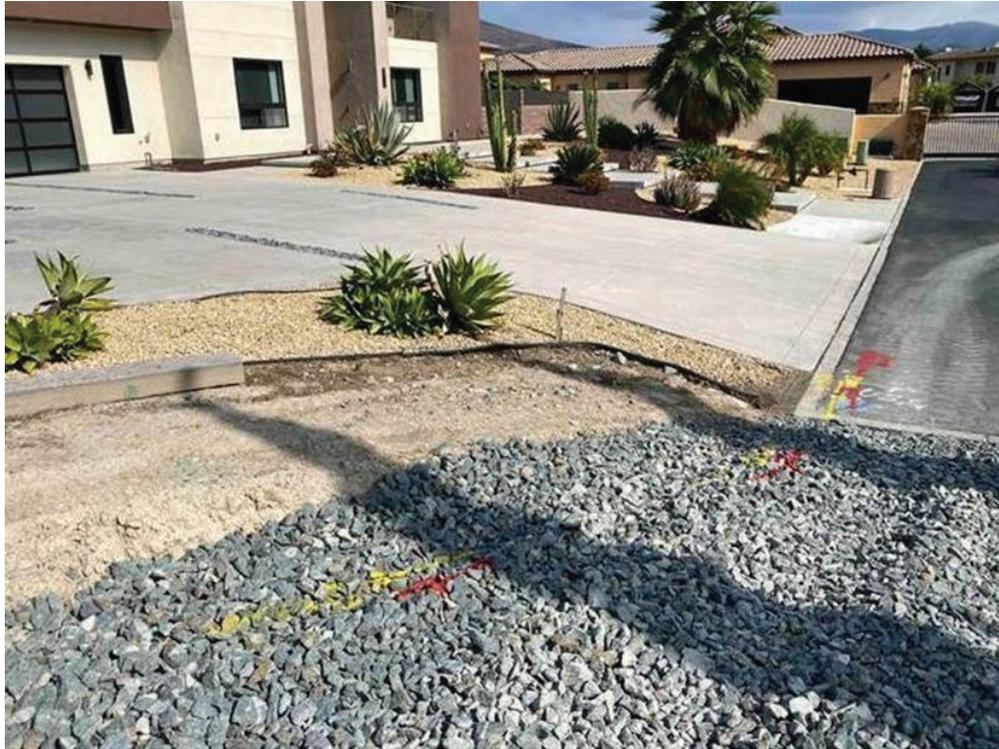
On October 5, 2021, San Diego Gas and Electric came out to locate and mark their gas and electric facilities (**Exh. 6**). The gas service line was marked as seen in photos (1 & 2) below.

Photo 1 (Courtesy SDG&E L&M) Gas and Electric Marks

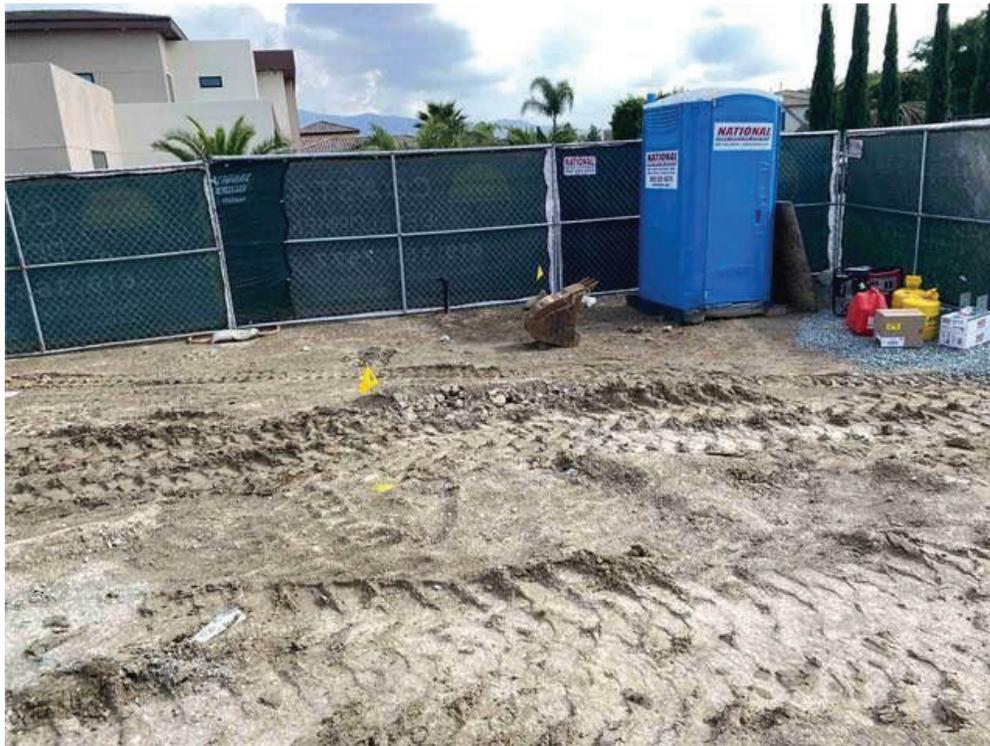
Photo 2 (Courtesy SDG&E L&M) Gas Marks

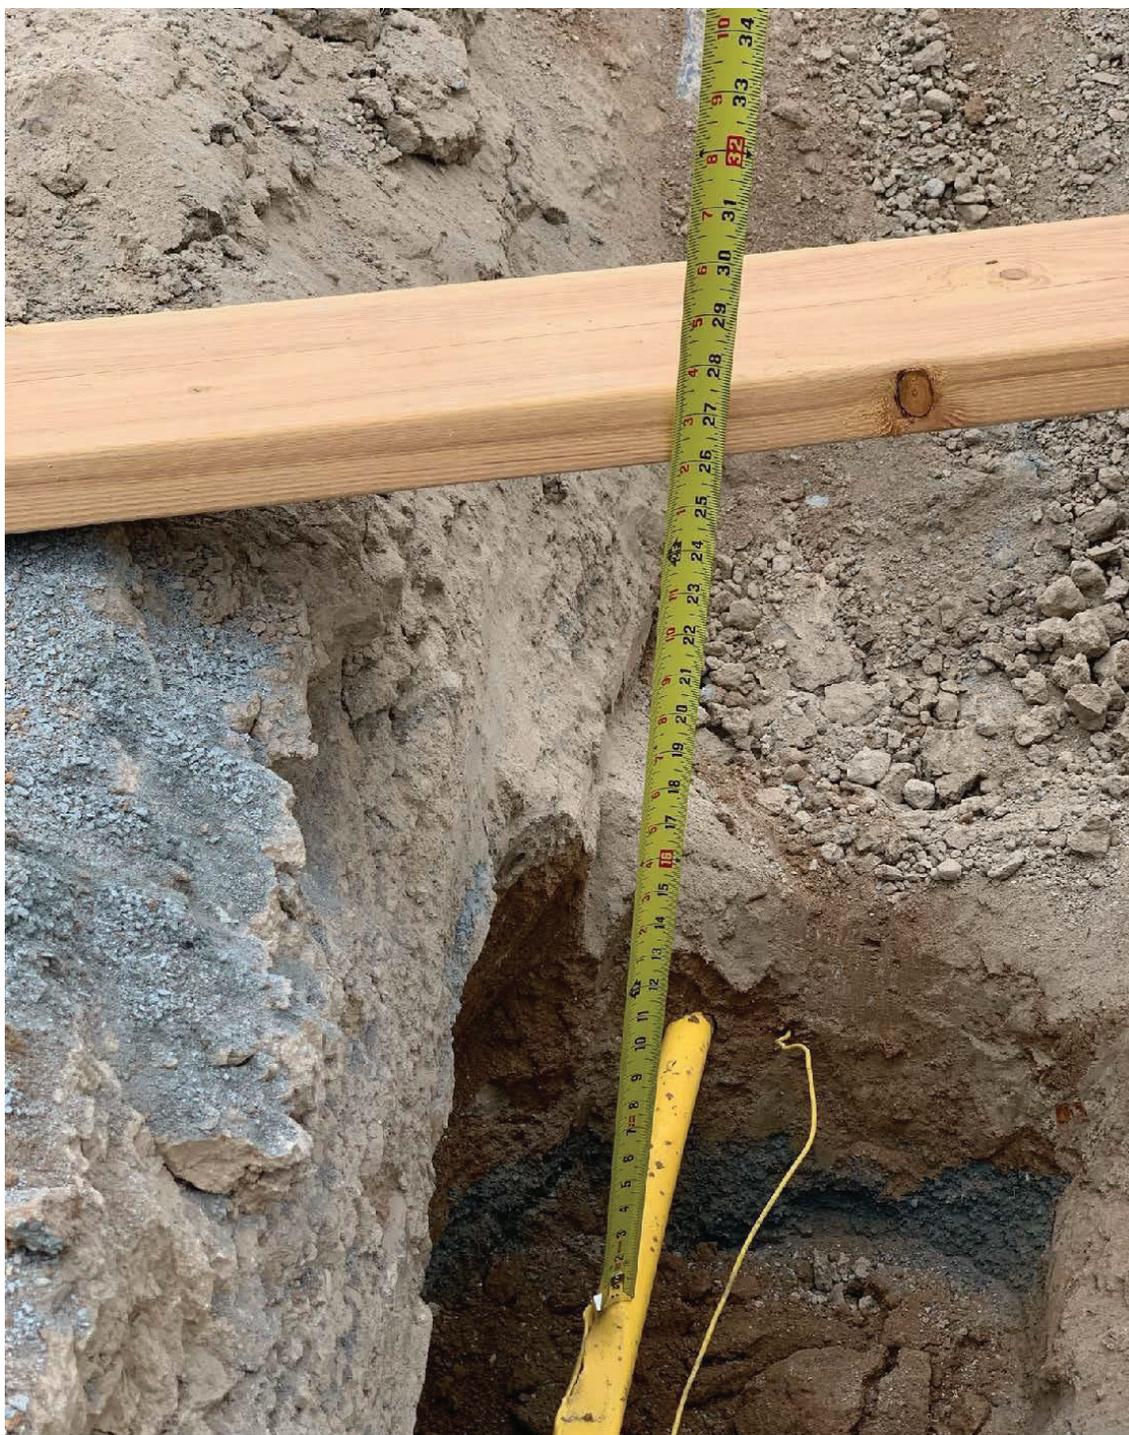
Photo 3 (Courtesy Coastal Development) Showing depth of line

- II. Coastal Development Group stated they were told that the gas line was 36” deep and it was actually 24” deep.**

Coastal Development Group employees acknowledged in their statements the line was marked accurately. Operators are not required to provide the depth of their facility when Locating and Marking.

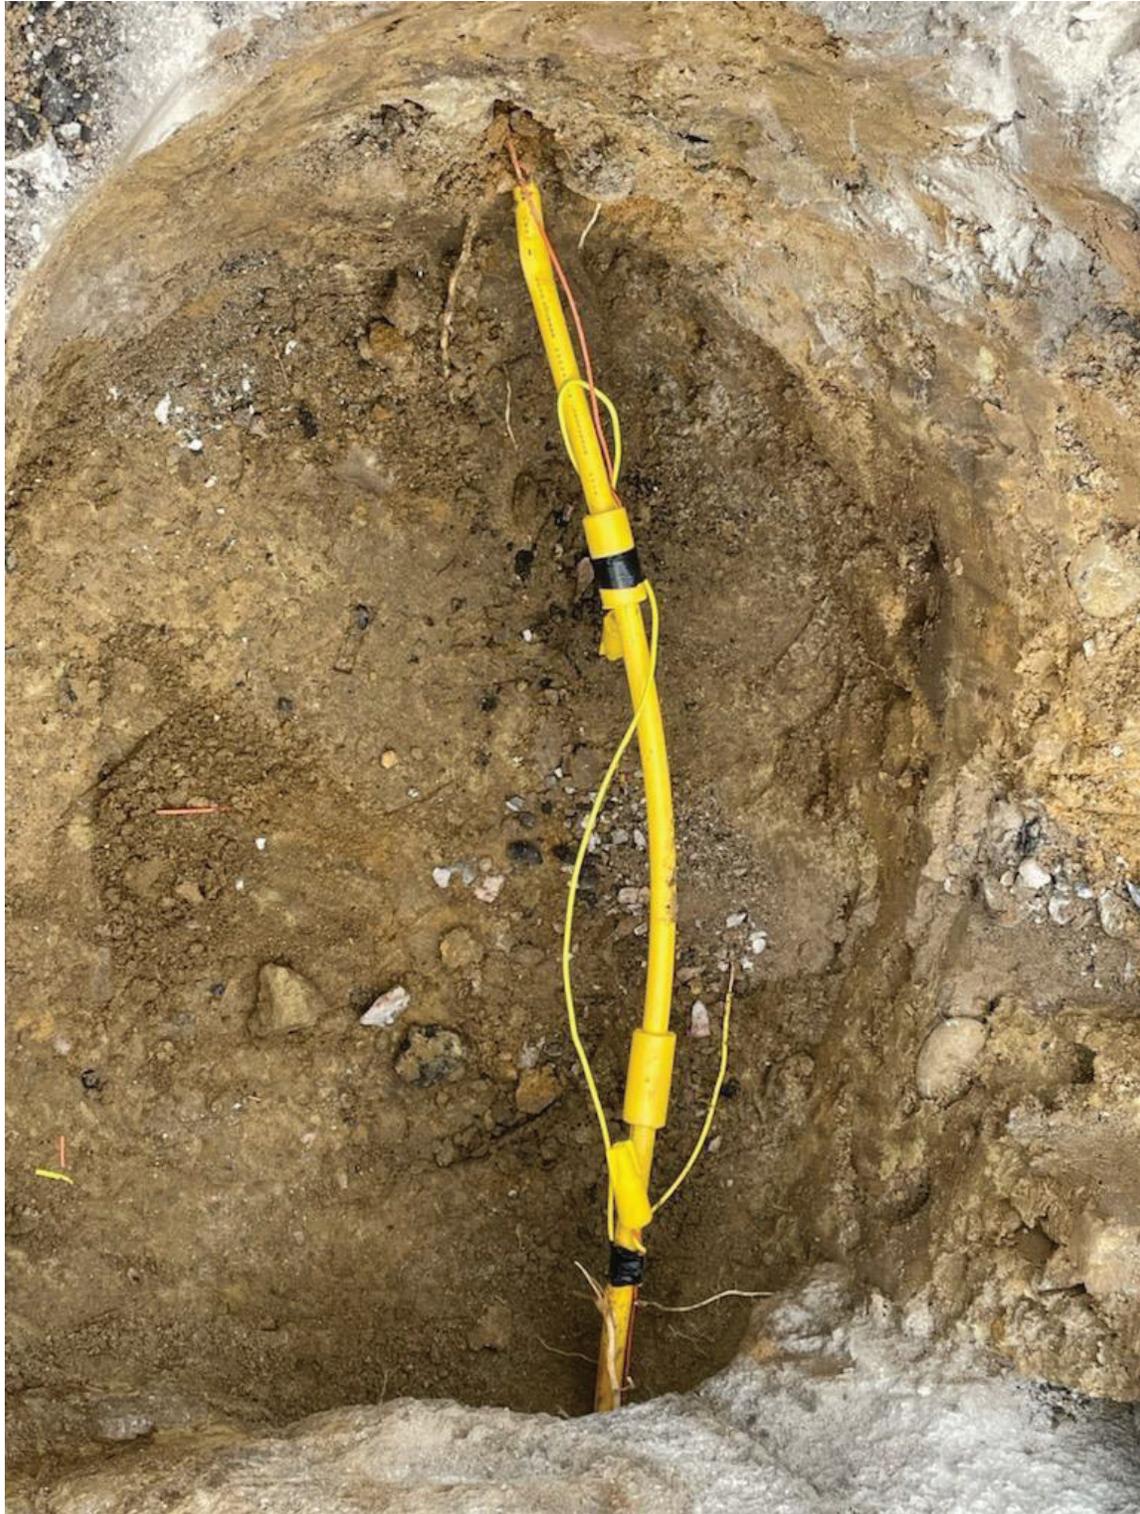
In response to a request for information on the incident, San Diego Gas and Electric (SDE&G) provided a damage report (**Exh. 10**) indicating the line was properly marked and that they were notified of a third-party damage to their 1” inch service line at [REDACTED] causing a release of gas on October 18, 2021. SDG&E personnel responded to scene and safely controlled the gas. There were no injuries or fatalities from this incident. SDG&E also provided Locate and Mark photos (See **Exh. 6**) and photos of the service line and tracer wire repairs (Photo 4) (**Exh. 11**).

Photo 4 (Courtesy SDG&E) Line and Tracer Wire Repair

Ferrier stated that he immediately called 911 and the Chula Vista Fire Department came in 15 to 20 minutes to evacuate residents. Ferrier further stated that San Diego Gas and Electric came and pinched the line repaired it and repaired the tracer line and left the scene.

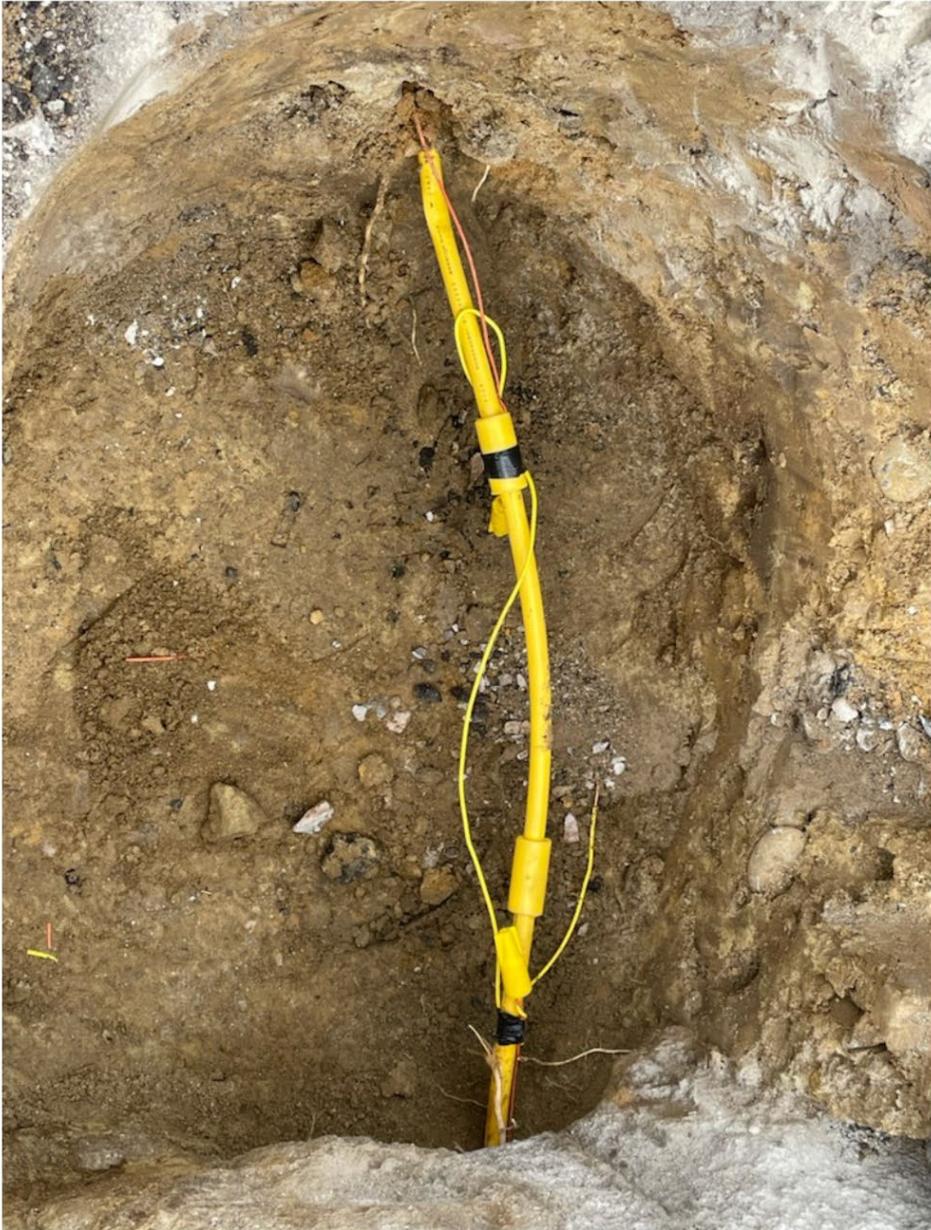
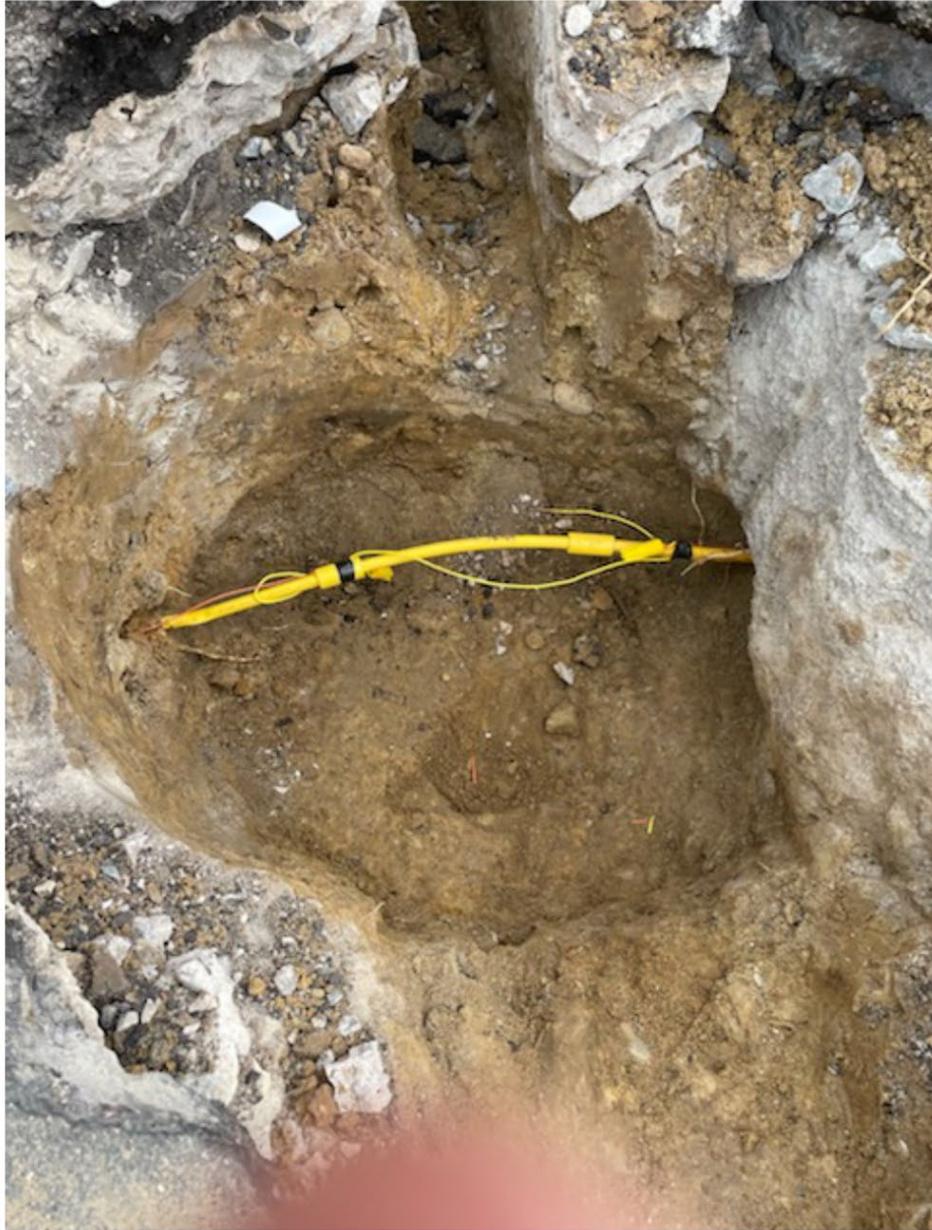
Evidence 11: Damage Repair Photos

On 10-18-2021, SDG&E was notified of a third-party damage at [REDACTED]. The third-party contractor struck a 1-inch plastic service line with an excavator, causing a release of gas. SDG&E personnel were sent to the scene and safely controlled the gas. There were no injuries or fatalities resulting from this incident.
