NOV_SCE_ATJ_20211118-01_Revised

NOTICE OF VIOLATION

Energy Safety Inspection Report

Report Name: SCE_ ATJ_20211118-01_Revised

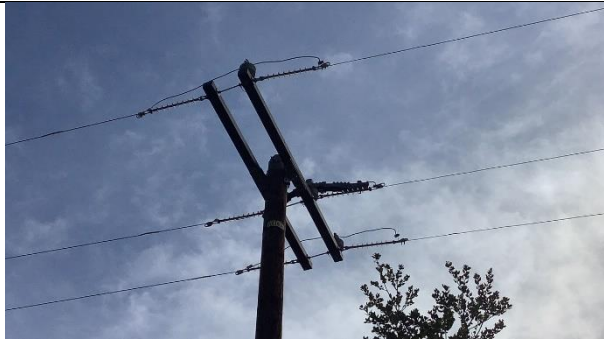
1. Violation 1: Per SCE’s 2021-Q1 quarterly data report (QDR), covered conductor was installed on poles numbered 4339409E, 4574184E, 4538061E, 4926384E, and 4263188E. All these structures reported a covered conductor initiative (2021 WMP initiative number 7.3.3.3.1) with a status of “Complete.” However, upon inspection, SCE has not even begun covered conductor installation at any of these locations. Energy Safety considers this data accuracy violation to be in the Moderate risk category.
2. Violation 2: Per SCE’s 2021-Q1 QDR, covered conductor was installed on poles numbered 4339409E, 4574184E, 4538061E, 4926384E, and 4263188E. Upon inspection, Energy Safety staff found no covered conductor installed at the above-mentioned structures. Given SCE’s focus on covered conductor as one of its flagship wildfire mitigation programs

Item1IA1Img1: No covered conductor

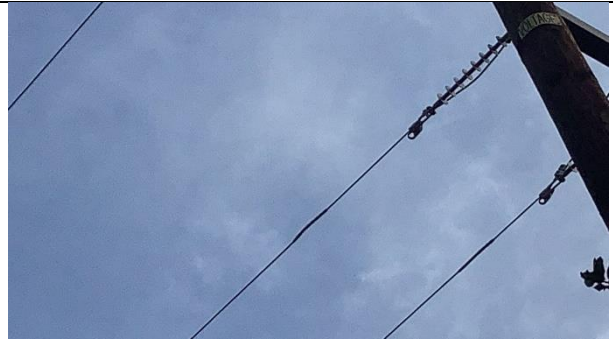
Item1IA1Img2: Close up of bare wire

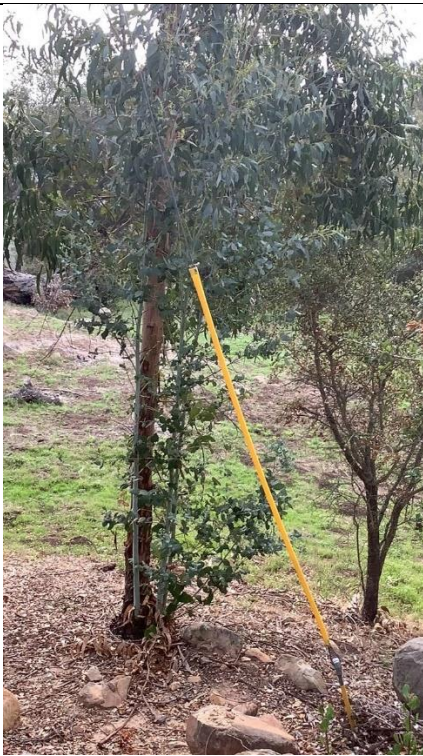
In addition to the violations discovered during WMP inspections of SCE's covered conductor installations, Energy Safety discovered two structures that had loose guy wires. Energy Safety considers loose guy wires as a condition that increases an electrical corporation's ignition risk because the primary purpose of a guy wire is to provide stability to a structure (e.g. a pole) where imbalanced loads are present. If a guy wire is loose and not maintained taut, it cannot serve its intended purpose of balancing load and adding stability, thus increasing the risk of structure failure and potential ignition under adverse weather conditions. Structures where loose guy wires were observed are identified in Table 3.

Item1GW1Img1: Loose guy wire

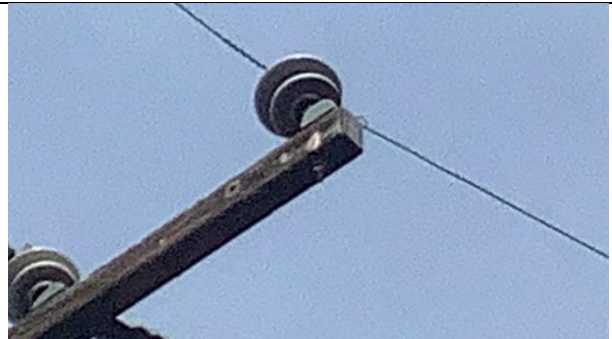
Item2IA1Img2: Bare wire closeup

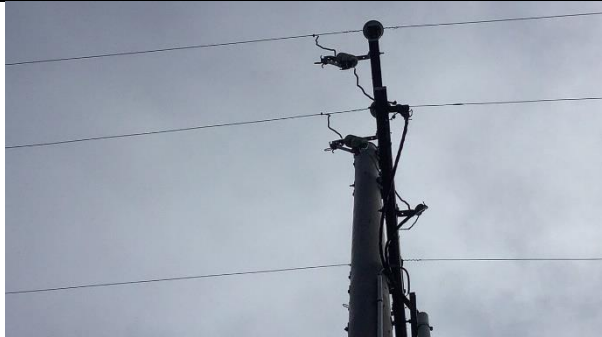
Item3IA1Img1: Bare wire

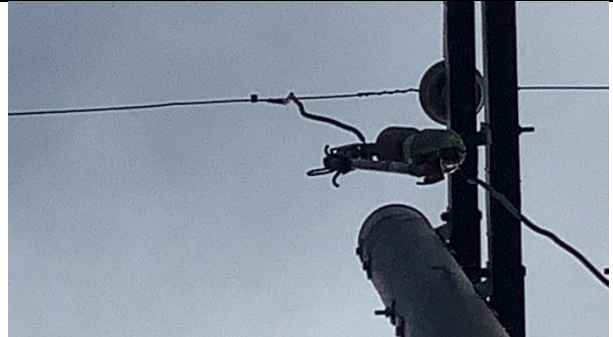
Item3IA1Img2: Close up of bare wire

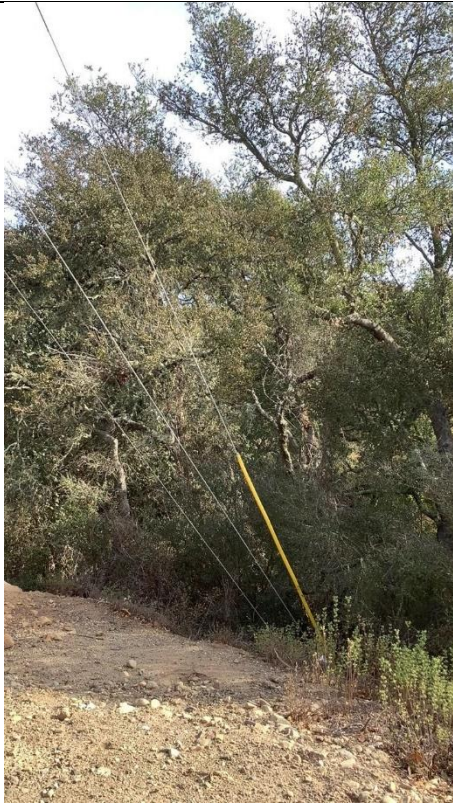
Item4GW1Img1: Loose guy wire

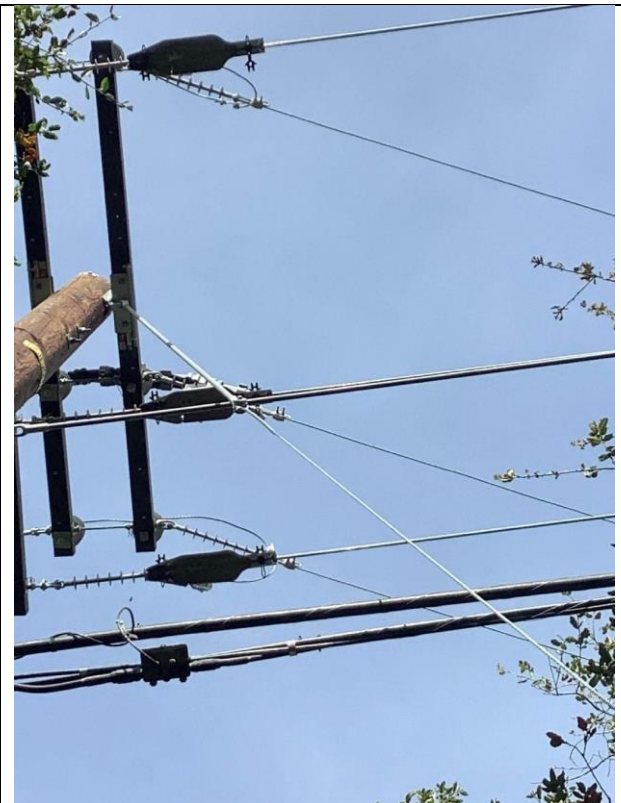
Item5IA1mg1: Bare wire

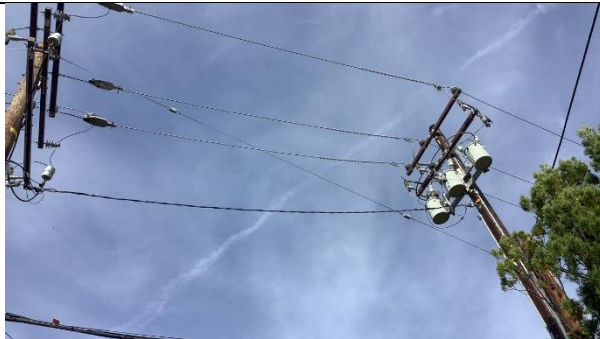
3. Violation 3: Per SCE’s Distribution Overhead Construction Standards (DOH), section PO 300, page 3 of 9, and Distribution Design Standards (DDS), section DDS-10, page 10-26, installation of a fiberglass guy strain insulator is required for distribution guying applications and repairs in high fire risk areas (HFRA) and shall be installed in conjunction with covered conductor installation¹. Poles numbered 1257280E, and 2144970E had covered conductor installed but failed to install fiberglass guy strain insulator, in accordance with SCE protocol. Energy Safety considers this violation for failure of adhering to protocol to be in the Minor risk category.

Item7IA1Img1: Porcelain guy insulator

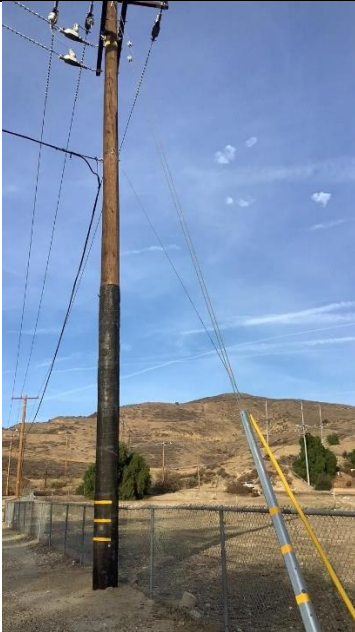
Item11IA1Img1: Overall view of down guy

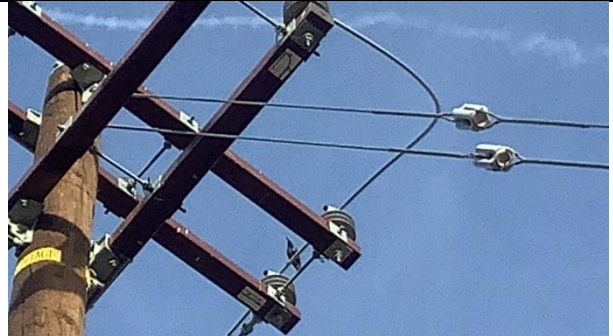
Item11IA1Img2: Close up of porcelain insulator
