NOV_SCE_ATJ_20211130-01_Revised

NOTICE OF VIOLATION

Energy Safety Inspection Report

Report Name: ATJ_SCE_20211130-01_Revised
Date(s) of Inspection: November 30, 2021
Inspector: Anthony Trujillo
Utility: Southern California Edison
Attention: Erik Takayesu, Vice President Asset Strategy and Planning

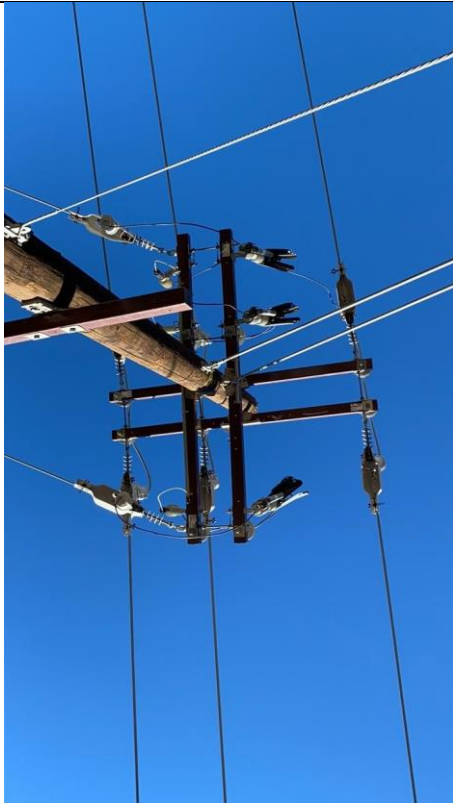
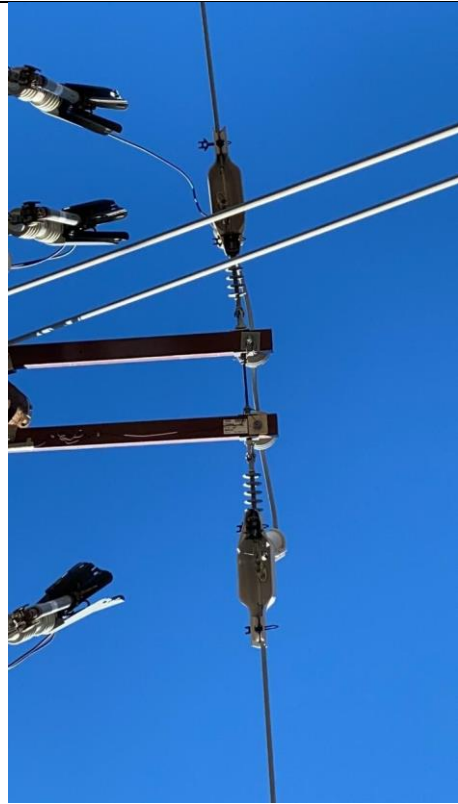
Structure ID: 463639E

| Item | Structure ID | HFTD | Initiative Number | Violation Type | Severity | Violation Description |
|---|---|---|---|---|---|--|
| 1 | 463639E | Tier 3 | 7.3.3.3.1 | Adherence to Protocol | Minor | Failure to install vibration dampers on a span |

Item1IA1mg1: Vibration dampers not installed

Item1IA1mg2: Close up, no vibration dampers installed

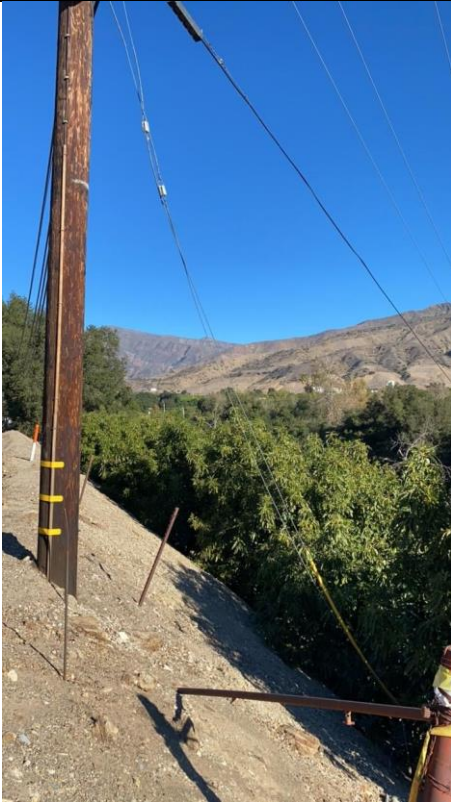
Structure ID: 1561562E

| Item | Structure ID | HFTD | Defect Type | Severity | Defect Description |
|---|---|---|---|---|---|
| 1 | 1561562E | Tier 3 | Down guy wire loose | Minor | Loose guy wire |

considers loose guy wires as a condition that increases an electrical corporation's ignition risk because the primary purpose of a guy wire is to provide stability to a structure (e.g., a pole) where imbalanced loads are present. If a guy wire is loose and not maintained taut, it cannot serve its intended purpose of balancing load and adding stability, thus increasing the risk of structure failure and potential ignition under adverse weather conditions. The structure where a loose guy wire was observed is identified in Table 3.

Item2GW1Img1: Overview of pole with loose down guy wire

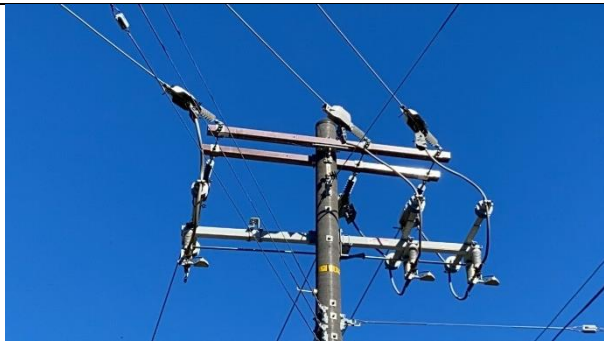
Structure ID: 929077E

| Item | Structure ID | HFTD | Initiative Number | Violation Type | Severity | Violation Description |
|---|---|---|---|---|---|--|
| 3 | 929077E | Tier 3 | 7.3.3.3.1 | Adherence to Protocol | Minor | Failure to install vibration dampers on a span |

Item6IA2Img1: Vibration dampers not installed

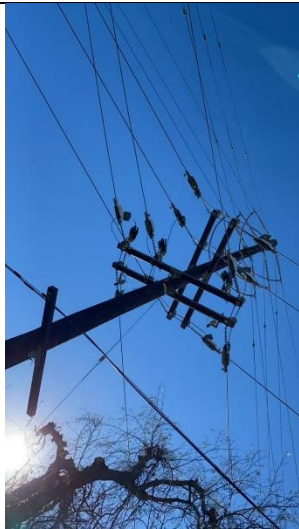
Structure ID: 929076E

| Item | Structure ID | HFTD | Initiative Number | Violation Type | Severity | Violation Description |
|---|---|---|---|---|---|--|
| 4 | 929076E | Tier 3 | 7.3.3.3.1 | Adherence to Protocol | Minor | Failure to install vibration dampers on a span |

Item7IA1Img1: Vibration dampers not installed

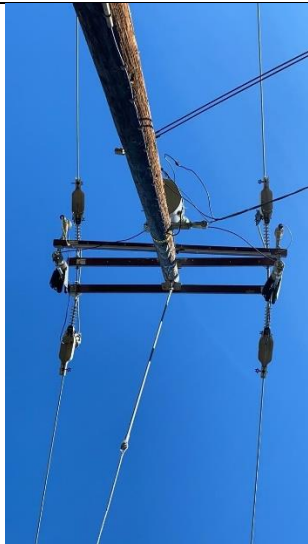
Structure ID: 4094275E

| Item | Structure ID | HFTD | Initiative Number | Violation Type | Severity | Violation Description |
|---|---|---|---|---|---|--|
| 5 | 4094275E | Tier 3 | 7.3.3.3.1 | Adherence to Protocol | Minor | Failure to install vibration dampers on a span |

Item8IA1Img1: Vibration dampers not installed

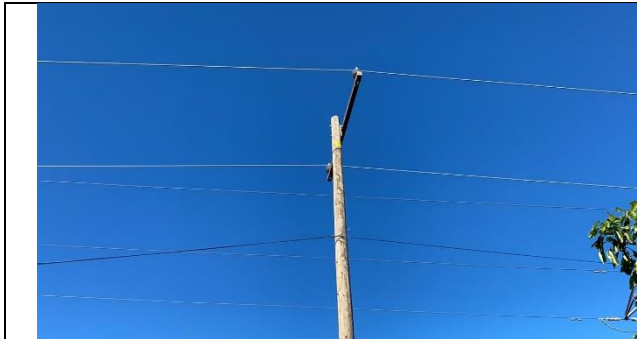
Structure ID: 4094276E

| Item | Structure ID | HFTD | Initiative Number | Violation Type | Severity | Violation Description |
|---|---|---|---|---|---|--|
| 6 | 4094276E | Tier 3 | 7.3.3.3.1 | Adherence to Protocol | Minor | Failure to install vibration dampers on a span |

Item9IA1img1: Vibration dampers not installed

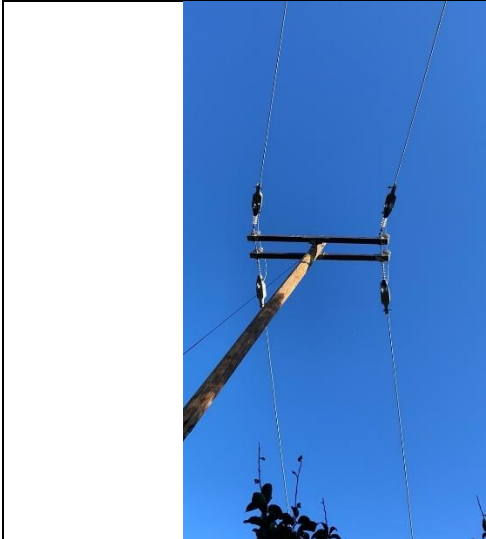
Structure ID: 4094278E

| Item | Structure ID | HFTD | Initiative Number | Violation Type | Severity | Violation Description |
|---|---|---|---|---|---|--|
| 8 | 4094278E | Tier 3 | 7.3.3.3.1 | Adherence to Protocol | Minor | Failure to install vibration dampers on a span |

Item11IA1mg1: Vibration dampers not installed

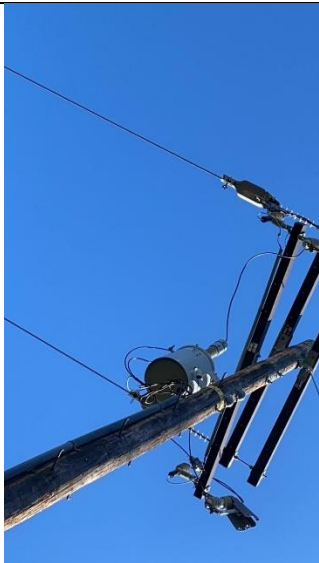
Structure ID: 4157910E

| Item | Structure ID | HFTD | Initiative Number | Violation Type | Severity | Violation Description |
|---|---|---|---|---|---|--|
| 9 | 4157910E | Tier 3 | 7.3.3.3.1 | Adherence to Protocol | Minor | Failure to install vibration dampers |

Item12IA1img1: Vibration dampers not installed

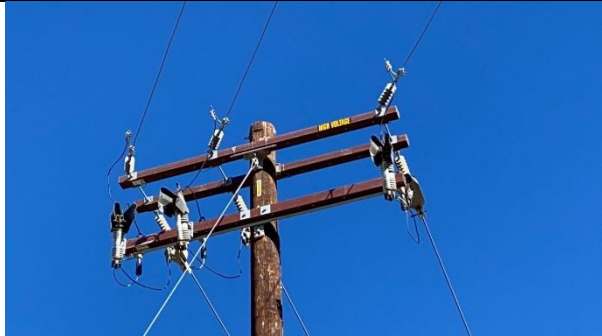
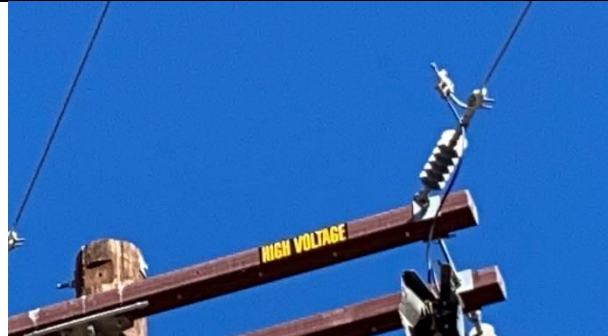
Structure ID: 4944416E

| Item | Structure ID | HFTD | Initiative Number | Violation Type | Severity | Violation Description |
|---|---|---|---|---|---|--|
| 10 | 4944416E | Tier 3 | 7.3.3.3.1 | Data Accuracy | Minor | Data submitted by SCE is inaccurate and indicates covered conductor work terminates one span to the East. Covered conductor terminates at this pole. |

Item13IA1mg1: Bare wire to covered conductor

Item13IA1mg2: Bare wire to covered conductor close up

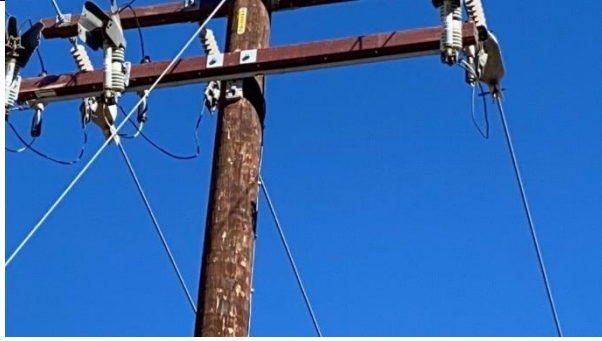
| Item | Structure ID | HFTD | Initiative Number | Violation Type | Severity | Violation Description |
|---|---|---|---|---|---|--|
| 11 | 4944416E | Tier 3 | 7.3.3.3.1 | Adherence to Protocol | Minor | Failure to install vibration dampers on a span |

Item13IA3Img1: Vibration dampers not installed

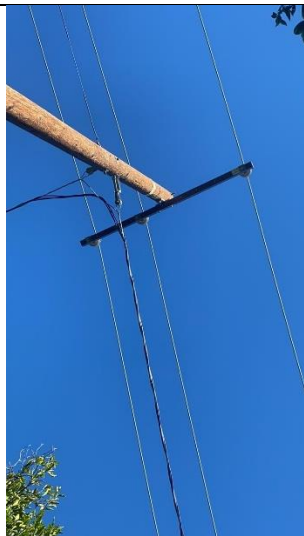
Structure ID: 1025312E

| Item | Structure ID | HFTD | Initiative Number | Violation Type | Severity | Violation Description |
|---|---|---|---|---|---|--|
| 13 | 1025312E | Tier 3 | 7.3.3.3.1 | Adherence to Protocol | Minor | Failure to install vibration dampers on a span |

Item15IA1img1: Vibration dampers not installed

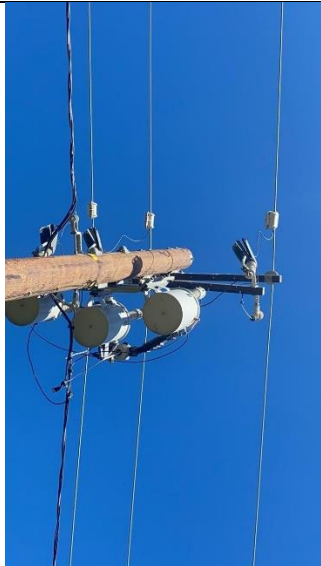
Structure ID: 1025313E

| Item | Structure ID | HFTD | Initiative Number | Violation Type | Severity | Violation Description |
|---|---|---|---|---|---|--|
| 14 | 1025313E | Tier 3 | 7.3.3.3.1 | Adherence to Protocol | Minor | Failure to install vibration dampers on a span |

Item16IA1Img1: No vibration dampers installed
