NOV\_SCE\_ATJ\_20211209-01\_Revised

# NOTICE OF VIOLATION

# Energy Safety Inspection Report

Report Name: ATJ\_SCE\_20211209-01\_Revised

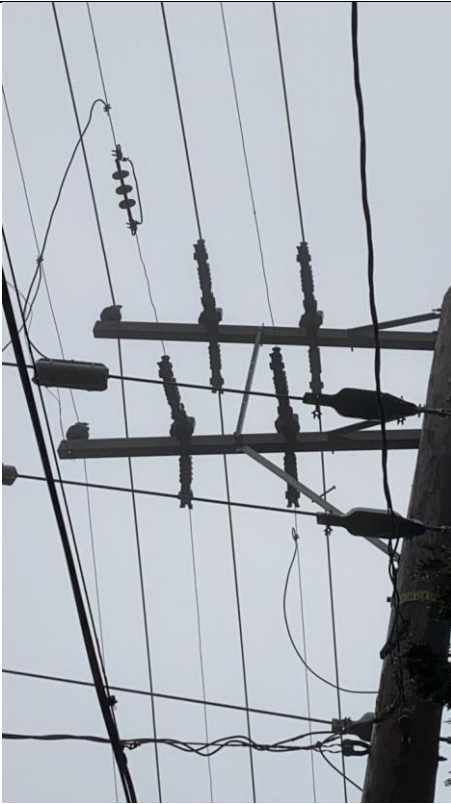
2. Violation 2: Per SCE's 2021-Q1 QDR, covered conductor was installed on poles numbered 687838E, 1403136E, 4558869E, 1763105E, and 1414393E. Upon inspection, Energy Safety staff found no covered conductor installed at the above-mentioned structures. Given SCE's focus on covered conductor as one of its flagship wildfire mitigation programs and the scope of this mitigation program, Energy Safety is greatly concerned about how much

**Item1IA1Img1:** Top level crossing phase showing bare wire and no covered conductor installed

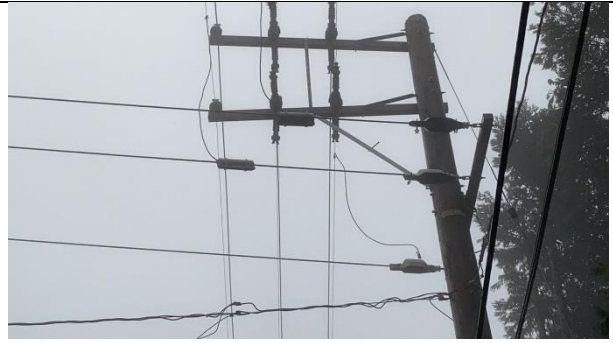
**Item1IA1Img2:** See mid-level of pole where covered conductor work was completed

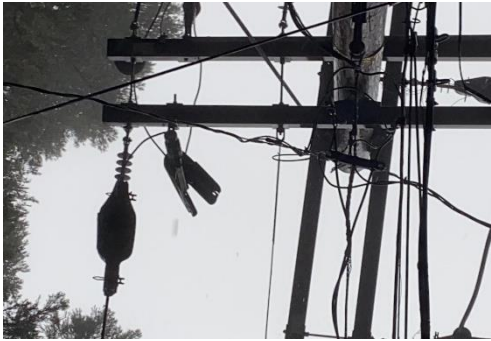
4. Violation 4: Per SCE's Distribution Overhead Construction Standards (DOH), Section CC 150.4, "All overhead equipment shall utilize appropriate wildlife covers."<sup>1</sup> Pole numbered 4931111E had a wildlife fuse cover improperly installed. Energy Safety considers this violation for failure of adhering to protocol to be in the Minor risk category.

Regarding wildlife fuse covers, per TE connectivity BCAC-G-CUTOUT (referred to by SCE as SAP10184097) product installation instructions, to install SCE SAP 10184097, "position the keyway slot on the bottom of the cover between the 1<sup>st</sup> and 2<sup>nd</sup> insulator skirts."<sup>1</sup> Energy Safety found one instance where wildlife fuse cover SAP 10184097, was not installed between the first and second insulator skirts. This structure is noted in Table 2.

**Item3IA2Img1:** Fuse cover does not sit between first and second insulator skirt

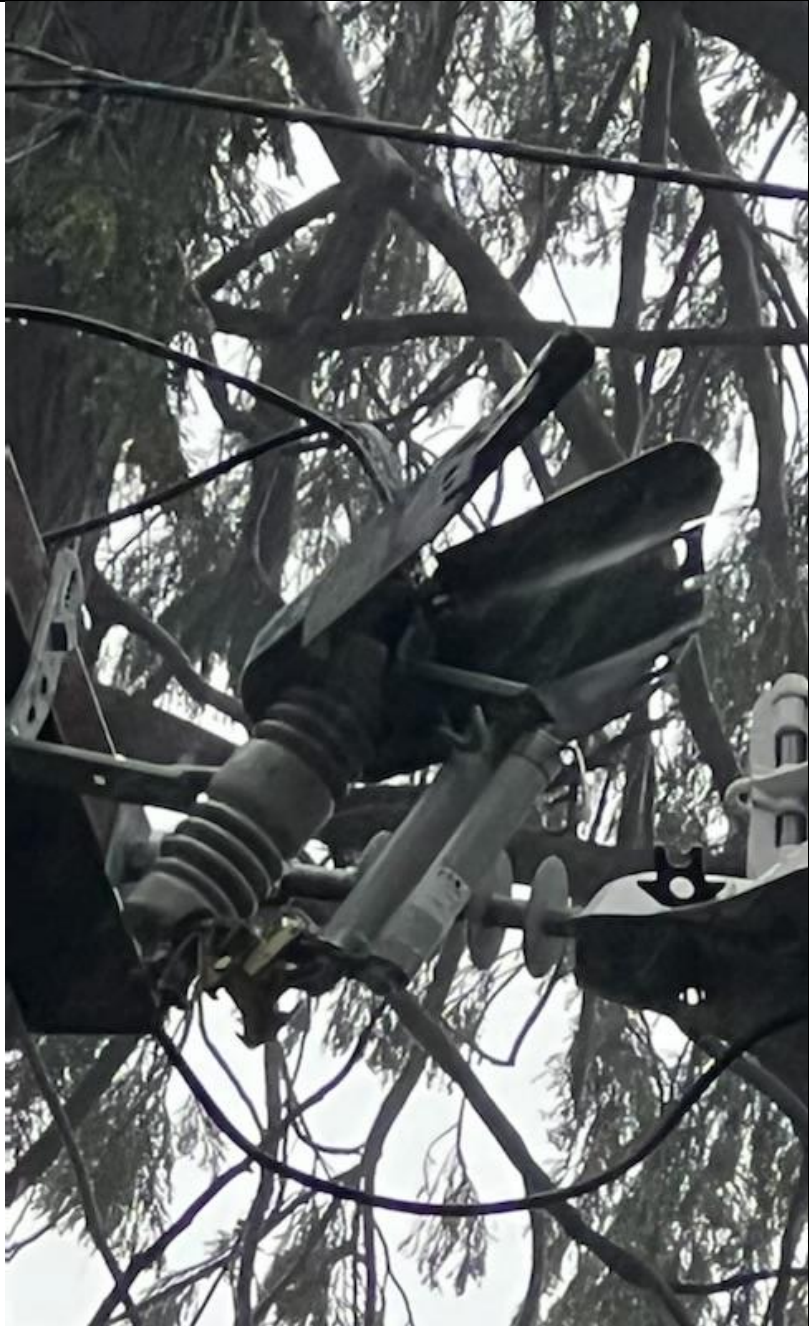
**Item3IA2Img2:** Close up of fuse cover from previous image

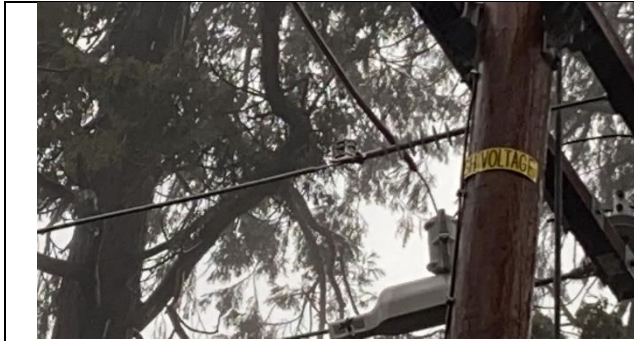
3. Violation 3: Per SCE's Distribution Overhead Construction Standards (DOH), "If conductor is exposed, install bolted wedge connector cover." Pole numbered 4931111E did not have bolted wedge connector cover installed on the center phase. Energy Safety considers this a violation for failure of adhering to protocol and in the Minor risk category.

In accordance with SCE's protocols for covered conductor installation, DOH CC 180, "If conductor is exposed, install bolted wedge connector cover." During the inspection, Energy Safety found one instance where a bolted wedge connector cover was not installed on exposed conductor where covered conductor work was completed, per SCE's protocols. Structures where this protocol was not followed are noted in Table 2 above.

**Item3IA4Img1:** Bare dead-end conductor with no cover

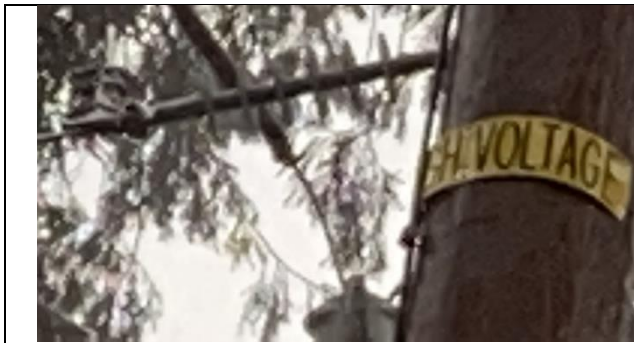
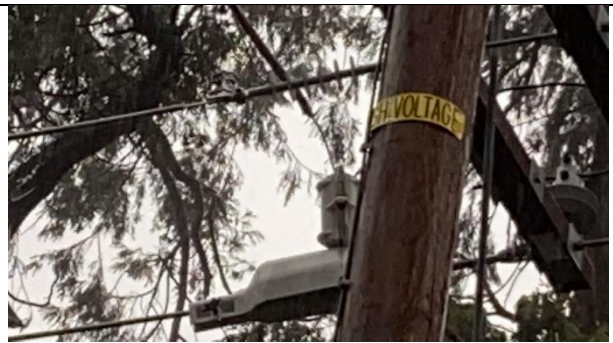
5. Violation 5: Per SCE's Distribution Overhead Construction Standards (DOH), section CC 150, jumpers that are connected to covered conductor must be covered. Energy Safety found that pole numbered 4931111E had a jumper connected to covered conductor that was bare before entering a bolted wedge connector cover. Energy Safety considers this violation for failure of adhering to protocol to be in the Minor risk category.

Per SCE's Distribution Overhead Construction Standards (DOH), section CC 150, jumpers that are connected to covered conductor shall be covered. Energy Safety found one instance where a jumper connected to covered conductor was bare before entering a bolted wedge connector cover. These structures are noted in Table 2.

**Item3IA5Img1:** Bare jumper going into bolted wedge connector cover

**Item3IA5Img2:** Overall photo bare jumper going into bolted wedge connector cover

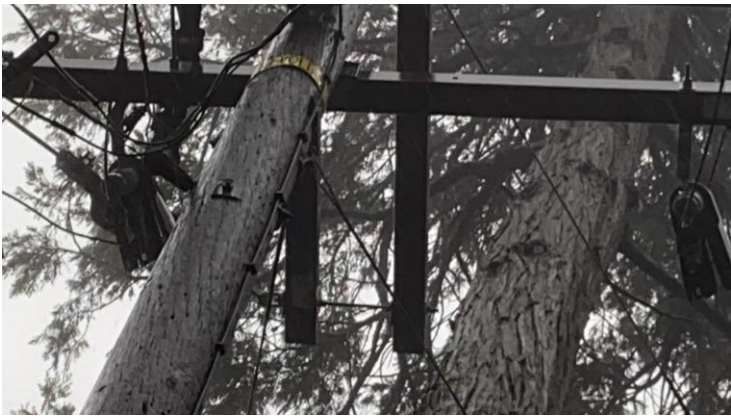
7. Violation 7: Per SCE's 2021-Q1 quarterly data report (QDR), covered conductor was not installed at pole numbered F16868Y. Structures adjacent were reported under the covered conductor initiative (2021 WMP initiative number 7.3.3.3.1) with a status of "complete." However, upon inspection, it was found that covered conductor was installed at this pole. Energy Safety considers this data accuracy violation to be in the Minor risk category.

<b>Item4IA3Img1:</b> View of pole crossarm with covered conductor

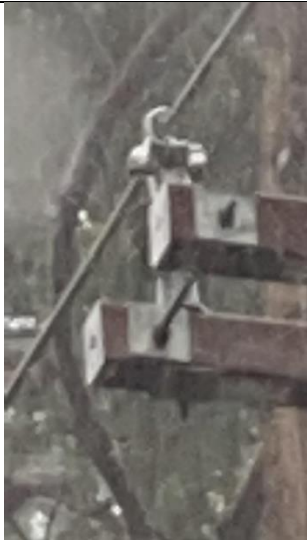
6. Violation 6: Per SCE's Distribution Overhead Construction Standards (DOH), section GR 200.5, "Vice-top insulators with nylon inserts shall only be used in covered conductor systems."<sup>2</sup> Poles numbered 549418E and 4421488E did not have vice-top insulators with nylon inserts where there was covered conductor. Energy Safety considers this violation for failure of adhering to protocol to be in the Minor risk category.

Per SCE's Distribution Overhead Construction Standards (DOH), section GR 200.5, "Vice-top insulators with nylon inserts shall only be used in covered conductor systems." Energy Safety found multiple instances where a covered conductor was not supported by the aforementioned type of insulator. Structures where this protocol was not followed are noted in Table 2 above.

**Item5IA3img1:** Close up view of insulator. Should be vice top polymer pin type insulators.

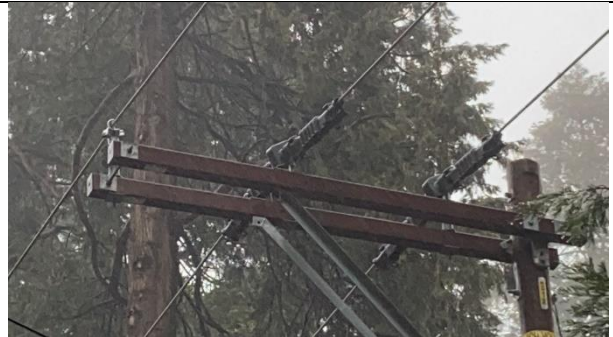
**Item5IA3img2:** Overall view of insulators with wildlife covers

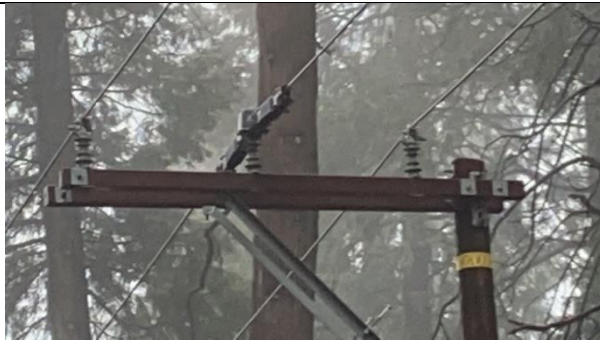
**Item6IA2Img1:** Overall view of insulators with cover. Insulators should be vice top polymer pin type insulators with nylon inserts

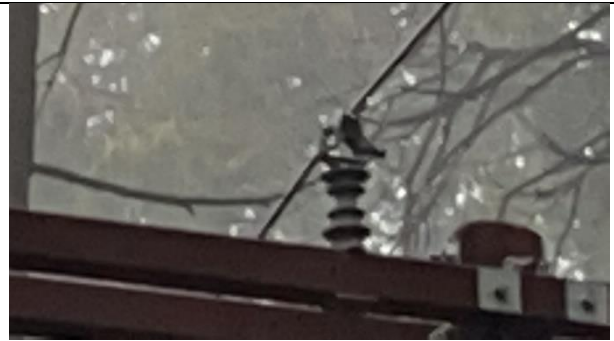
**Item6IA2Img2:** Close up of insulator from previous image

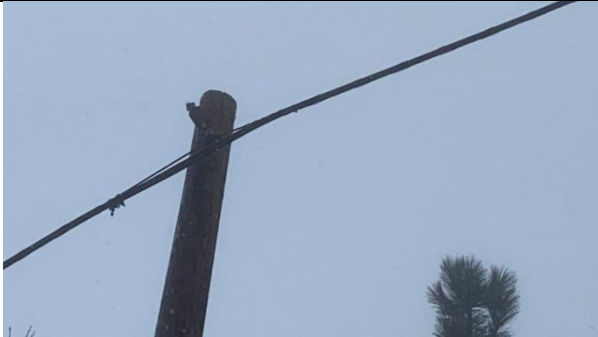
**Item9IA1img1:** Close up no covered conductor

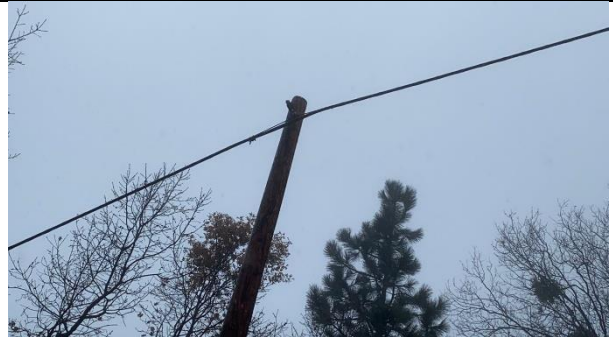
**Item9IA1img2:** Zoomed out view of top of pole with no covered conductor

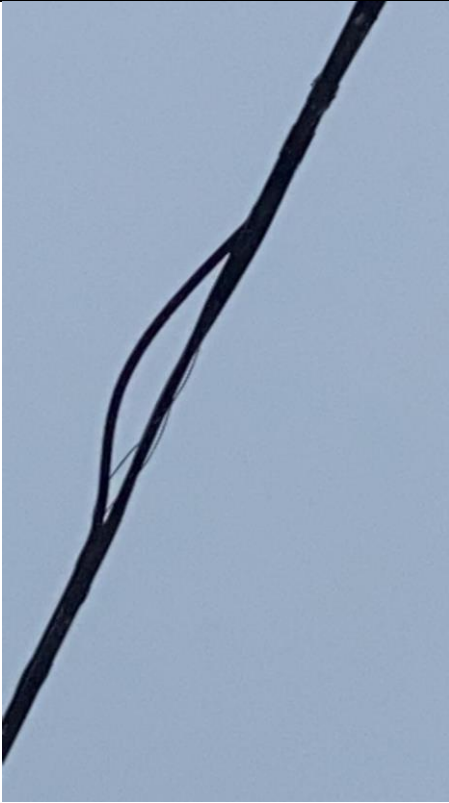
Energy Safety discovered multiple conductors that had broken and frayed strands. Energy Safety considers the presence of broken or frayed conductor strands a condition that increases the electrical corporation's ignition risk because the broken strands can weaken the conductor. The weakening of conductors can result in heightened risk of conductor failure or of arcing that could result in an ignition. Structures where broken conductor strands were observed are identified in Table 3.

**Item9CD4Img1:** Broken support strand

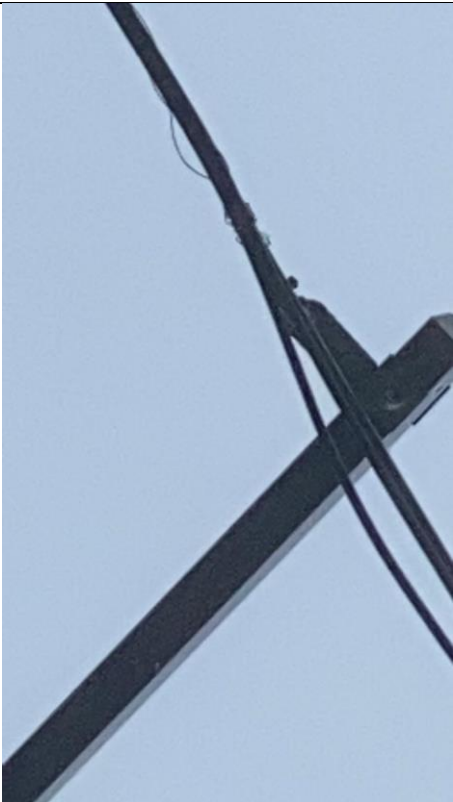
<b>Item10CD4Img1:</b> Fraying conductor

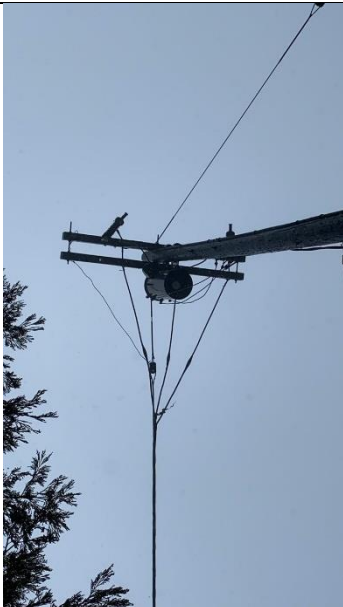
**Item11IA1img1:** No covered conductor installed
