**Federal Aviation  
Administration**

# Summary of the FAA's Review of the Boeing 737 MAX

Return to Service of the Boeing 737 MAX Aircraft

Date: November 18, 2020

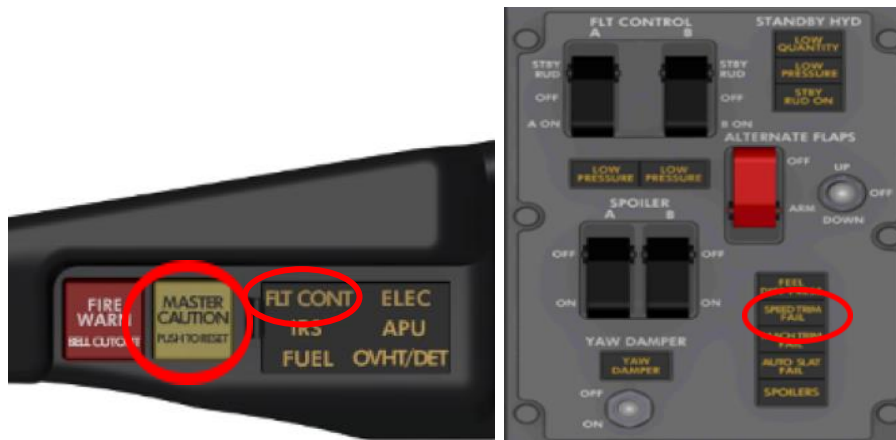
FIGURE 2 SPEED TRIM FAIL ANNUNCIATION

Effect of Erroneous AOA Value on MCAS — if the valid AOA value differs from the other valid AOA sensor value by more than 5.5 degrees for a specified duration the AOA values are considered erroneous, the split vane monitor will detect the failure and both the MCAS and Speed Trim functions will be disabled for the remainder of the flight. Activation of the split vane monitor will completely disable the STS (which includes both MCAS and Speed Trim System), will trigger a Master Caution indication, an illumination of the Flight Control (FLT CONT) annunciator, and an illumination of the SPEED TRIM FAIL light on the

overhead panel. The Master Caution indication and the FLT CONT annunciator can be reset by pressing the MASTER CAUTION PUSH TO RESET button. The SPEED TRIM FAIL light will remain illuminated for the remainder of the flight. In addition, an accompanying maintenance item is recorded for the loss of MCAS and Speed Trim. The SPEED TRIM FAIL annunciation is shown in Figure 2.

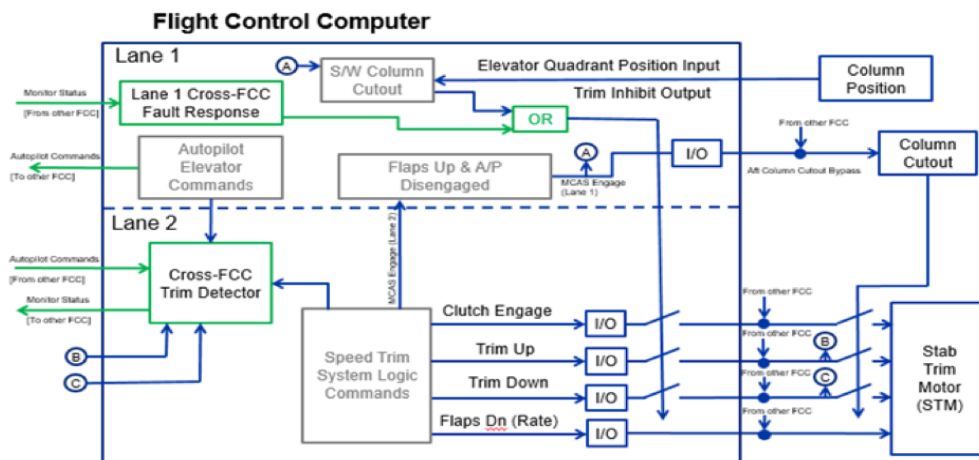
FIGURE 3 SIMPLIFIED SCHEMATIC OF THE UPDATED FCC SOFTWARE

The Cross-FCC Trim Monitor is a new feature to address Safety Item #6: OTHER POSSIBLE FCC STABILIZER RUNAWAY FAILURES and provides additional protection against erroneous FCC trim commands caused by postulated failures in the FCC Lane 2 CPU or I/O chips. This monitor is implemented in Lane 2 of the FCC.

If the stabilizer trim discrete outputs differ from the trim-command calculation in the local channel's monitor for a cumulative one second, as determined by an up/down counter, then the local channel will take control of STS (if it doesn't already have it), and send a discrete to Lane 1 of the foreign channel, indicating that the monitor has tripped. This will cause Lane 1 of the foreign channel to prevent transmittal of the foreign channel's Lane 2 stabilizer trim discrete outputs. If able, Lane 2 of the foreign channel will then set a SPEED TRIM FAIL discrete that will be observed during pilot execution of the descent phase Master Caution recall checklist procedure as described earlier in this section.

A simplified schematic of the Cross-FCC Trim Monitor added in the updated FCC software is shown in Figure 3 below.

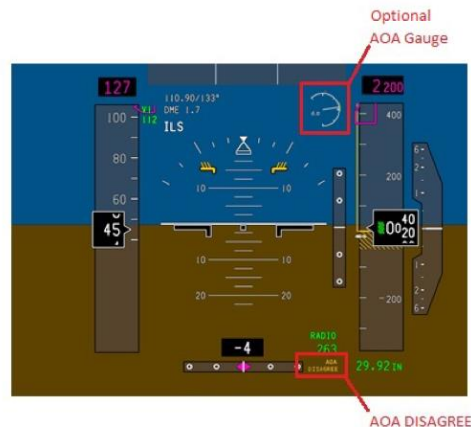
FIGURE 4 737 MAX MDS PFD WITH AOA DISAGREE AND AOA GAUGE

The 737 MAX MDS software change updates the AOA DISAGREE annunciation logic and addresses Safety Item #5: AOA DISAGREE. The AOA DISAGREE annunciation is displayed on the captain's and first officer's PFD when the left and right AOA values differ by more than 10 degrees for longer than 10 continuous seconds. An optional AOA gauge displays the AOA value on the captain's and first officer's PFD when the option is enabled. The AOA DISAGREE annunciation and AOA gauge are illustrated in Figure 4.

- Ensure the AOA DISAGREE annunciation logic is always enabled, regardless of the AOA gauge option.
- Maintains the AOA DISAGREE annunciation below 400 feet radio altitude displayed through landing to avoid the flightcrew missing the alert during a high workload condition.

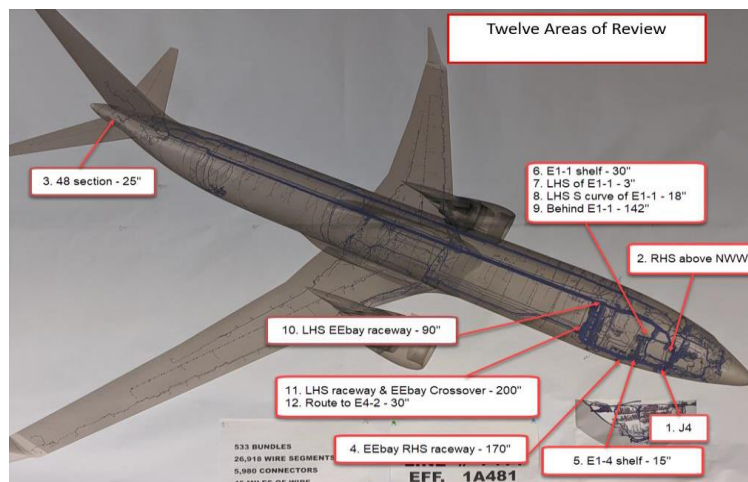
FIGURE 5 737 MAX STABILIZER TRIM MOTOR WIRE SEPARATION

As part of the FAA's review of these design changes, the agency re-reviewed the entirety of the 737 MAX horizontal stabilizer control system. This review revealed that the physical separation of the horizontal stabilizer trim-arm wiring and the horizontal stabilizer trim-control wiring does not meet the criteria specified in 14 CFR 25.1707. The FAA promulgated this design standard in 2007 and therefore it is part of the certification basis of the 737 MAX but not of previous Boeing Model 737 airplanes. Certain wiring installations must have enough physical separation so that a wiring failure cannot create a hazard. (See 14 CFR 25.1707).

Since design changes must comply with FAA regulations, the FAA requires changes to the wiring installation to meet the required physical separation between the horizontal stabilizer trim-arm wiring and the horizontal stabilizer trim-control wiring. This action brings the airplanes into regulatory compliance. The stabilizer trim-arm wiring has since been rerouted in 12 areas of the airplane's Electrical Equipment bay and Section 48 to prevent a potential simultaneous short circuit between the stabilizer arm and control wiring and another 28VDC wire. The 737 MAX design change will include physical separation of existing wires and/or routing of new wires to ensure compliance with the regulation. (See Figure 5).
