NOV_SCE_EDC_ 20211207-01_Revised

NOTICE OF VIOLATION

Energy Safety Inspection Report

Report Name: SCE_EDC_20211207-01_Revised

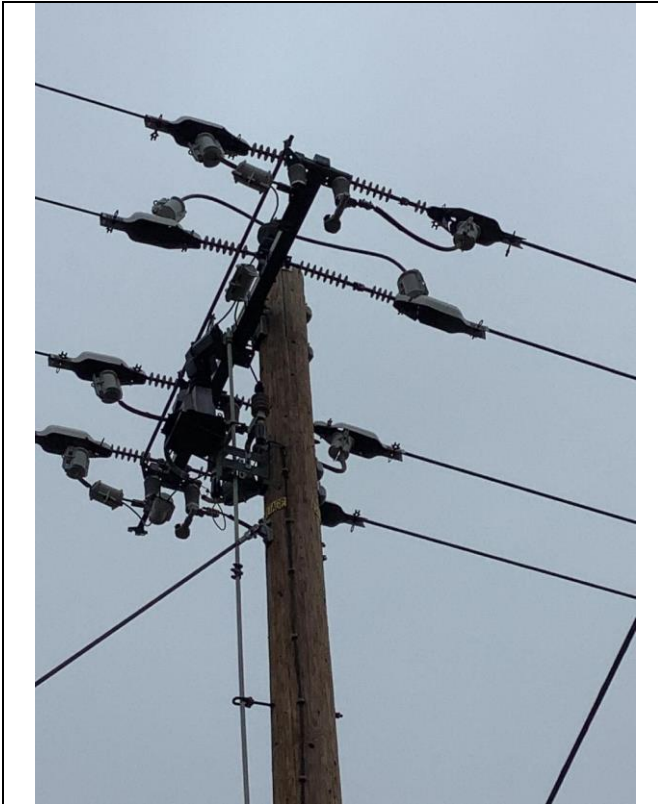
Structure ID: 4556900E

Per SCE's DDS and DOH, when installing covered conductor, vibration dampers must also be installed.² Energy Safety staff found that vibration dampers were not installed at multiple structures where covered conductor installation was completed. The structures missing vibration dampers where covered conductor was installed are identified in Table 2 above. On November 19, 2021, SCE submitted a memo to Energy Safety titled, "Interim Deviation from Standards on Vibration Damper for Covered Conductor" (hereafter, "Memo"). This Memo was dated August 18, 2021, and indicates that due to supply chain issues, SCE will suspend the installation of vibration dampers until December 31, 2021. In accordance with SCE's Q2 QDR submission, the covered conductor installations inspected by Energy Safety were completed prior to the issuance of the Memo. Also, SCE informed Energy Safety of this supply chain issue only after inspections commenced. Consequently, Energy Safety finds

Item5IA1img1: No vibration dampers installed

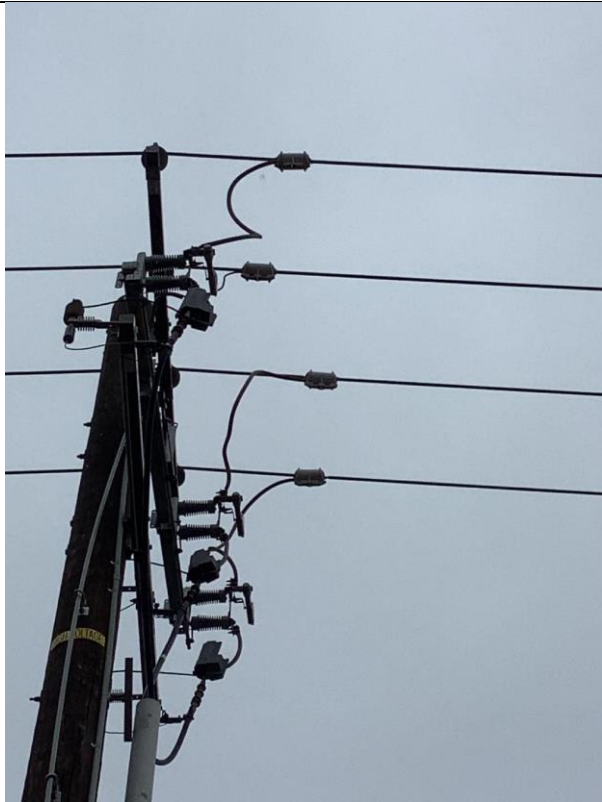
Structure ID: 4554800

Item6IA1Img1: No vibration dampers installed

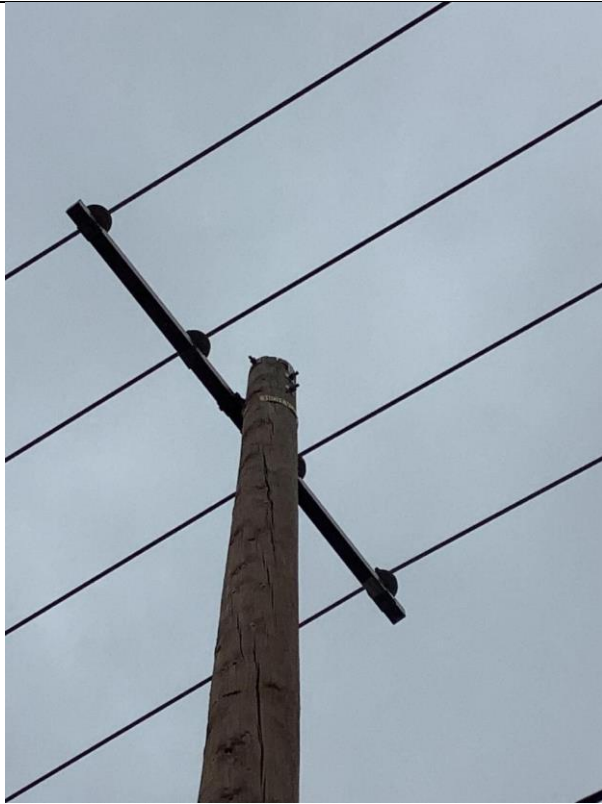
Structure ID: 4554797E

Item7IA1Img1: No vibration dampers installed

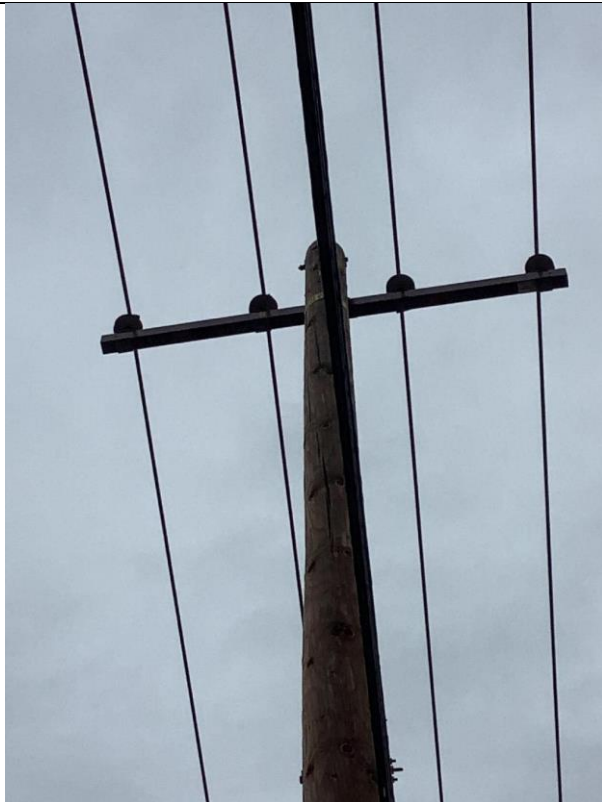
Structure ID: 4554795

Item8IA1Img1: No vibration dampers installed

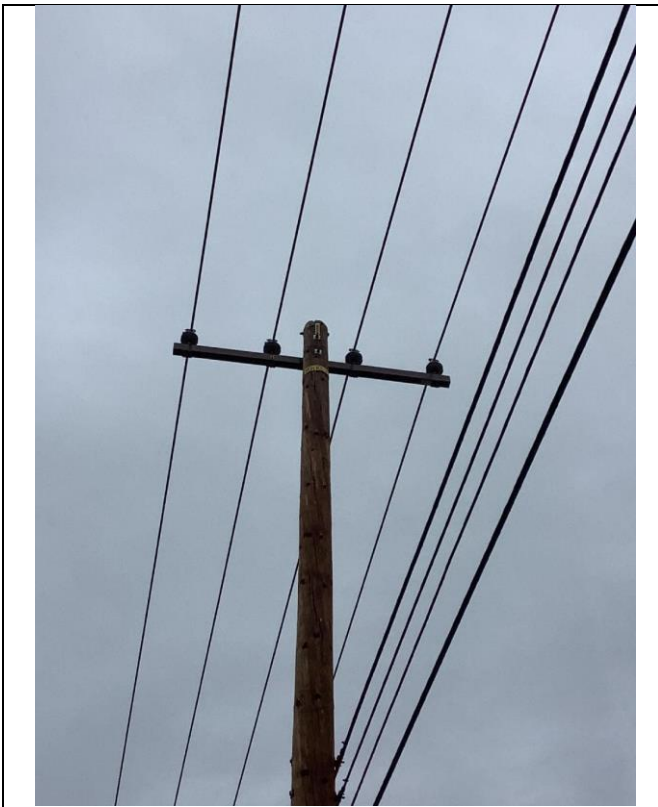
Structure ID: 4554793E

Item9IA1Img1: No vibration dampers installed

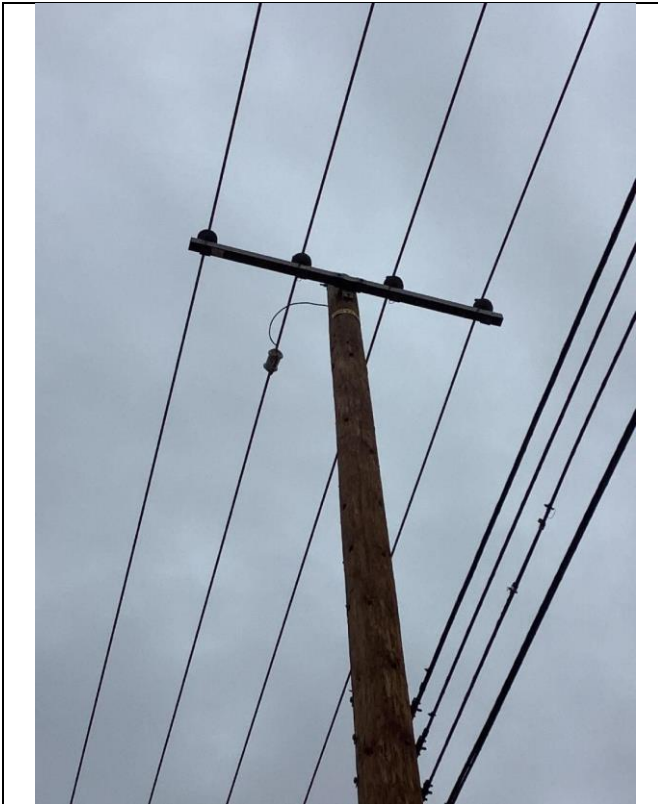
Structure ID: 4554792E

Item10IA1img1: No vibration dampers installed

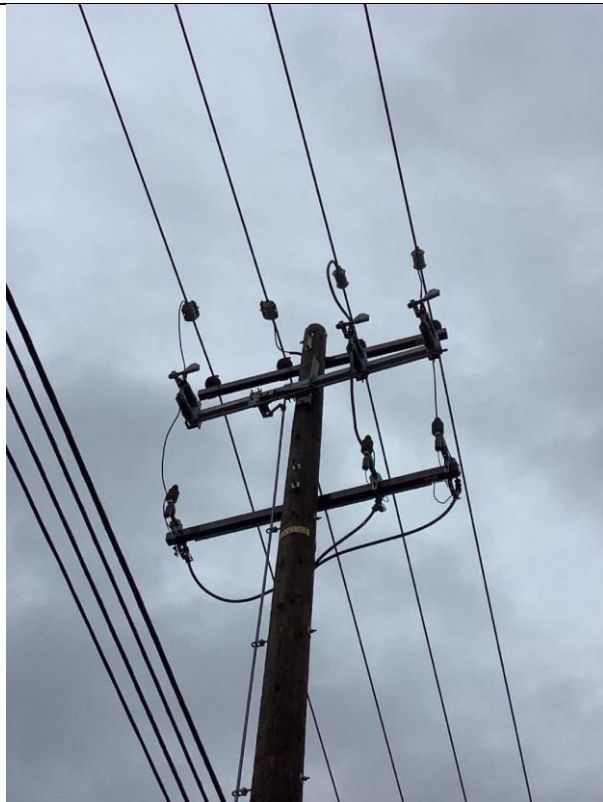
Structure ID: 4554791E

Item11IA1Img1: No vibration dampers installed

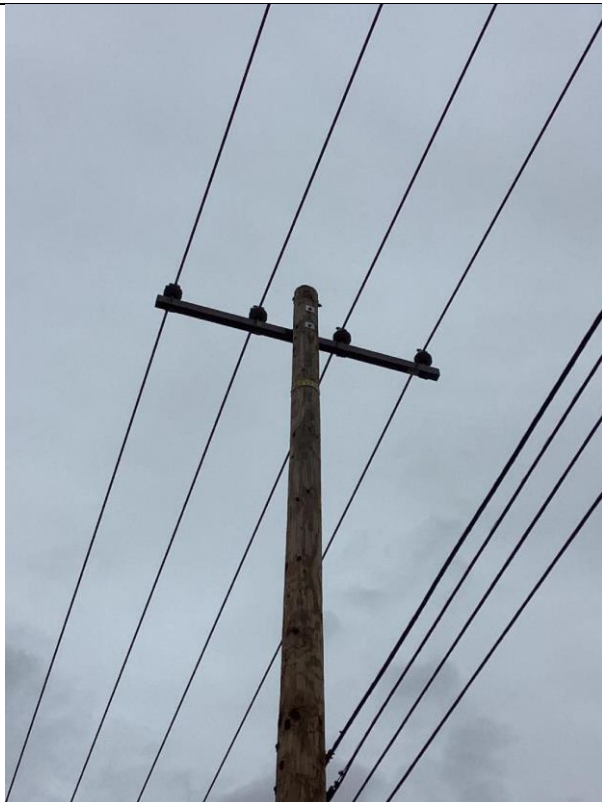
Structure ID: 4554789E

Item12IA1Img1: No vibration dampers installed

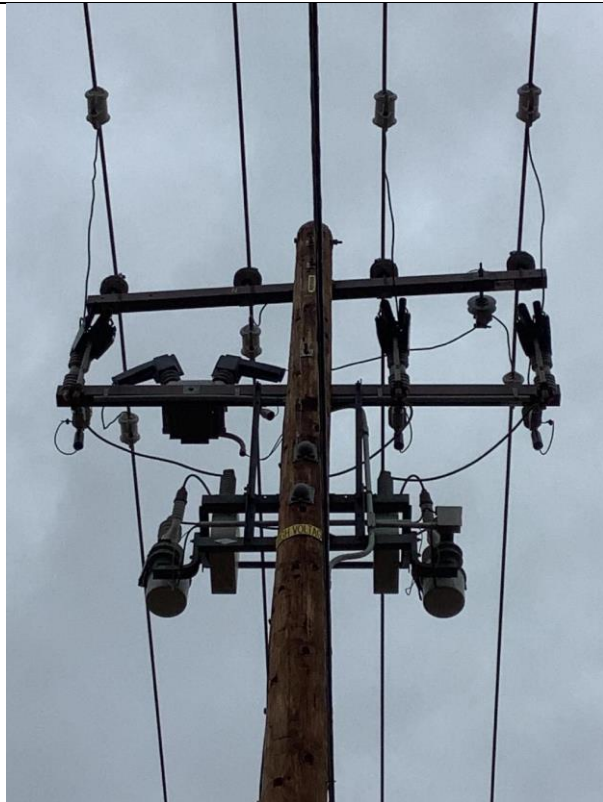
Structure ID: 4554786E

Item13IA1mg1: No vibration dampers installed

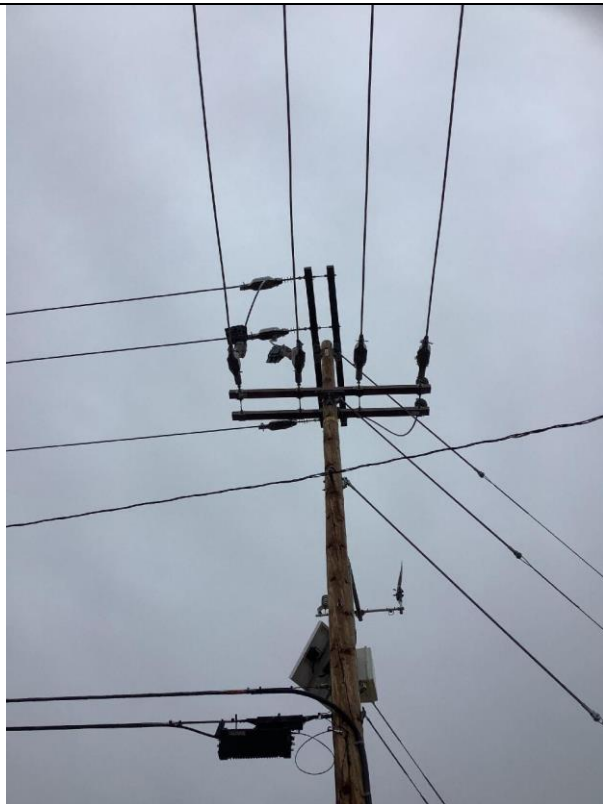
Structure ID: 4494709E

Item15IA1img1: No vibration dampers installed

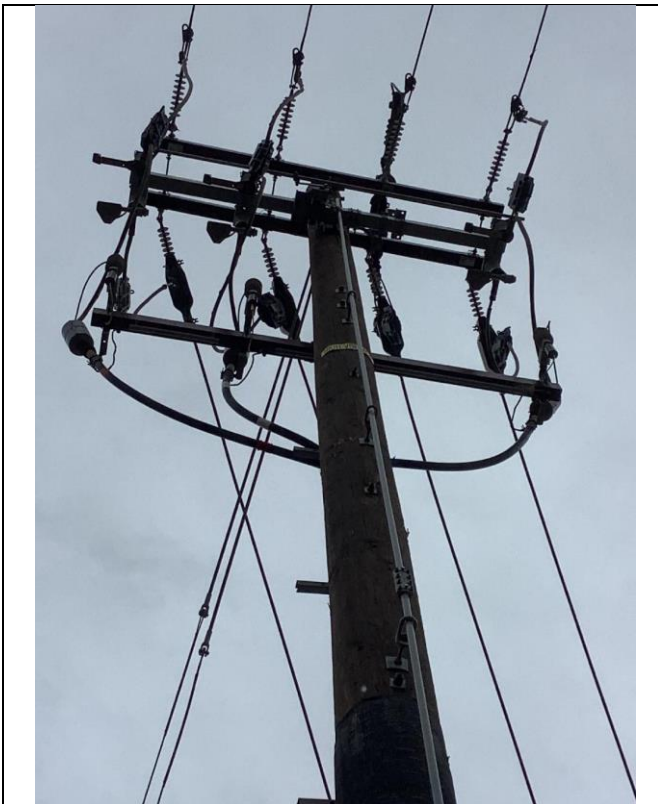
Structure ID: 4415240E

Item16IA1Img1: No vibration dampers installed

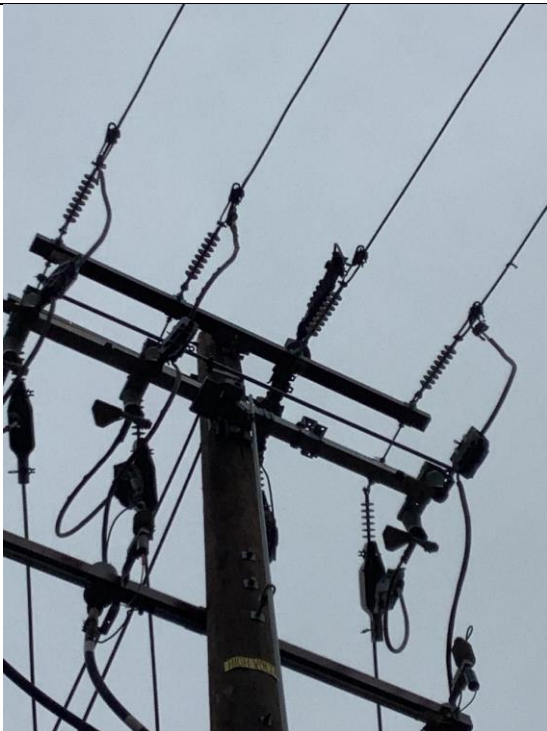
Per SCE's Distribution Overhead Construction Standards (DOH), in circumstances of double dead end construction on 4-wire covered conductor installations, if conductor is exposed, bolted wedge connector covers must be installed.¹ Also, SCE's Distribution Design Standards (DDS), Section 10, 5.7.C.1.f. states, "Covered conductor systems shall be an all-covered system." Per SCE's DOH, Section CC 150.4, page 5 of 5, "All overhead equipment shall utilize appropriate wildlife covers." This means that wildlife covers shall be installed on dead-ends, terminations, connectors, equipment bushings, and any partially covered exposed conductor. Energy Safety observed structures that did not have a wildlife cover on bolted wedge connectors. The structures where Energy Safety observed this violation of adherence to protocol are noted in Table 2 above.

Item16IA2Img1: Bolted wedge connector cover not installed

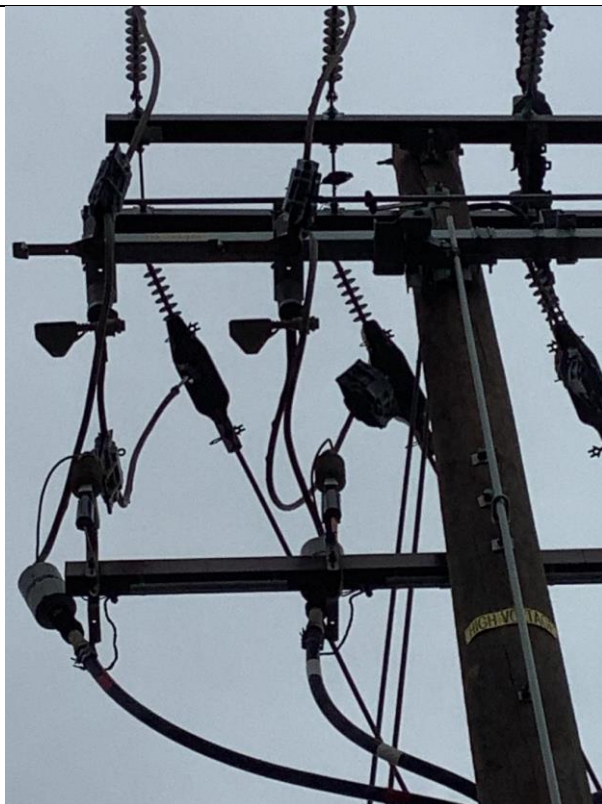
Item16IA3Img1: No cover on jumper wire

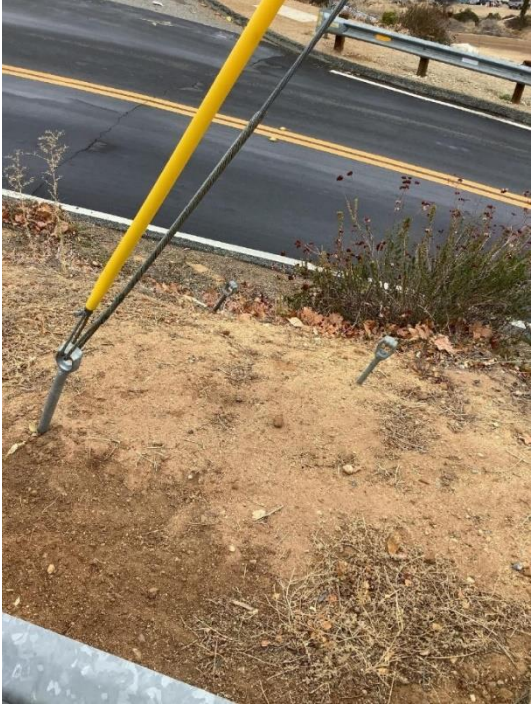
4. Violation 4: Per SCE's protocols for DOH, PO 300 page 9 of 9, “when an anchor location is abandoned, the rod and plate shall be removed if in a hazardous or potentially dangerous location. Otherwise, cut the rods off at least 12 inches below the ground line and abandon the remaining anchor. Screw anchor rods may be either unscrewed or cut off. Under no conditions should the rod be bent over or left exposed.” Energy Safety identified pole numbered 4415240E in violation of this protocol. The pole was replaced and the guy anchors were left in the ground unused. Energy Safety considers this violation to be in the Minor risk category.

Per SCE's DOH, PO 300 page 9 of 9, when a guy anchor location is abandoned, the rod and plate shall be removed if in a hazardous or potentially dangerous location. Otherwise, cut the rods off at least 12 inches below the ground line and abandon the remaining anchor. Screw anchor rods may be either unscrewed or cut off. Under no conditions should the rod be bent over or left exposed. Structures where this protocol was not followed are noted in Table 2 above. The pole was replaced, and there were two guy anchors left in the ground not being used. The potential for someone to trip and fall is due to the guy anchor being left in place and not used.

Item16IA4Img1: Guy anchors left in in the ground

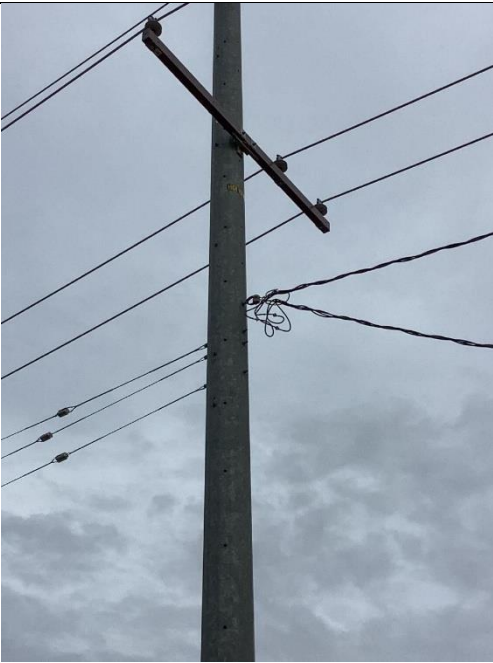
Structure ID: 4775180E

Item17IA1mg1: No vibration dampers installed

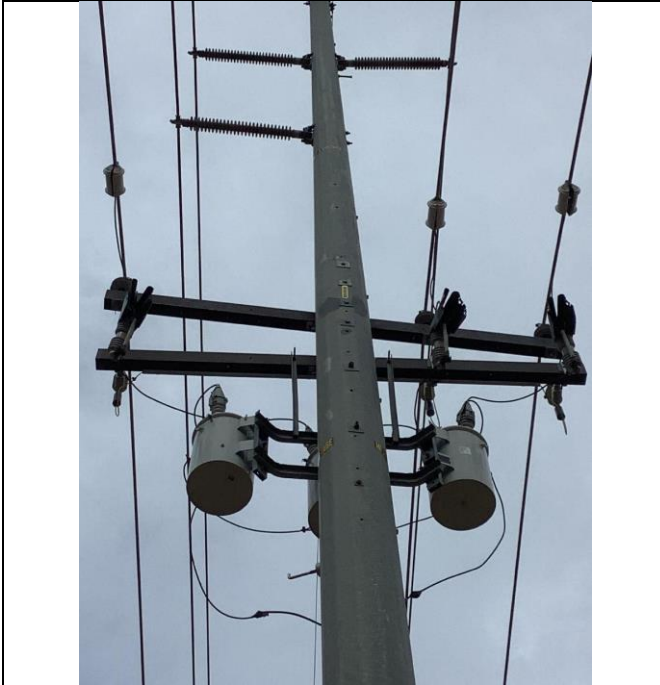
Structure ID: 4775179E

Item18IA1mg1: No vibration dampers installed

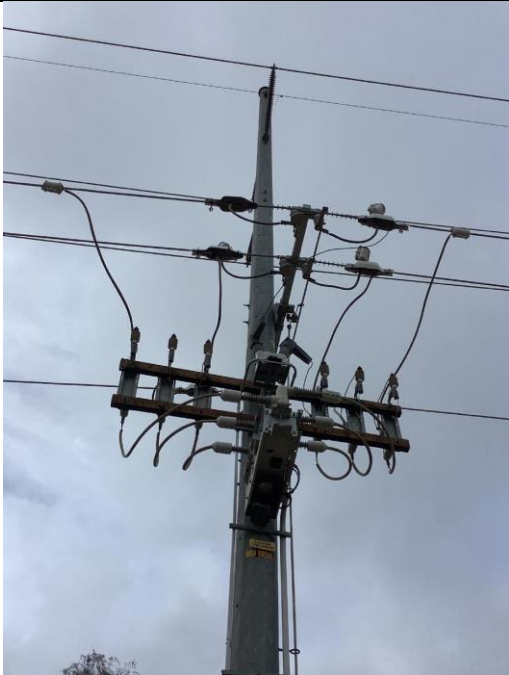
Structure ID: 4775178E

Item19IA1Img1: No vibration dampers installed

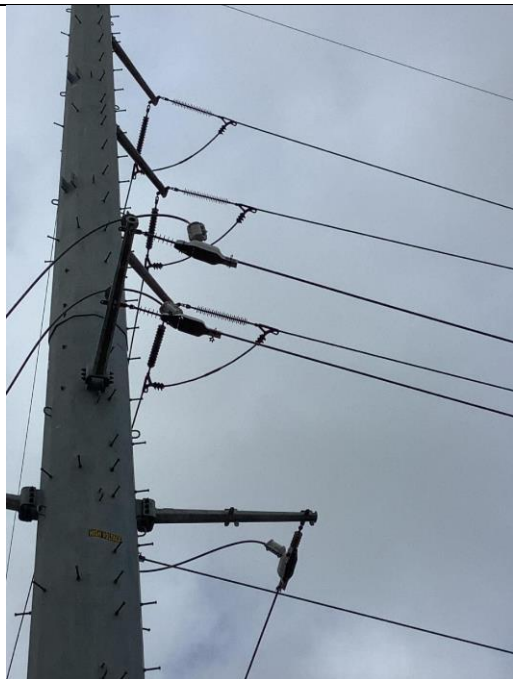
Structure ID: 4775176E

Item20IA1img1: No vibration dampers installed
