NOTICE OF VIOLATION

Energy Safety Inspection Report

Report Name: ATJ_SCE_20221202-01_Revised
Inspection Date(s): December 2, 2021
Inspector: Anthony Trujillo
Utility: Southern California Edison
Attention: Erik Takayesu, Vice President Asset Strategy and Planning

On December 2, 2021, I performed a walking inspection of Southern California Edison (SCE) covered conductor installations, 2021 WMP initiative number 7.3.3.3.1, along Ridge Route Road and North Gate Road near the city of Castaic, California. Detailed findings from this field inspection are laid out in Section II below.

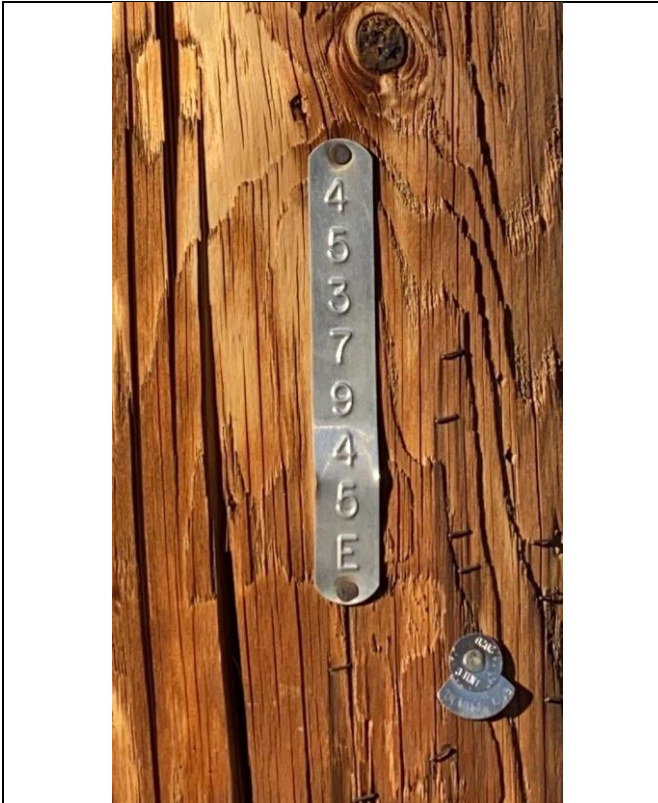
Item1IA1Img1: Pole ID

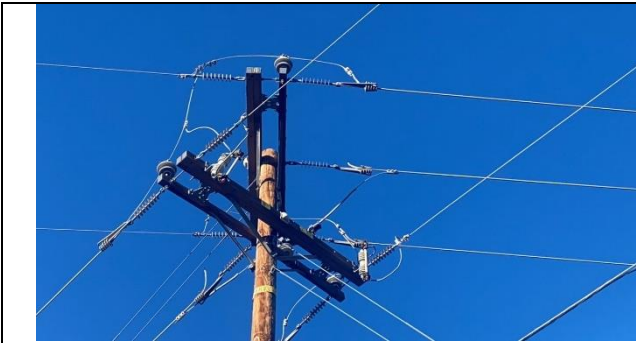
Item1IA2Img1: Overall pole phases

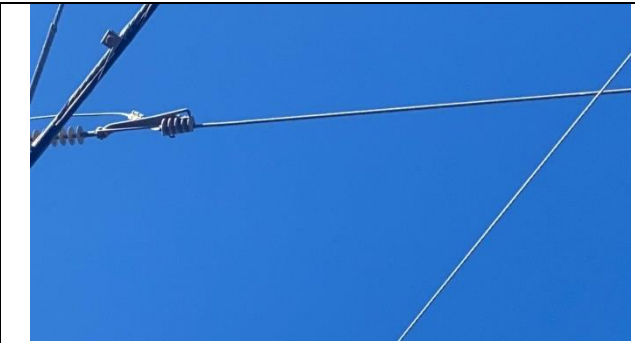
2. Violation 2: Per SCE's 2021-Q2 QDR, covered conductor was installed on poles numbered 45377945E, 4568486E, OH-7017637, and OH-7017636. Upon inspection, Energy Safety staff found no covered conductor installed at the above-mentioned structures. Given SCE's focus on covered conductor as one of its flagship wildfire mitigation programs and the scope of this mitigation program, Energy Safety is greatly concerned about how much covered conductor work is completed and how prevalent this issue may be. Energy Safety

Item1IA2Img3: Bare conductors

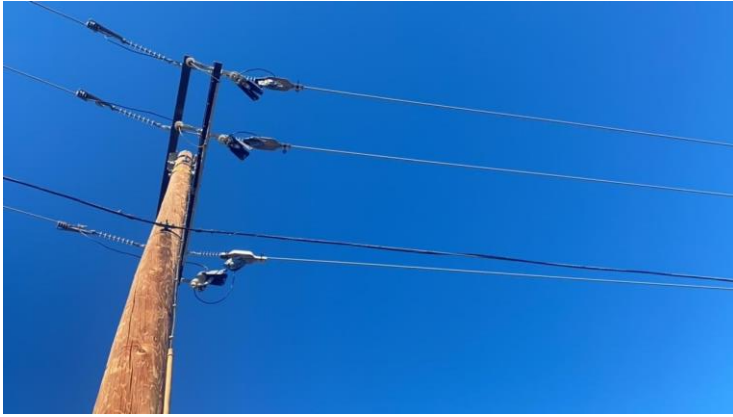
Per SCE's DDS and DOH, when installing covered conductor, vibration dampers must also be installed.¹ Energy Safety staff found that vibration dampers were not installed at multiple structures where covered conductor installation was completed. The structures missing vibration dampers where covered conductor was installed are identified in Table 2 above. On November 19, 2021, SCE submitted a memo to Energy Safety titled, "Interim Deviation from Standards on Vibration Damper for Covered Conductor"² (hereafter, "Memo"). This Memo was dated August 18, 2021, and indicates that due to supply chain issues, SCE will suspend the installation of vibration dampers until December 31, 2021. In accordance with SCE's Q2 QDR submission, the covered conductor installations inspected by Energy Safety were completed prior to the issuance of the Memo. Also, SCE informed Energy Safety of this supply chain issue only after inspections commenced. Consequently, Energy Safety finds that SCE is still in violation of its protocols requiring the installation of vibration dampers as part of covered conductor installations.

Item2IA1img1: No vibration dampers

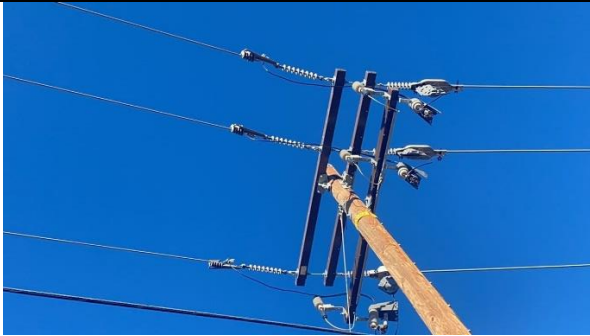
Per SCE's DOH, Section CC 180, Sheet 1 of 1, when transitioning from covered conductor to bare wire, "dead-end clamps" and "if conductor is exposed, install bolted wedge connector cover" are required. Also, DDS, Section 10, 5.7.C.1.f., "Covered conductor systems shall be an all-covered system. This means that wildlife covers shall be installed on dead-ends, terminations, connectors, equipment bushings, and any partially covered exposed conductor. Further covering other equipment with wildlife protection covers will increase the covered conductor system's overall effectiveness at preventing contact-with-object faults." Energy Safety observed a structure that did not have bolted wedge connector covers when transitioning from bare to covered conductor. The structure is noted in Table 2 above.

Item2IA3img1: No bolted wedge connector covers when transitioning from bare to covered conductor

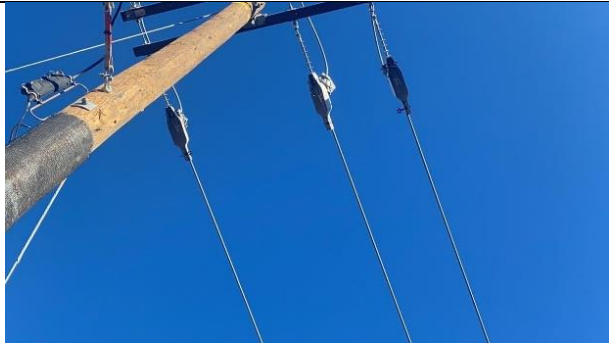
Item3IA1Img1: No vibration dampers

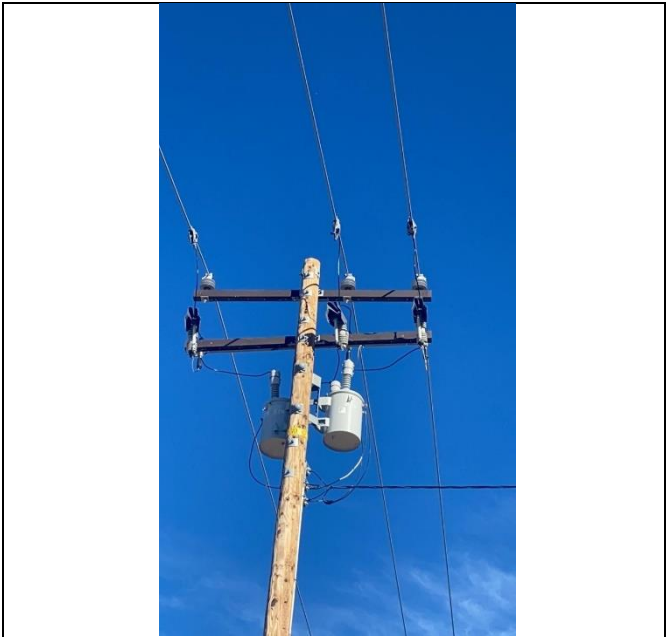
Item6IA1img1: No vibration dampers

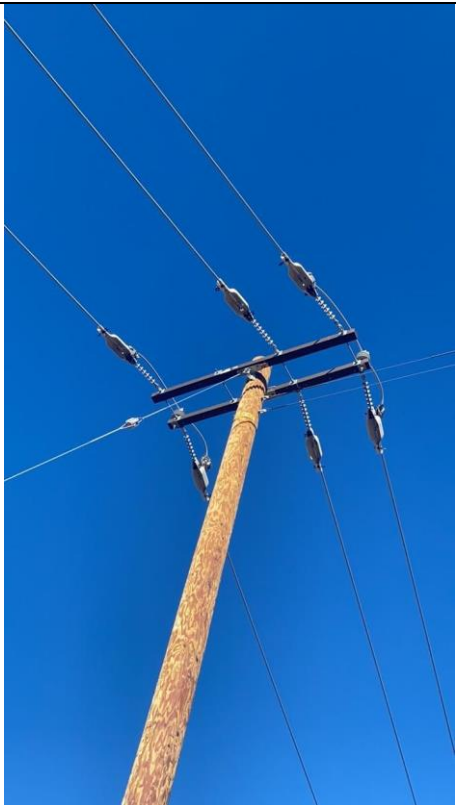
Item9IA1img1: No vibration dampers

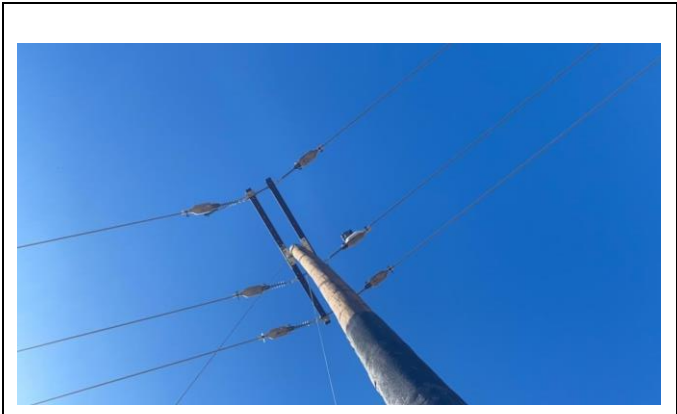
Item12IA1Img1: No vibration dampers

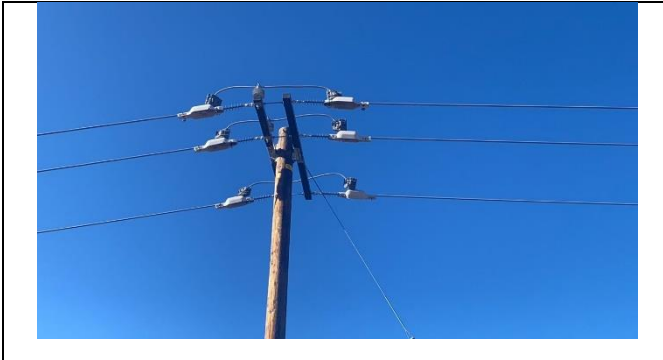
Item13IA1Img1: No vibration dampers

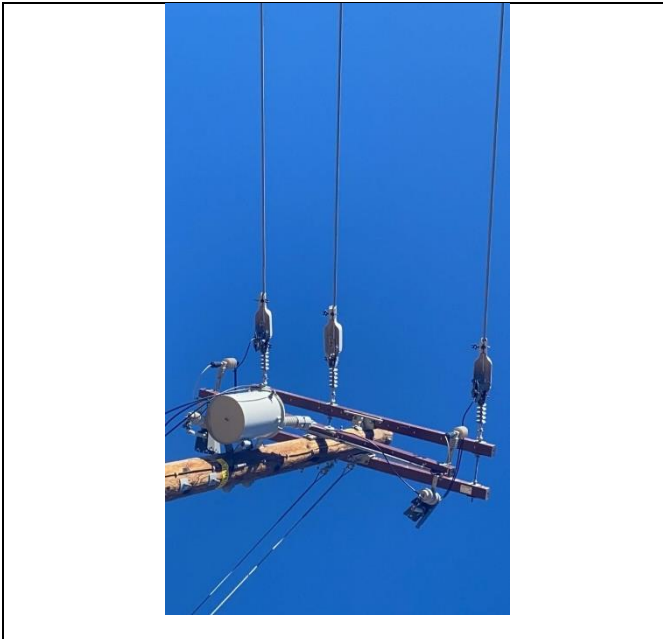
Item14IA1img1: No vibration dampers

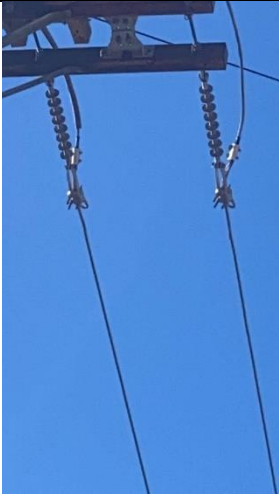
Item15GImg3: Bare wire on all phases closeup

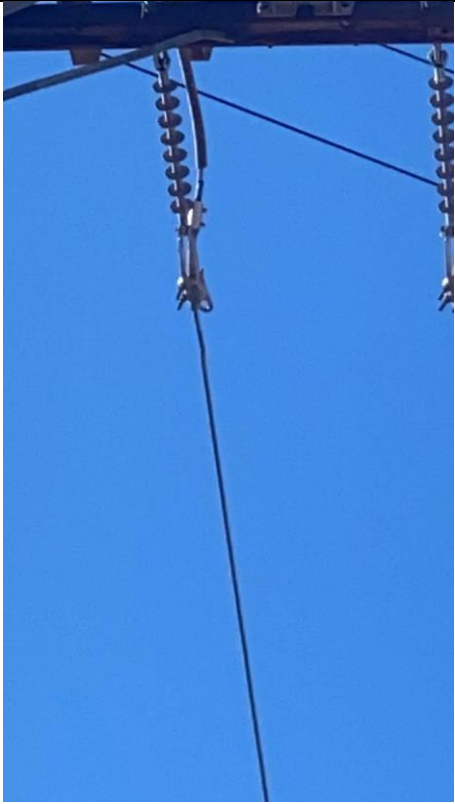
Item15IA1Img1: Bare conductor

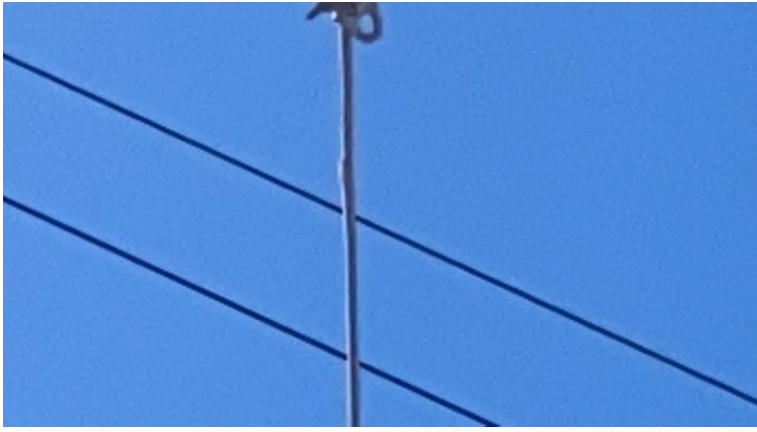
In addition to the violations discovered during WMP inspections of SCE's covered conductor installations, Energy Safety discovered one conductor that showed evidence of bird caging. Energy Safety considers bird caging as a condition that increases an electrical corporation's ignition risk because bird caging is a potential indicator of degradation in a conductor and compromises its structural integrity. Bird caging on a supply conductor can weaken its strength and lead to a wire down event and ignition, thus increasing the risk of conductor failure and potential ignition. The span where bird caging was observed is identified in Table 3.

Item15CD5Img1: Close up of phase bird caging

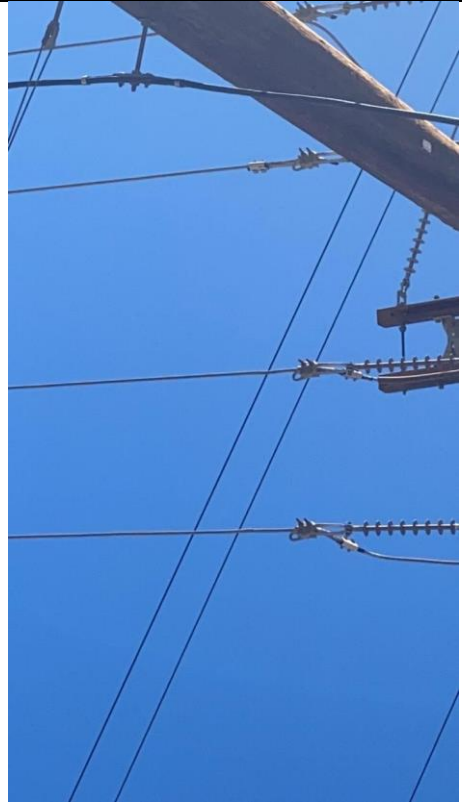
Item15CD5Img2: Overall view, bird caging on bottom phase

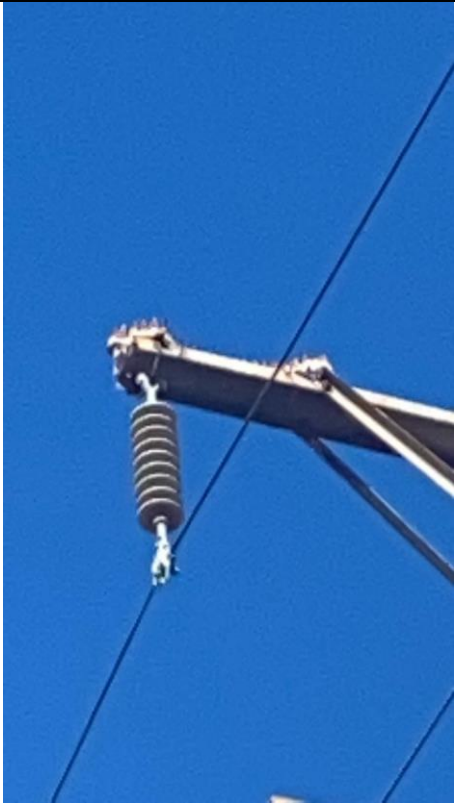
Item16IA1Img1: Bare conductor

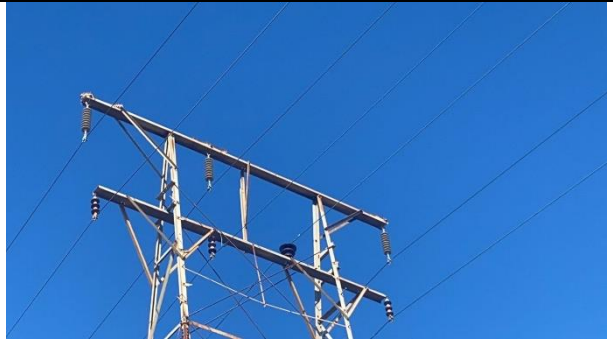
Item16IA1Img2: Overall view of bare conductor

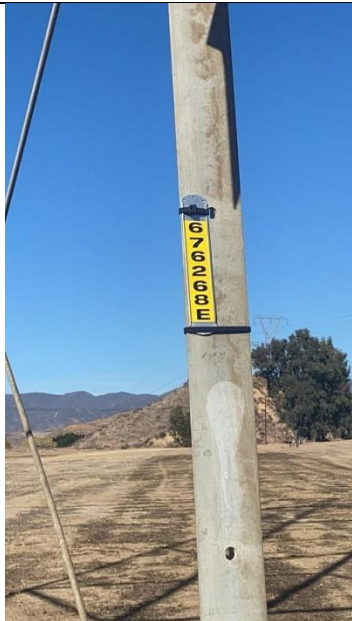
Item16IA2Img1: Correct structure ID

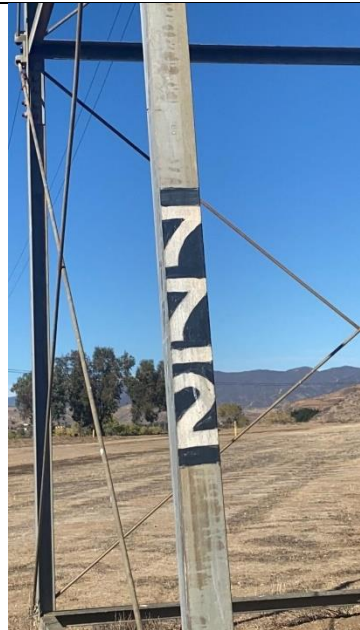
Item16IA2Img2: Other structure ID

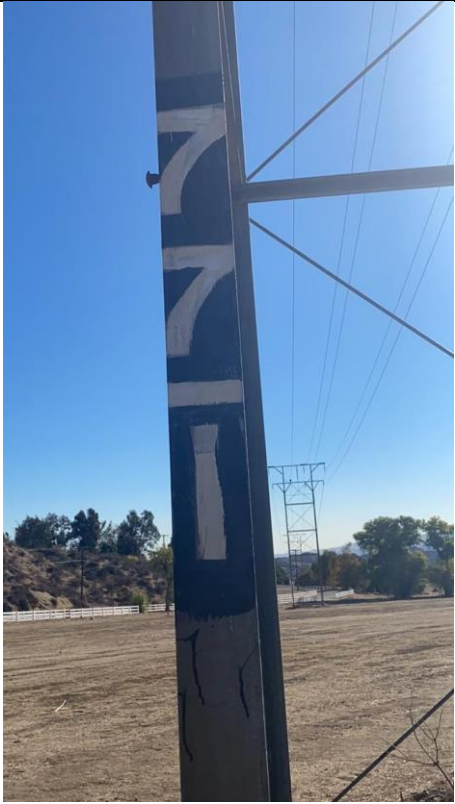
Item17GImg3: Other structure ID
