NOV_SCE_ATJ_20211208-01_Revised

NOTICE OF VIOLATION

Energy Safety Inspection Report

Report Name: ATJ_SCE_20211208-01
Inspection Date(s): December 8, 2021
Inspector: Anthony Trujillo
Utility: Southern California Edison
Attention: Erik Takayesu, Vice President Assets Strategy and Planning

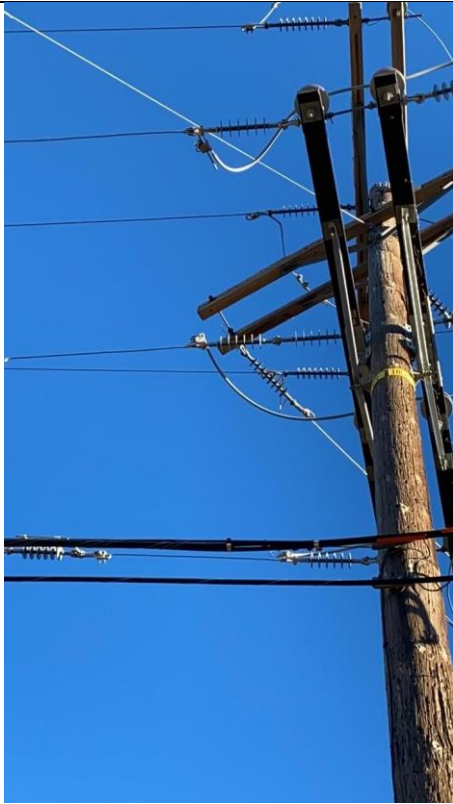
Finally, Energy Safety discovered a guy wire that was within six inches of a 12kV primary conductor. Energy Safety considers energized conductors that are in close proximity of a guy wire a potential ignition driver. Guy wires that may slap energized conductors may cause arcing, increasing an electrical corporation's ignition risk. The structure where Energy Safety observed a down guy wire in close proximity of bare conductor is identified in Table 3.

Item1IA2Img1: Guy wire is within 6 inches of bare conductor (top of photo, guy wire coming out of the picture)

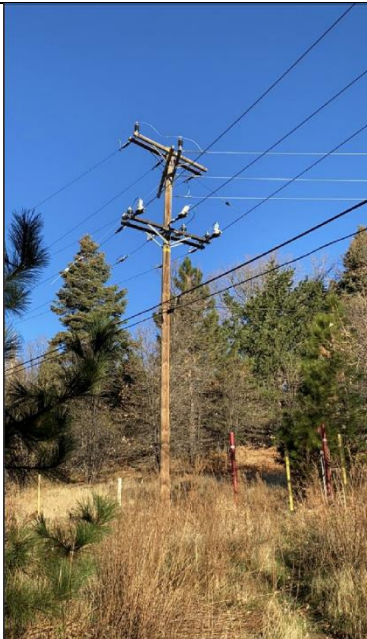
3. Violation 3: Per SCE’s DOH, when transitioning from covered conductor to bare wire, “if conductor is exposed, install bolted wedge connector cover.” Per SCE’s DDS, Section 10, 5.7.C.1.f, “Covered conductor systems shall be an all-covered system. This means that wildlife covers shall be installed on dead-ends, terminations, connectors, equipment bushings, and any partially covered exposed conductor.” Pole 1008927E did not have bolted wedge connector covers when transitioning from bare to covered conductor. Energy Safety considers this failure to follow protocol violation to be in the Minor risk category.
4. Violation 4: At pole numbered 4621322E, the pole identification number on the structure did not match the identification number provided by SCE in its QDR. Energy Safety considers this data accuracy violation to be in the Minor risk category.

Per SCE's DOH, Section CC 150, page 3 of 5, in circumstances of 4-wire covered conductor double dead-end construction, if conductor is exposed, bolted wedge connector covers must be installed. Also, DDS, Section 10, 5.7.C.1.f. states, "Covered conductor systems shall be an all-covered system." Per SCE's DOH, Section CC 150.4, page 5 of 5, "All overhead equipment shall utilize appropriate wildlife covers. This means that wildlife covers shall be installed on dead-ends, terminations, connectors, equipment bushings, and any partially covered exposed conductor." Energy Safety observed structure numbered 4487750E that did not have bolted wedge connector cover installed when transitioning from bare to covered conductor. This structure is noted in Table 2 above.

Item1CD2Img1: No wildlife covers at transition from bare to covered conductor

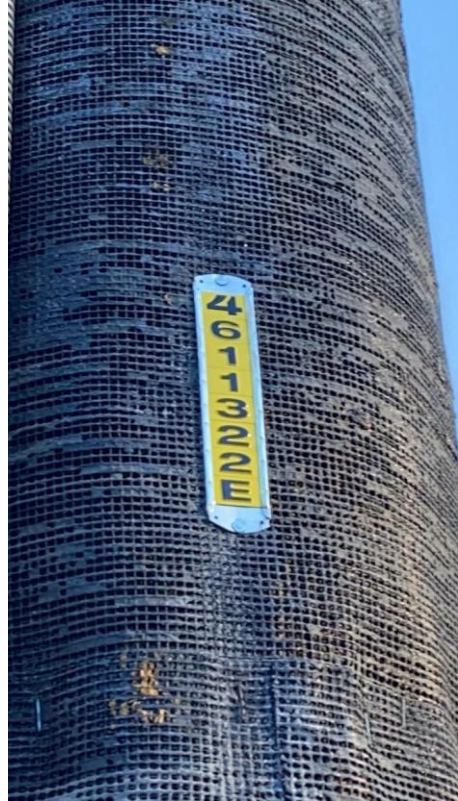
During the inspections, Energy Safety also found one structure where the structure identification number provided by SCE did not match the structure identification number observed in the field. The structure where Energy Safety observed this data accuracy issue is noted in Table 2 above.

Item4Gimg2: Pole ID

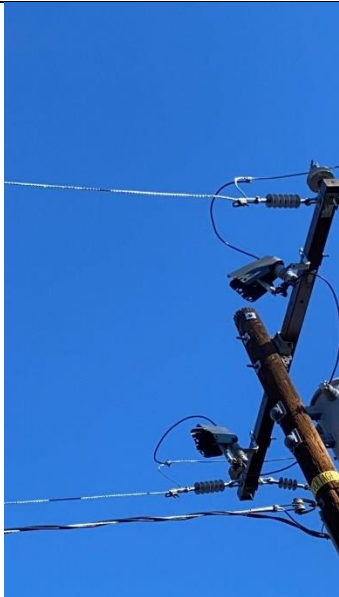
1. Violation 1: Per SCE’s 2021-Q1 and Q2 quarterly data report (QDR), covered conductor was installed on poles numbered 453043E, and 4920022E. These structures reported covered conductor initiative (2021 WMP initiative number 7.3.3.3.1) with a status of “complete.” However, upon inspection, SCE has not even begun covered conductor installation at these locations. Energy Safety considers this data accuracy violation to be in the Moderate risk category.

2. Violation 2: Per SCE’s 2021-Q1 and Q2 QDR, covered conductor was installed on poles numbered 453043E, and 4920022E. Upon inspection, Energy Safety staff found no covered conductor installed at the above-mentioned structures. Given SCE’s focus on covered conductor as one of its flagship wildfire mitigation programs and the scope of this mitigation program, Energy Safety is greatly concerned about how much covered conductor work is completed and how prevalent this issue may be. Energy Safety

Item5IA1img1: Bare wire

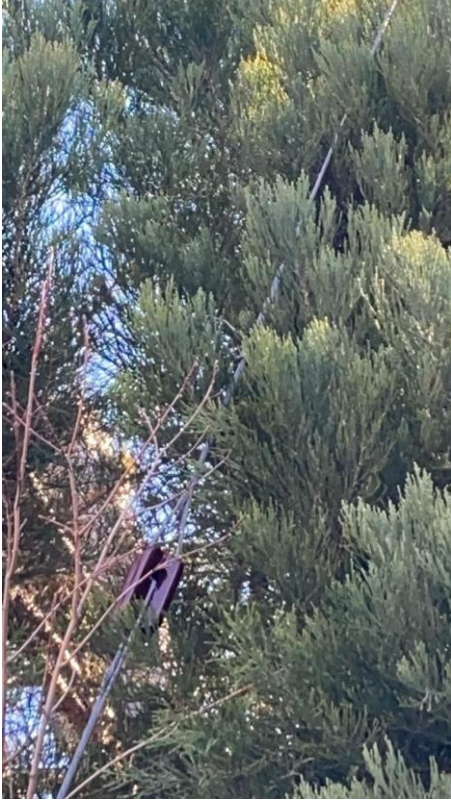
In addition to the violations discovered during WMP inspections of SCE's covered conductor installations, Energy Safety discovered vegetation contacting a guy wire above the insulator. Guy wires are metallic and can become energized in some circumstances. Insulators break the current path and prevent electricity from reaching the ground where a down guy wire is anchored. However, the portion above the insulator can remain energized until the circuit is deenergized and may cause

an ignition if energized while in contact with vegetation. Accordingly, Energy Safety considers vegetation in contact with down guy wires above the insulator a condition that increases an electrical corporation's ignition risk. The structure where Energy Safety observed vegetation in contact with the guy wire above the insulator is noted in Table 3.

Item5GW2Img1: Vegetation touching guy wire above insulator

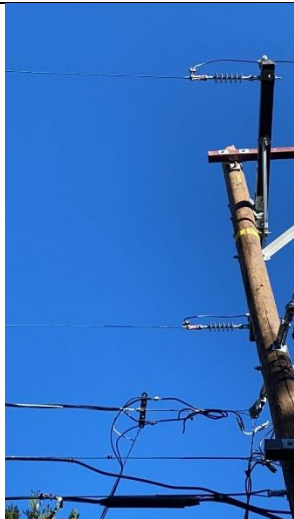
Item6IA1Img1: Bare wire

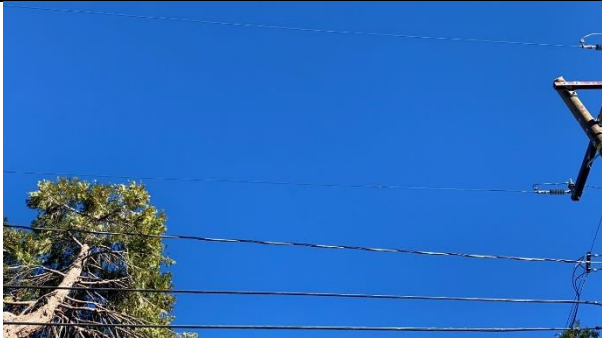
Energy Safety also discovered a conductor that had an excessive number of splices along a single phase. Energy Safety considers the presence of three or more splices along a single-phase conductor to be an indicator of potential issues with electrical loading or physical weakening of the line. The weakening of conductors can result in heightened risk of conductor failure or of arcing that could result in an ignition. The structure where Energy Safety observed excessive splices observed along a single phase is identified in Table 3.

Item6CD9Img1: 3 splices on one phase

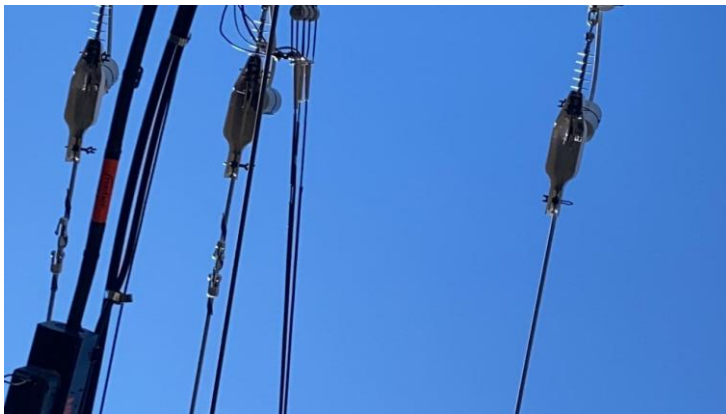
Item16IA1Img1: Note to Utility: In photo, right phase missing vibration damper
