NOD\_SCE\_GCA\_ 20211118-01

# NOTICE OF DEFECT

# Energy Safety Inspection Report

Report Name: GCA\_SCE\_20211118-01  
Date(s): November 18, 2021  
Inspector: Gary Candelas  
Utility: Southern California Edison  
Attention: Erik Takayesu  
Vice President Asset Strategy and Planning

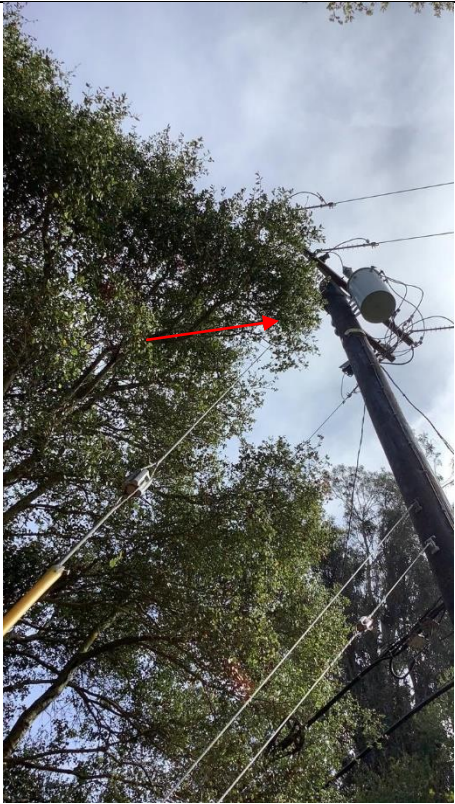
1. Defect 1: Pole numbered 4892458E had vegetation contacting guy wire above the insulator. Guy wires may become energized and pose an increased risk if in contact with vegetation. Energy Safety considers this risk to be in the Minor category.

Energy Safety discovered vegetation contacting the guy wire above the insulator. Guy wires are metallic and can become energized in some circumstances. Insulators break the current path and prevent electricity from reaching the ground where a down guy wire is anchored. However, the portion above the insulator may remain energized until the circuit is deenergized and may cause an ignition if energized while in contact with vegetation. Accordingly, Energy Safety considers vegetation in contact with down guy wires above the insulator a condition that increases an electrical corporation's ignition risk. A structure where vegetation was in contact with the guy wire above the insulator is noted in Table 2.

**Item4GW2Img1:** Vegetation contacting guy wire above insulator

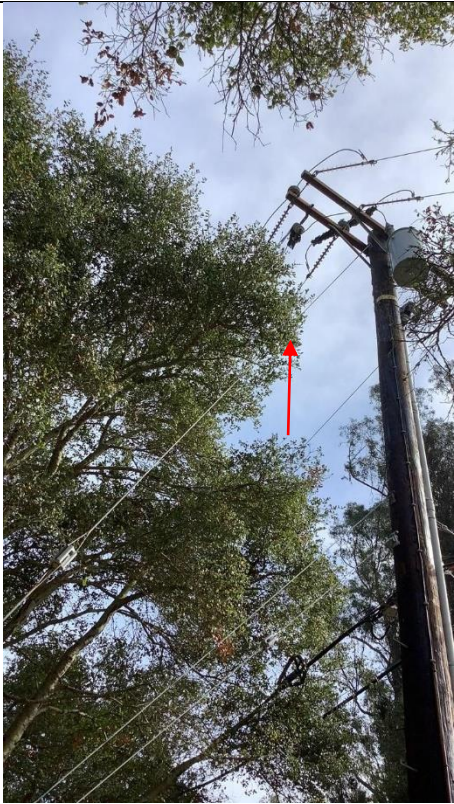
**Item4GW2Img2:** Vegetation contacting guy wire above insulator
