NOV_SCE_MYU_ 20220224-01

NOTICE OF VIOLATION

Report Name: NOV SCE MYU 20220224-01

Date(s): February 24, 2022 Inspector: Matthew Yunge

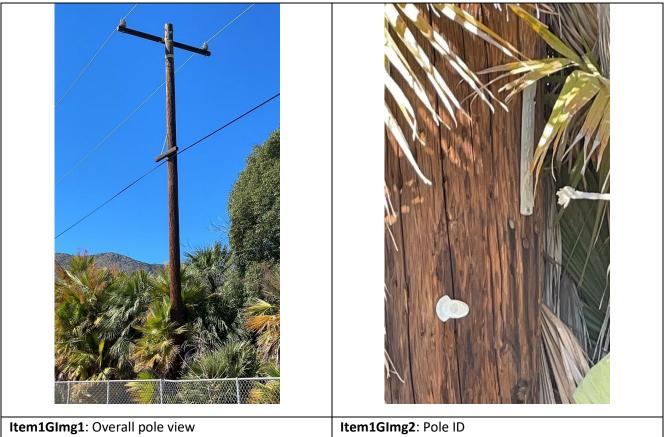
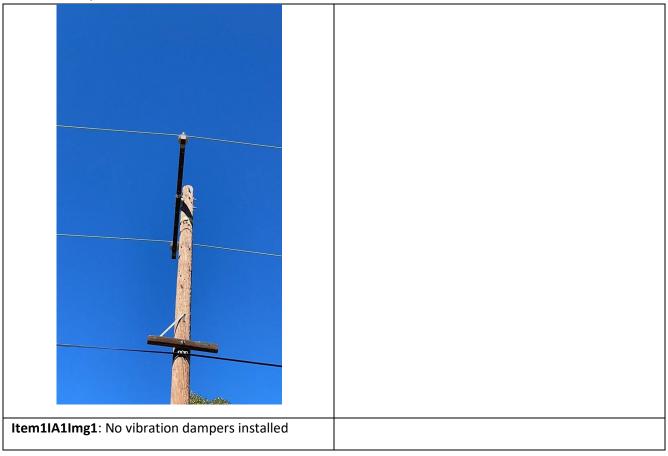
Structure ID: 1896709E

Item	Structure ID	HFTD	Initiative Number	Violation Type	Severity	Violation Description
1	1896709E	Tier 3	7.3.3.3.1	Adherence to Protocol	Minor	Failure to install vibration dampers on a span
2	1896708E	Tier 3	7.3.3.3.1	Adherence to	Minor	Failure to install vibration dampers on a
				Protocol		span

Per SCE's Distribution Design Standards (DDS) and Distribution Overhead Construction Standards (DOH), when installing covered conductor, vibration dampers must also be installed.¹ Energy Safety staff found that vibration dampers were not installed at multiple structures where covered conductor was completed. The structures missing vibration dampers where covered conductor was installed are identified in Table 2 above. On November 19, 2021, SCE submitted a memo to Energy Safety titled, "Interim Deviation from Standards on Vibration Damper for Covered Conductor"² (hereafter, "Memo"). This Memo was dated August 18, 2021, and indicates that due to supply chain issues, SCE will suspend the installation of vibration dampers until December 31, 2021. In accordance with SCE's Q1 QDR submission, the covered conductor installations inspected by Energy Safety were completed prior to the issuance of the Memo. Also, SCE informed Energy Safety of this supply chain issue only after inspections commenced. Consequently, Energy Safety finds that SCE is still in violation of its protocols requiring the installation of vibration dampers as part of covered conductor installations.
