NOTICE OF VIOLATION

Energy Safety Inspection Report

Report Name: IAG_SCE_20211117-03

On November 17, 2021, I performed a walking inspection of Southern California (SCE) covered conductor installations, 2021 WMP initiative number 7.3.3.3.1, in the city of Camarillo, California. Detailed findings from this field inspection are laid out in Section II below.

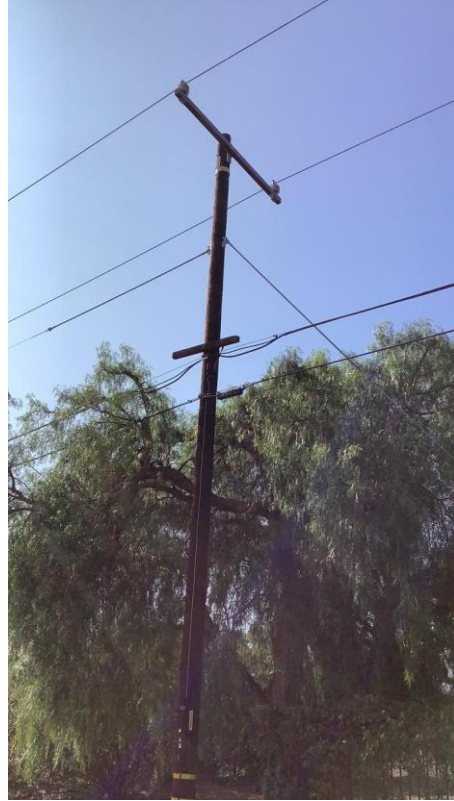
Item1Gimg2: Overall view of the pole and covered conductor installation

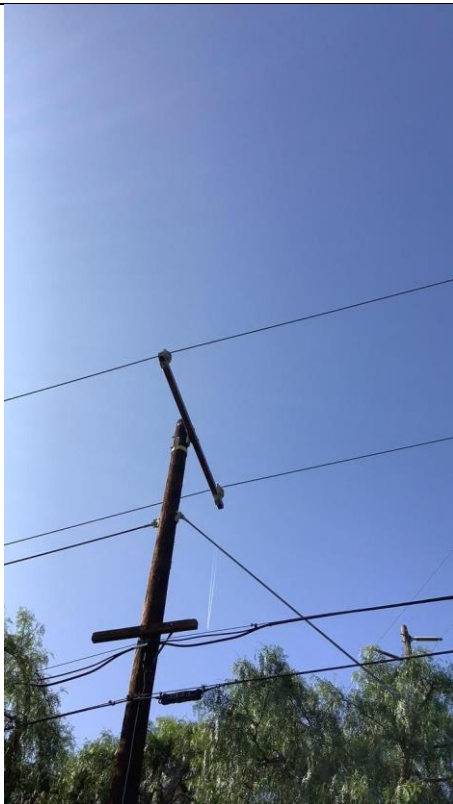
1. Violation 1: Per SCE's Distribution Design Standards (DDS), section DDS-10, page 10-82, "for the 336 (30/7) ACSR covered conductor, vibration dampers shall be installed on every span in both light loading and heavy loading areas." Also, SCE's Distribution Overhead Construction Standards (DOH), section CC 190, page 1 of 11, indicates that vibration dampers are required when installing covered conductor. Poles numbered 1147447E, 1147443E and 4831822E had covered conductor installed but failed to install vibration dampers. Energy Safety considers this violation for failure of adhering to protocol to be in the Minor risk category.

Item1IA1Img1: No vibration dampers are installed

In accordance with the Energy Safety Compliance Process, outlined in Table 1 below are the correction timelines for identified violations relative to their risk category. Within 30 days from the issuance date of this notice of violation (NOV), May 23, 2022, advise Energy Safety of corrective actions taken or planned by SCE to remedy the above identified violation(s) and prevent recurrence. This response shall be filed in the Energy Safety e-Filing system under the

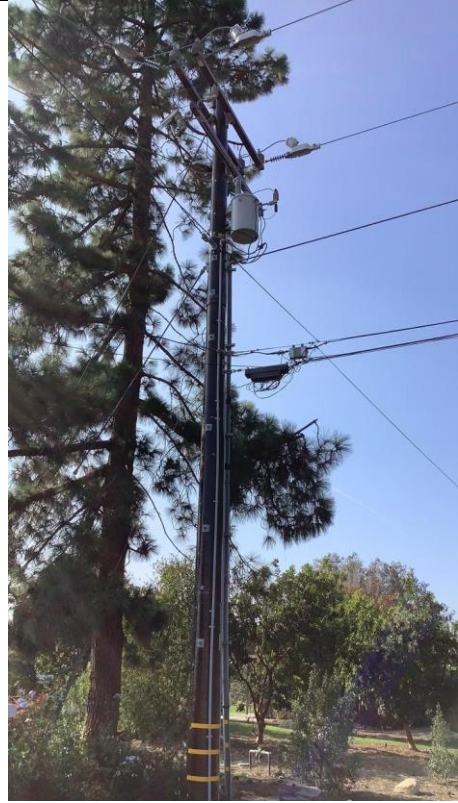
Item2Gimg2: Overall view of the pole and covered conductor installation.

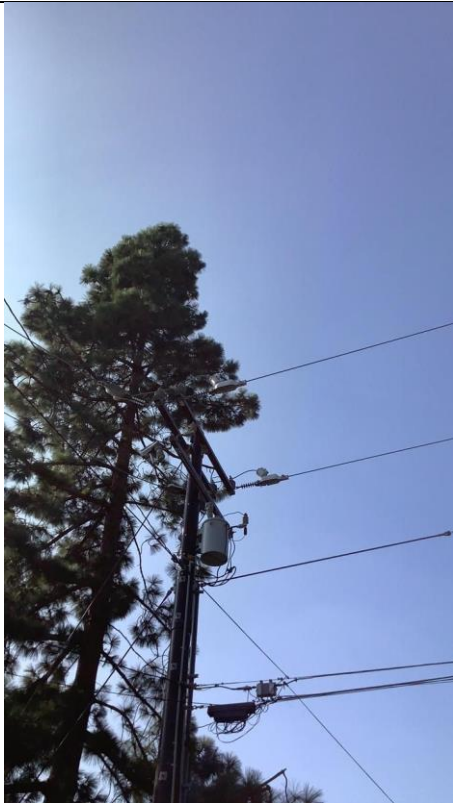
Item2IA1Img1: No vibration dampers are installed

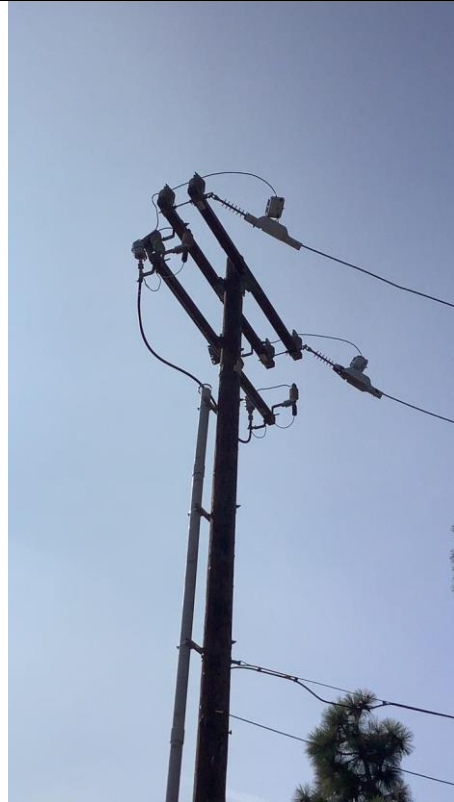
Item3GImg2: Overall view of the pole and covered conductor installed

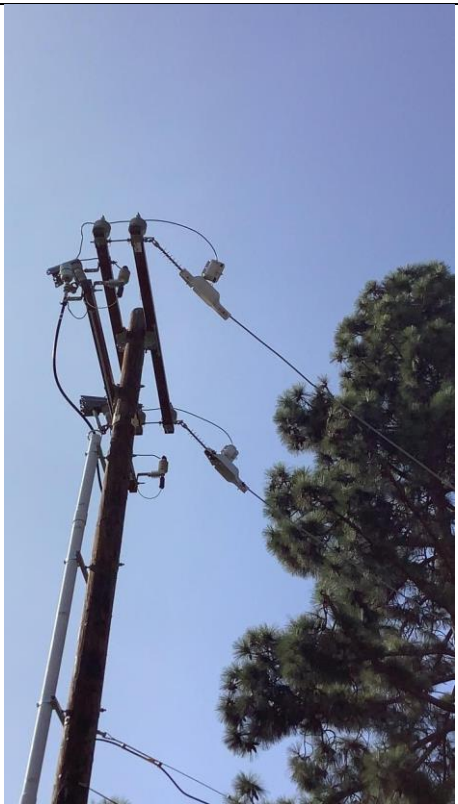
Item3IA1Img1: No vibration dampers are installed
