NOV_SCE_IAG_20211117-04

NOTICE OF VIOLATION

Energy Safety Inspection Report

Report Name: IAG_SCE_20211117-04

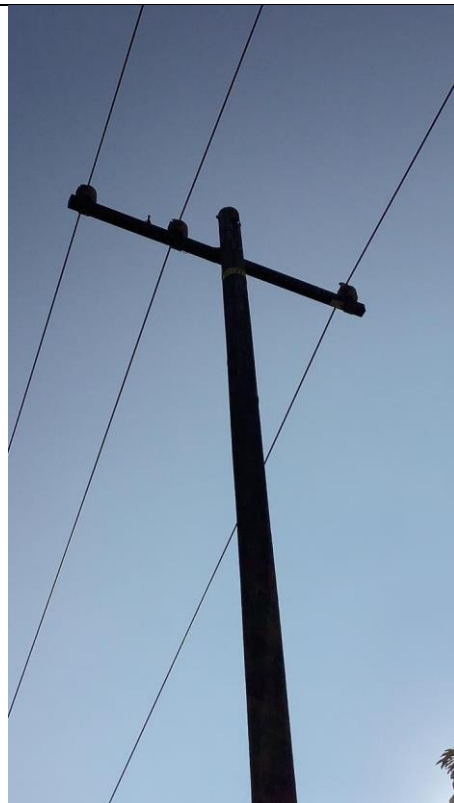
Item1Gimg2: Overall view of the pole and covered conductor installation

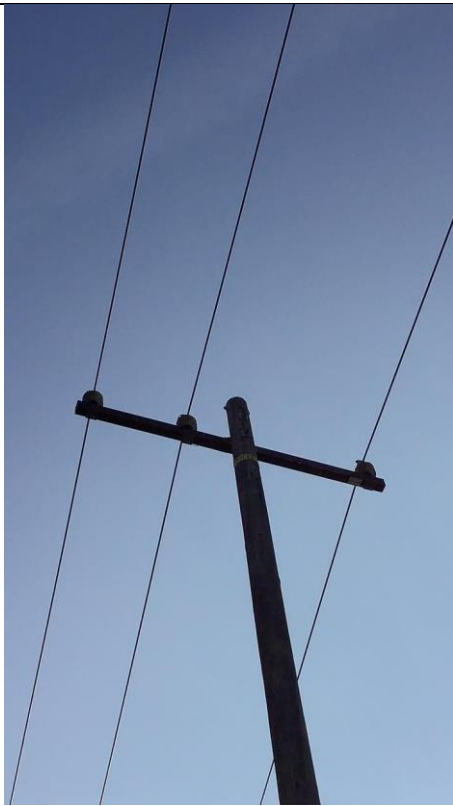
1. Violation 1: Per SCE’s Distribution Design Standards (DDS), section DDS-10, page 10-82, “for the 336 (30/7) ACSR covered conductor, vibration dampers shall be installed on every span in both light loading and heavy loading areas” and SCE’s Distribution Overhead Construction Standards (DOH), section CC 190, page 1 of 11, vibration dampers are required when installing covered conductor. Pole numbered X6067E had covered conductor installed but failed to install vibration dampers. Energy Safety considers this violation for failure of adhering to protocol to be in the Minor risk category.

Item	Structure ID	HFTD	Initiative Number	Violation Type	Severity	Violation Description
1	X6067E	Tier 2	7.3.3.3.1	Adherence to Protocol	Minor	Failure to install vibration dampers on a span

Per SCE's Distribution Design Standards (DDS), Distribution Overhead Construction Standards (DOH), when installing covered conductor, vibration dampers must be installed.¹ Energy Safety staff found that vibration dampers were not installed at multiple structures where covered conductor was completed. The structures missing vibration dampers where covered conductor was installed are identified in Table 2 above. On November 19, 2021, SCE submitted a memo to Energy Safety titled, "Interim Deviation from Standards on Vibration Damper for Covered Conductor"² (hereafter, "Memo"). This Memo was dated August 18, 2021, and indicates that due to supply chain issues, SCE will suspend the installation of vibration dampers until December 31, 2021. In accordance with SCE's Q1 QDR submission, the covered conductor installations inspected by Energy Safety were completed prior to the issuance of the Memo. Also, SCE informed Energy Safety of this supply chain issue only after inspections commenced. Consequently, Energy Safety finds that SCE is still in violation of its protocols requiring the installation of vibration dampers as part of covered conductor installations.

Item1IA1Img1: No vibration dampers are installed
