NOV_SCE_IAG_ 20211117-05

NOTICE OF VIOLATION

Energy Safety Inspection Report

Report Name: IAG_SCE_20211117-05

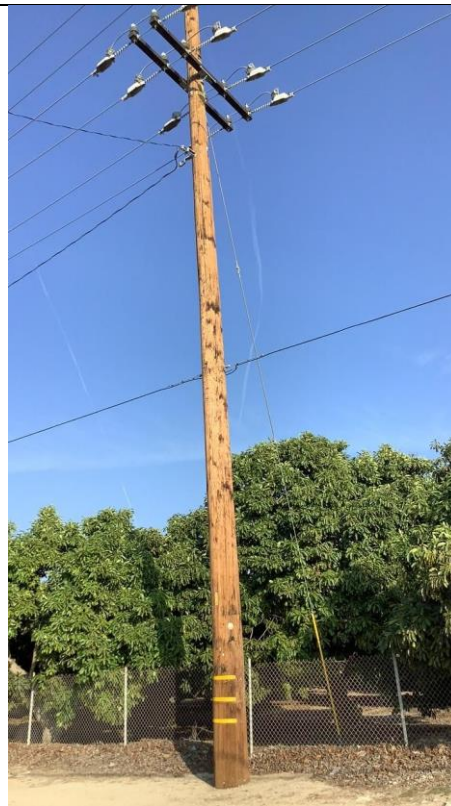
Item1Gimg2: Overall view of the pole, covered conductor installed

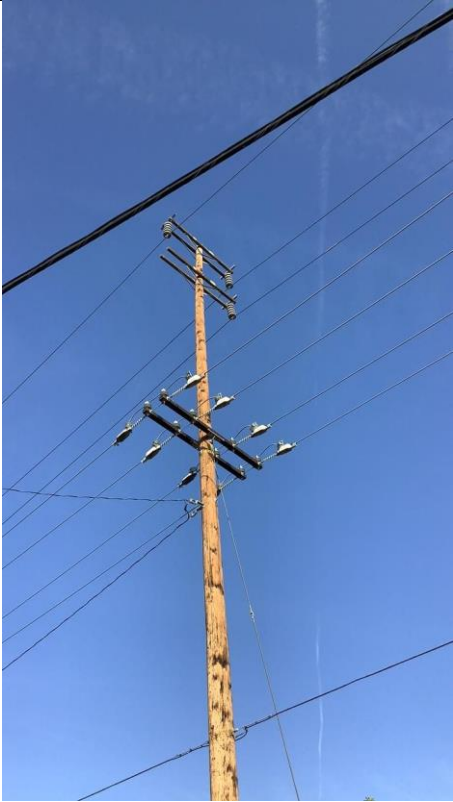
Item	Structure ID	HFTD	Initiative Number	Violation Type	Severity	Violation Description
1	4205199E	Tier 3	7.3.3.3.1	Adherence to Protocol	Minor	Failure to install vibration dampers on a span

Per SCE's Distribution Design Standards (DDS), Distribution Overhead Construction Standards (DOH), when installing covered conductor, vibration dampers must be installed.¹ Energy Safety staff found that vibration dampers were not installed at multiple structures where covered conductor was completed. The structures missing vibration dampers where covered conductor was installed are identified in Table 2 above. On November 19, 2021, SCE submitted a memo to Energy Safety titled, "Interim Deviation from Standards on Vibration Damper for Covered Conductor"² (hereafter, "Memo"). This Memo was dated August 18, 2021, and indicates that due to supply chain issues, SCE will suspend the installation of vibration dampers until December 31, 2021. Because the covered conductor installations inspected by Energy Safety were completed prior to the issuance of the Memo and SCE informed Energy Safety of this supply chain issue only after inspections commenced, Energy Safety finds that SCE is in violation of its protocols requiring the installation of vibration dampers as part of covered conductor installations.

Item1IA1Img1: No vibration dampers are installed
