NOV_SCE_EDC_ 20211208-01

NOTICE OF VIOLATION

Energy Safety Inspection Report

Report Name: SCE_EDC_20211208

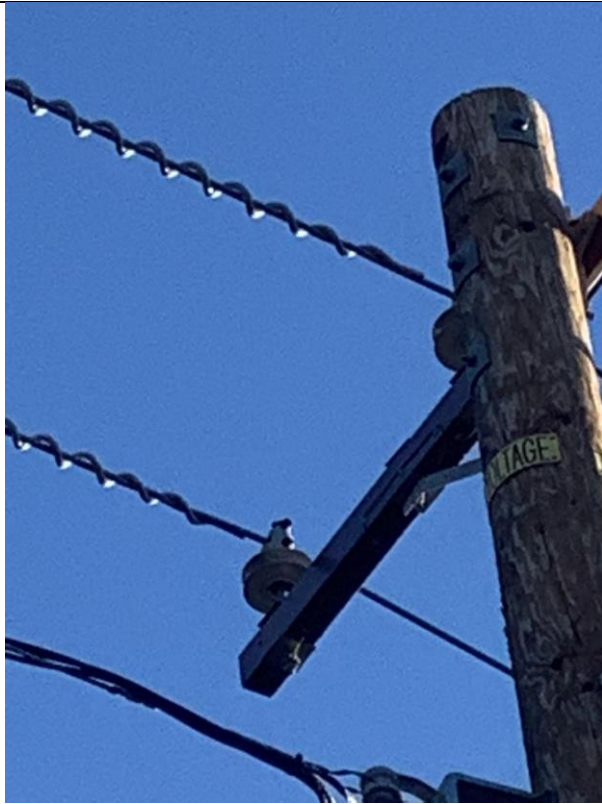
3. Violation 3: Per SCE's Distribution Overhead Standards (DOH), section CC 190, page 3 of 11, install the “vibration damper onto the conductor by wrapping the damping section onto the conductor in a clockwise fashion. Maintain a minimum of 6 inches away from the splice side on the opposite side to the structure, or on the other end of the span.” Pole number 1008929E had a vibration damper installed but was found to be within six inches of the structure. Energy Safety considers this violation for failure of adhering to protocol to be in the Minor risk category.

Per SCE's Distribution Overhead Standards (DOH), Section CC 190, page 3 of 11, the vibration damper must be installed to maintain a minimum of 6 inches away from the splice on the opposite side to the structure, or on the other end of the span.¹ These structures are noted in table 2 above.

Item2IA1img1: Vibration damper within 6 inches of insulator

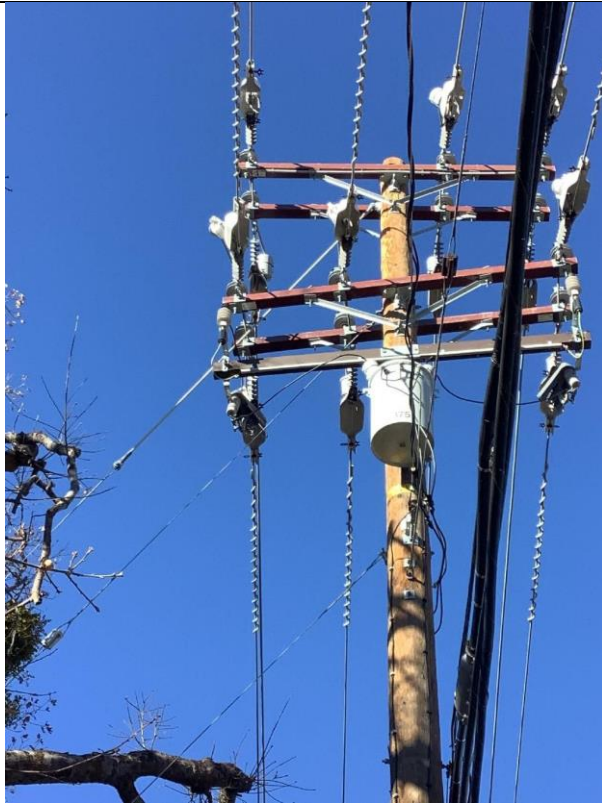
Item3IA1mg1: No fiberglass guy insulator installed at the secondary level

In HFRA installations of covered conductor it is required to upgrade wood crossarms with composite, upgrade all insulators to a polymer insulator, install wildlife protection covers, upgrade fuses where applicable, and upgrade down guy/span guy installation to include Fiberglass Guy Strain Insulators. The standards outlining these requirements are attached in the document titled "DDS Requirements Binder" as well as the attached "DOH Section CC".

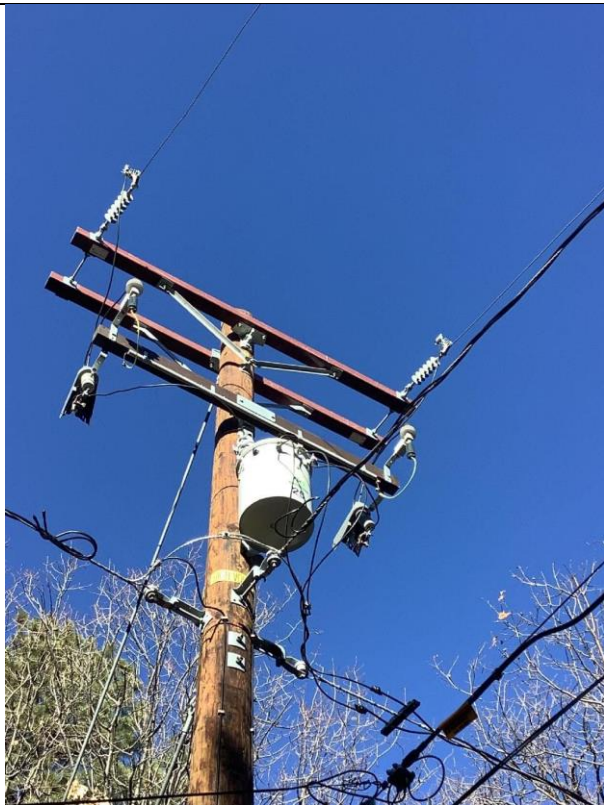
1. Violation 1: Per SCE’s 2021-Q1 Quarterly Data Report (QDR), covered conductor was installed on pole numbered 2348187E. This structure reported a covered conductor initiative (2021 WMP initiative number 7.3.3.3.1) with a status of “complete.” However, upon inspection, SCE has not even begun covered conductor installation at any of these locations. Energy Safety considers this data accuracy violation to be in the Moderate Risk category.
2. Violation 2: Per SCE’s 2021-Q1 QDR, covered conductor was installed on pole numbered 2348187E. Upon inspection, Energy Safety staff found no covered conductor installed at the above-mentioned structures. Given SCE’s focus on covered conductor as one of its flagship wildfire mitigation programs and the scope of this mitigation program, Energy Safety is greatly concerned about how much covered conductor work is completed and

how prevalent this issue may be. Energy Safety considers this violation related to incomplete WMP work to be in the Moderate Risk category.

In its 2021-Q1 and 2021-Q2 quarterly data report (QDR) submission on May 1, 2021, and August 1, 2021, SCE provided initiative data indicating that a covered conductor installation project (WMP initiative number 7.3.3.3.1) in Lake Arrowhead was completed. This QDR submission represented the reporting periods of January through March (Q1) and April through June (i.e., Q2) of 2021. Based on this information received from SCE, Energy Safety planned an inspection of select structures in this area to assess the accuracy of SCE data, the completeness of SCE's work, and whether SCE followed its protocols for covered conductor installation. Upon arriving to the inspection location, Energy Safety observed that covered conductor was not installed where SCE's QDR indicated covered conductor work had a status of "Complete." These structures are noted in Table 2 above.

Item4IA1Img1: No covered conductor installed as reported
