NOTICE OF VIOLATION

Energy Safety Inspection Report

Report Name: IAG_SCE_20211117-01

On November 17, 2021, I performed a walking inspection of Southern California Edison (SCE) covered conductor installations, 2021 WMP initiative number 7.3.3.3.1, in the city of Moorpark, California. Detailed findings from this field inspection are laid out in Section II below.

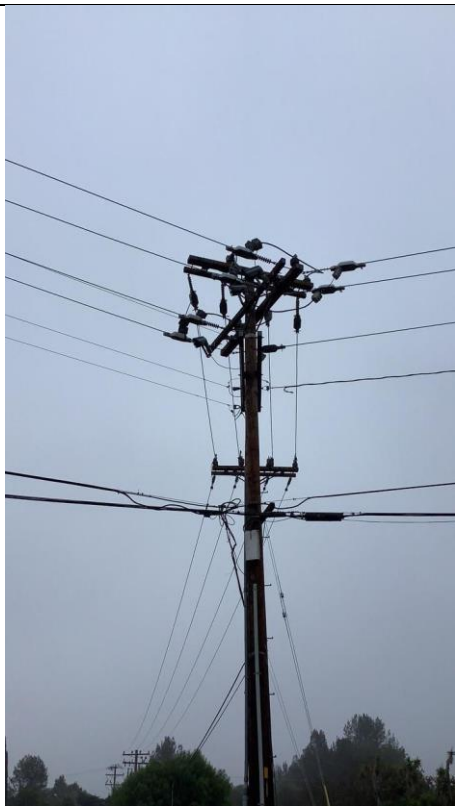
Item1G1mg2: Overall view of the pole and covered conductor

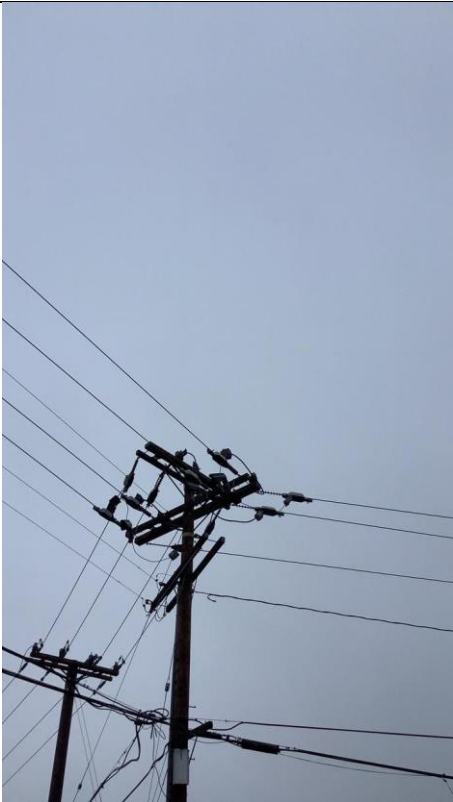
Item	Structure ID	HFTD	Initiative Number	Violation Type	Severity	Violation Description
1	382961E	Tier 3	7.3.3.3.1	Adherence to Protocol	Minor	Failure to install vibration dampers on a span
2	1603388E	Tier 3	7.3.3.3.1	Adherence to Protocol	Minor	Failure to install vibration dampers on a span
3	4920630E	Tier 3	7.3.3.3.1	Adherence to Protocol	Minor	Failure to install vibration dampers on a span
4	2170089E	Tier 3	7.3.3.3.1	Adherence to Protocol	Minor	Failure to install vibration dampers on a span

Per SCE’s Distribution Design Standards (DDS) and Distribution Overhead Construction Standards (DOH), when installing covered conductor, vibration dampers must also be installed.¹ Energy Safety staff found that vibration dampers were not installed at multiple structures where covered conductor was completed. The structures missing vibration dampers where covered conductor was installed are identified in Table 2 above. On November 19, 2021, SCE submitted a memo to Energy Safety titled, "Interim Deviation from Standards on Vibration Damper for Covered Conductor"² (hereafter, Memo”). This Memo was dated August 18, 2021, and indicates that due to supply chain issues, SCE will suspend the installation of vibration dampers until December 31, 2021. In accordance with SCE’s Q2 QDR submission, the covered conductor installations inspected by Energy Safety were completed prior to the issuance of the Memo. Also, SCE informed Energy Safety of this supply chain issue only after inspections commenced. Consequently, Energy Safety finds that SCE is still in violation of its protocols requiring the installation of vibration dampers as part of covered conductor installations.

Item1IA1Img1: No vibration dampers are installed

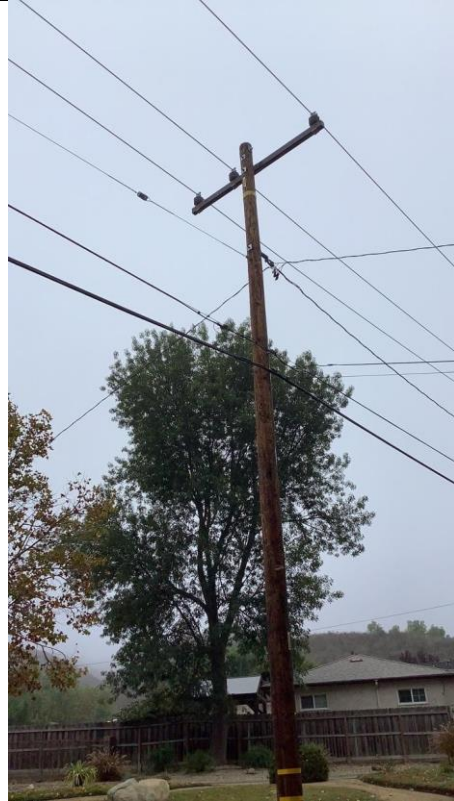
Item2Gimg2: Overall view of the pole and covered conductor

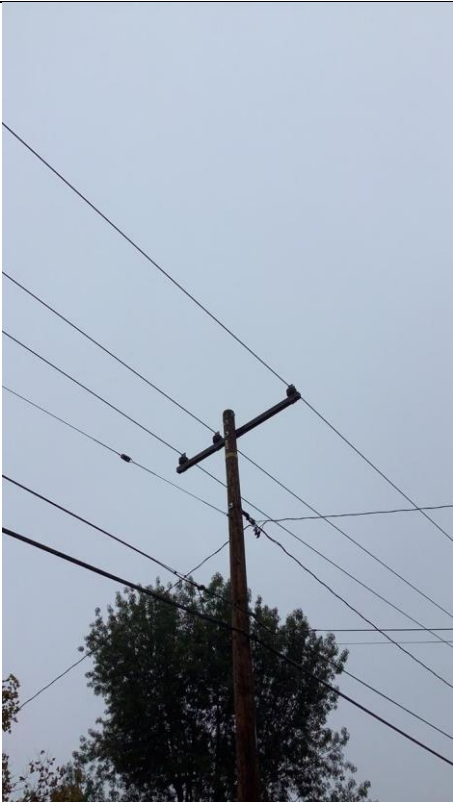
Item2IA1Img1: No vibration dampers are installed

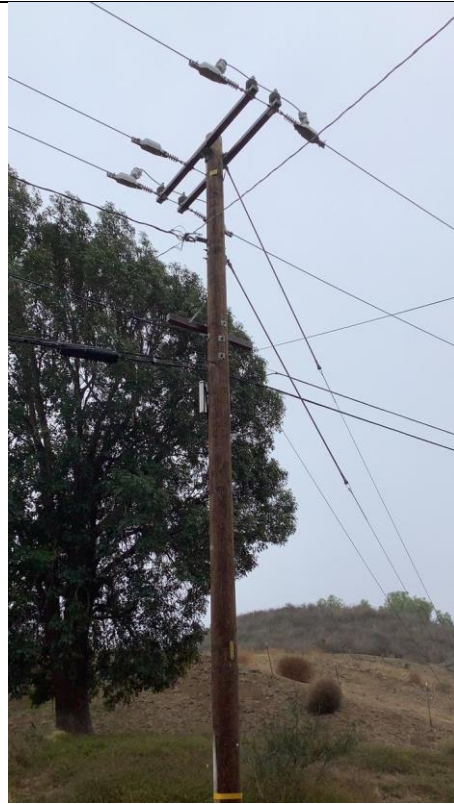
Item3GImg2: Overall view of the pole and covered conductor installed

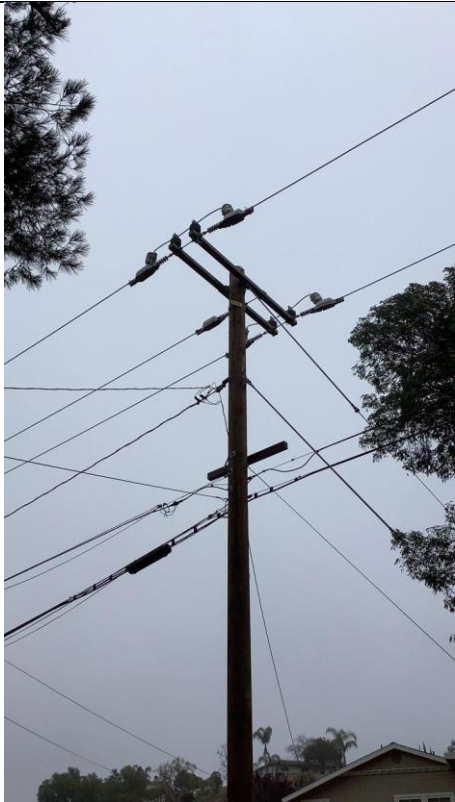
Item3IA1Img1: No vibration dampers are installed

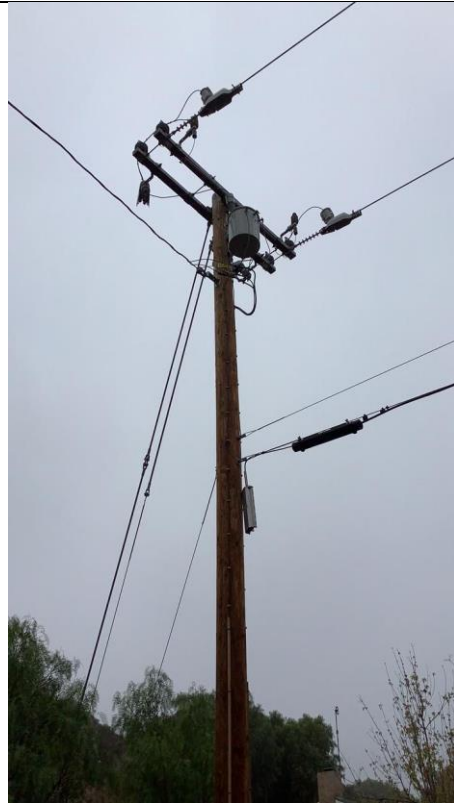
Item4GImg2: Overall view of the pole and covered conductor

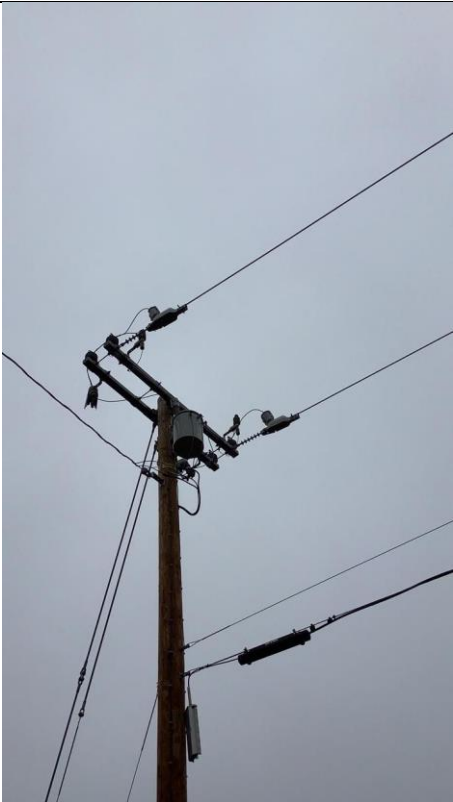
Item4IA1img1: No vibration dampers are installed
