NOV\_SCE\_IAG\_20211117-02

## **NOTICE OF VIOLATION**

# Energy Safety Inspection Report

Report Name: IAG\_SCE\_20211117-02

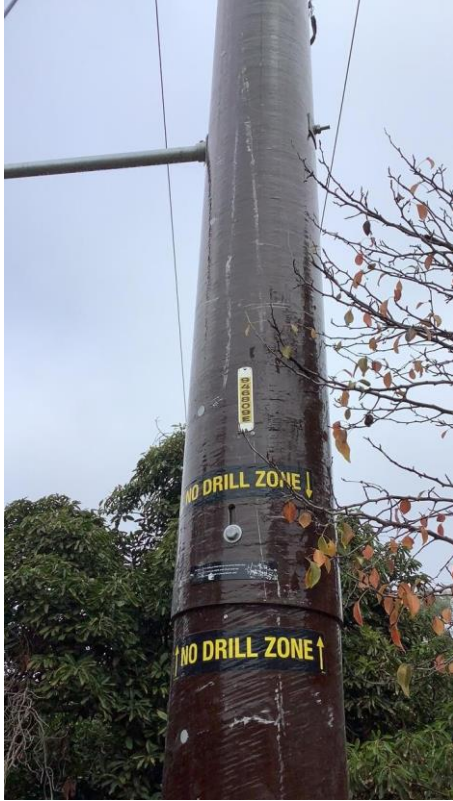
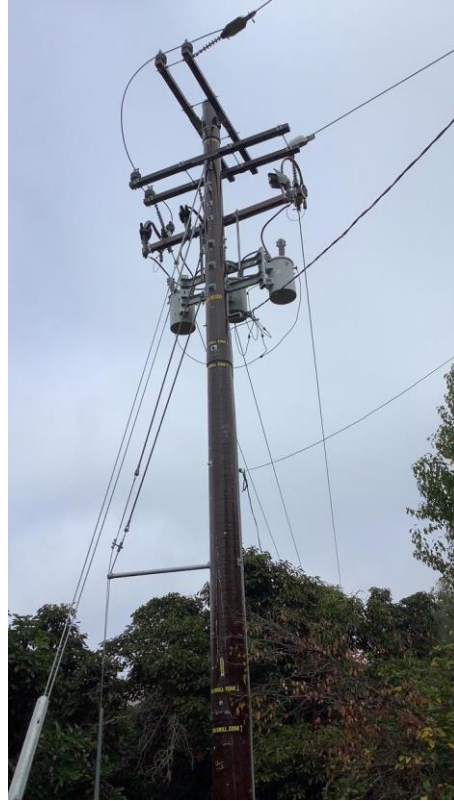
Structure ID: 946809E

Item1GImg1: Pole 946809E

Item1GImg2: Overall view of the pole and covered conductor

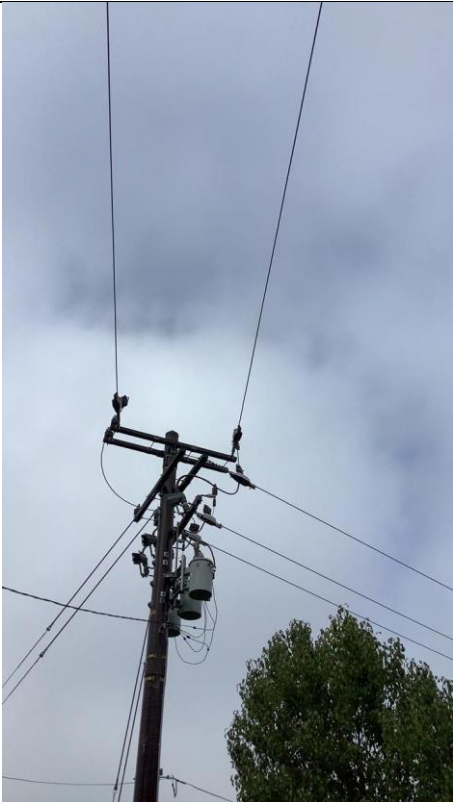
Item	Structure ID	HFTD	Initiative Number	Violation Type	Severity	Violation Description
1	946809E	Tier 3	7.3.3.3.1	Adherence to Protocol	Minor	Failure to install vibration dampers on a span
2	4651151	Tier 3	7.3.3.3.1	Adherence to Protocol	Minor	Failure to install vibration dampers on a span
3	946808E	Tier 3	7.3.3.3.1	Adherence to Protocol	Minor	Failure to install vibration dampers on a span

Per SCE’s Distribution Design Standards (DDS) and Distribution Overhead Construction Standards (DOH), when installing covered conductor, vibration dampers must also be installed.<sup>1</sup> Energy Safety staff found that vibration dampers were not installed at multiple structures where covered conductor was completed. The structures missing vibration dampers where covered conductor was installed are identified in Table 2 above. On November 19, 2021, SCE submitted a memo to Energy Safety titled, "Interim Deviation from Standards on Vibration Damper for Covered Conductor"<sup>2</sup> (hereafter, “Memo”). This Memo was dated August 18, 2021, and indicates that due to supply chain issues, SCE will suspend the installation of vibration dampers until December 31, 2021. In accordance with SCE’s Q2 QDR submission, the covered conductor installations inspected by Energy Safety were completed prior to the issuance of the Memo. Also, SCE informed Energy Safety of this supply chain issue only after inspections commenced. Consequently, Energy Safety finds that SCE is still in violation of its protocols requiring the installation of vibration dampers as part of covered conductor installations.

Item1IA1Img1: No vibration dampers are installed

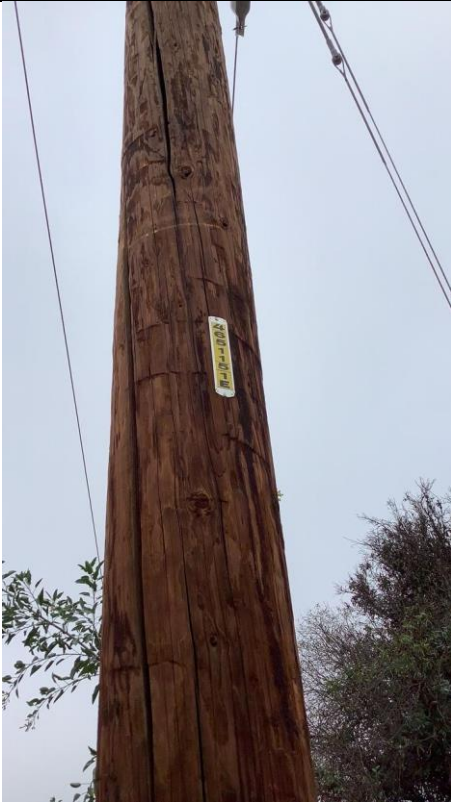
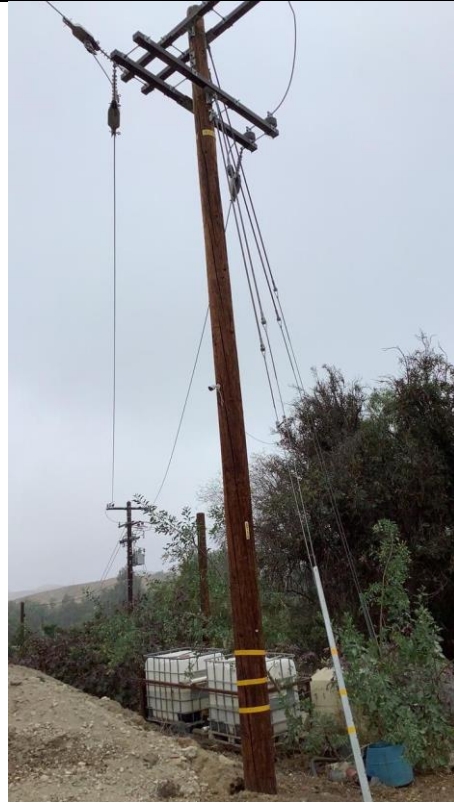
Structure ID: 4651151E

Item2GImg1: Pole 4651151E

Item2GImg2: Overall view of the pole and covered conductor

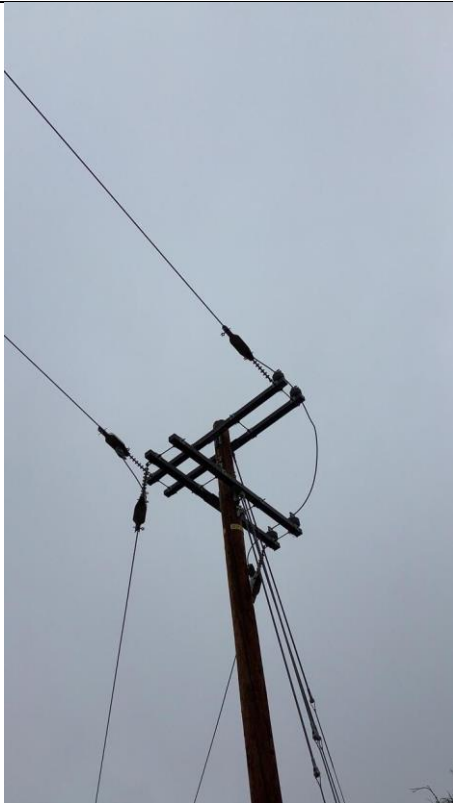
Item2IA1Img1: No vibration dampers are installed

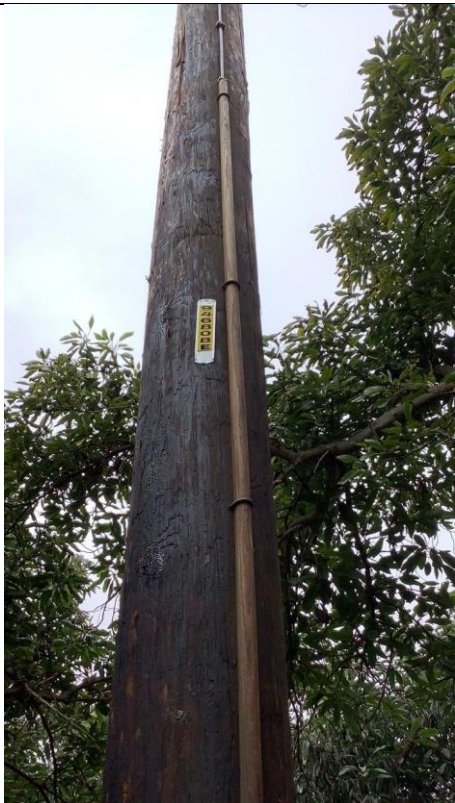
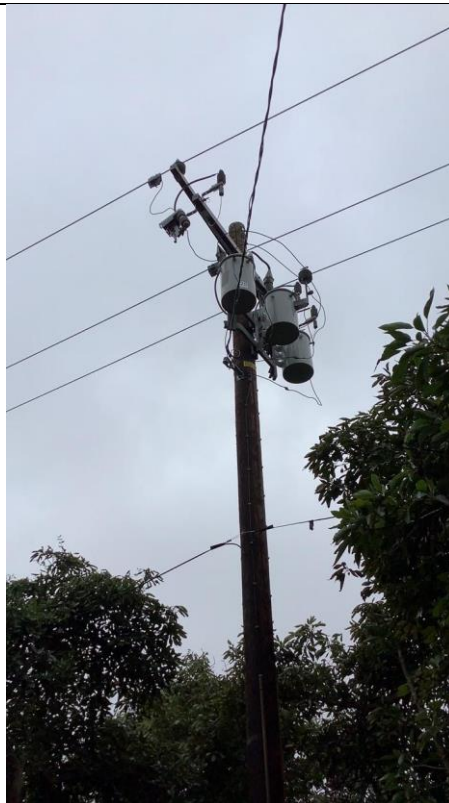
Structure ID: 946808E

Item3GImg1: Pole 946808E

Item3GImg2: Overall view of the pole and covered conductor

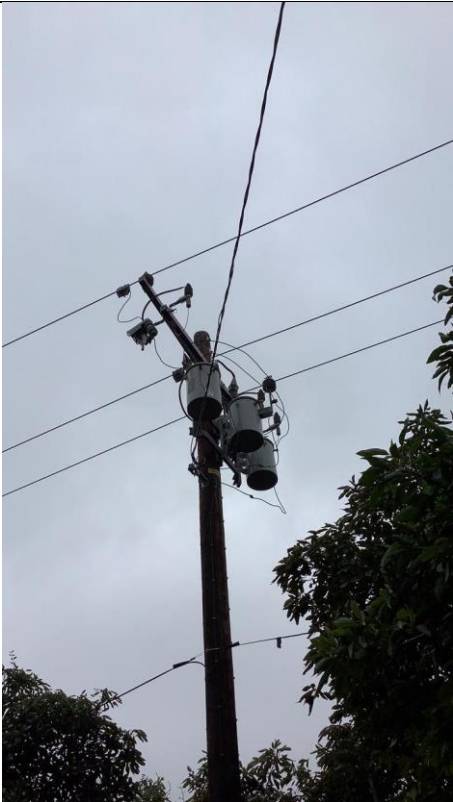
Item3IA1Img1: No vibration dampers are installed
