NOTICE OF VIOLATION

Energy Safety Inspection Report

Report Name: SCE_GCA_2021116-01

Date(s): November 16, 2021

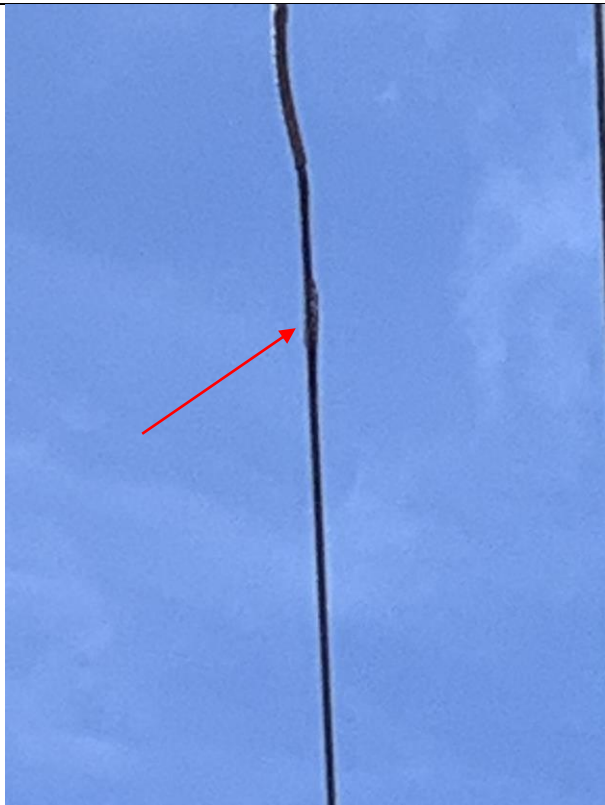
Item	Structure ID	HFTD	Defect Type	Risk Category	Defect Description
1	X11580E	Tier 3	Conductor evidence of bird caging	Minor	Bird caging near phase splice. Bird caging is on the eastmost conductor and the middle conductor.

During the inspections, Energy Safety also discovered a phase conductor that showed evidence of bird-caging. Bird-caging on a supply conductor can weaken its strength and lead to a wire down event and ignition, thus increasing the risk of structural failure and potential ignition under adverse weather conditions. Energy Safety considers this a minor defect due to the severity of the bird-caging. The structure where bird-caging was observed is identified in Table 3. See photos labeled Item4CD5Img1, Item4CD5Img2, Item4CD5Img1 for visual representation.

<p>Item4CD5Img1: Bird-Cage middle conductor from pole X11580E at 0.2 span</p>	<p>Item4CD5Img2: Close up of bird-caging</p>

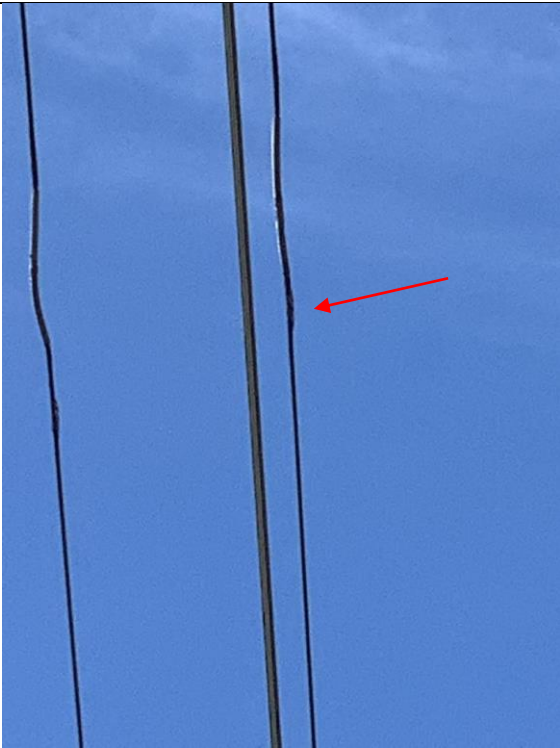
Item4CD5Img3: Bird-Caging middle conductor near pole X11580E

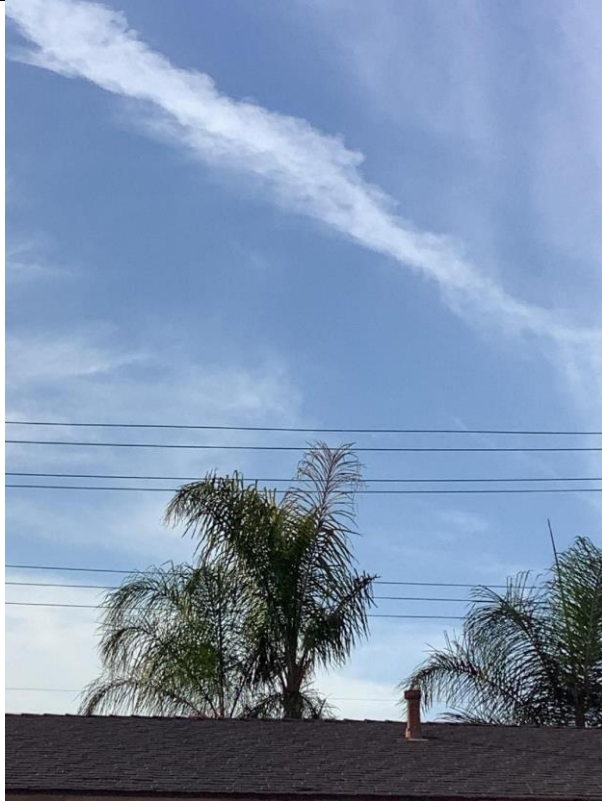
1. Per SCE’s Distribution Vegetation Management Plan (DVMP), Version 4, page 8, indicates that regulatory clearance distances between vegetation and conductors are to be maintained at all times. A queen palm frond was found in contact with conductors near pole 1473452E. Energy Safety considers this violation to be in the severe category due to the nature of increased ignition risk from vegetation contact with conductors.

Item	Structure ID	HFTD	Initiative Number	Violation Type	Risk Category	Violation Description
1	1473452E	Tier 3	7.3.5.20	Adherence to Protocol	Severe	Palm fronds in contact with conductors.

Item9GImg1: Queen palm touching conductor

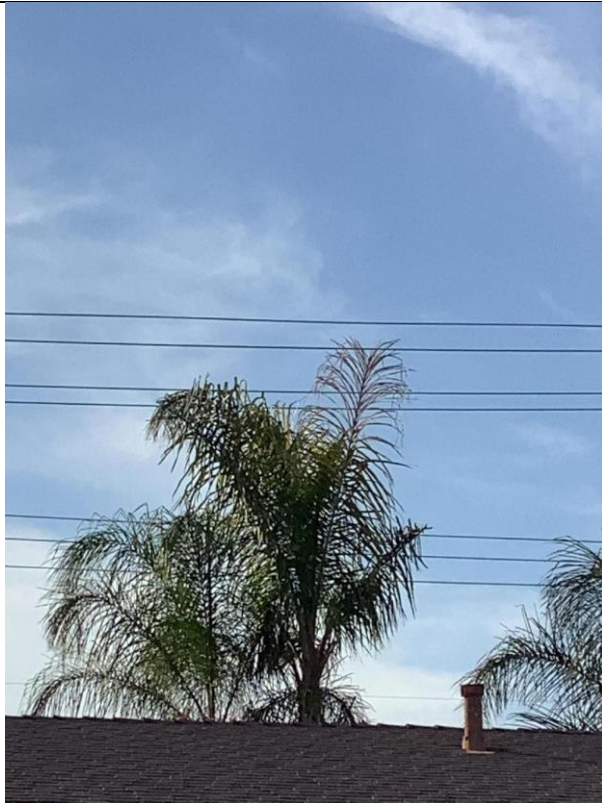
In accordance with SCE’s protocols, as stated in its Distribution Vegetation Management Plan (DVMP), “Compliance Clearance Distance¹ (CCD) [is] to be maintained at all times based on line voltage.”² The referenced DVMP excerpt may be found in Appendix B. In addition, SCE’s 2021 WMP update states, “The line clearance scope in HFRA is driven by the CPUC requirements and GO95 Rule 35 Appendix E.”³ During the inspection, Energy Safety found a Queen Palm frond in contact with the primary conductors. The palm was found in a residential backyard near pole 1473452E. Energy Safety notified SCE Regulatory Affairs and Compliance Advisor Erick Sanchez, via phone on November 16, 2021, of vegetation in direct contact with the primary conductors. Mr. Sanchez acknowledged receipt of the information and indicated that SCE would remediate ignition risk as soon as possible. On November 19, 2021, Mr. Sanchez indicated to Energy Safety staff, via text message, that SCE mitigated the vegetation contact discovered by Energy Safety on November 16, 2021. The structure where compliance clearance distance was not maintained is noted in Table 2.

Item9IA1Img1: Palm fronds contacting the conductor.

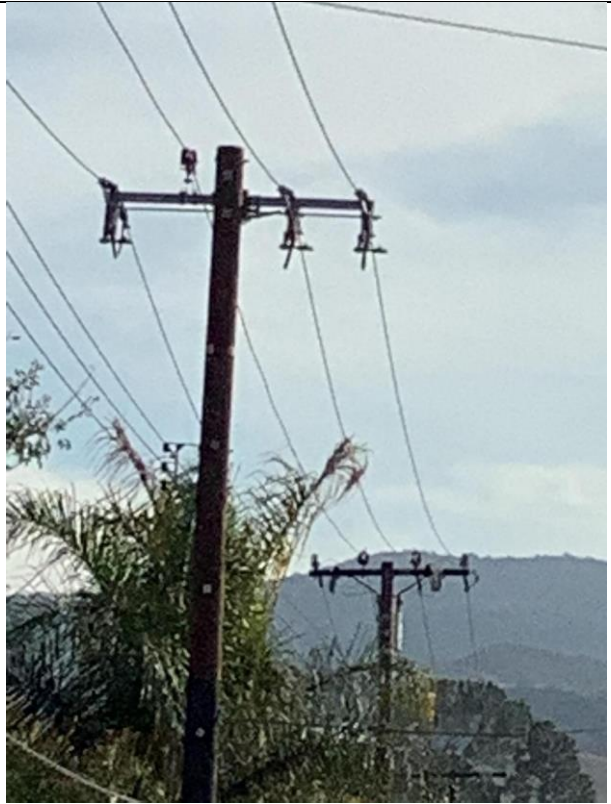
Item9IA1Img2: Palm fronds contacting the conductor.

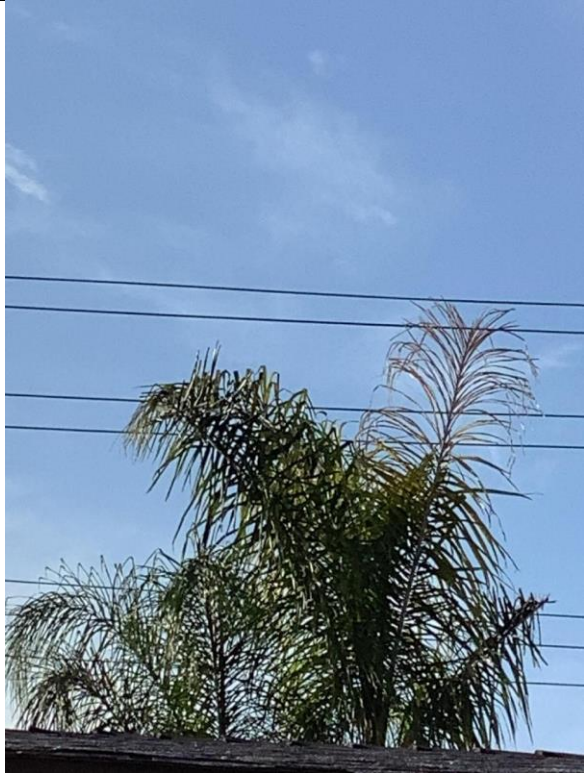
Item9IA1Img3: Palm fronds contacting conductor

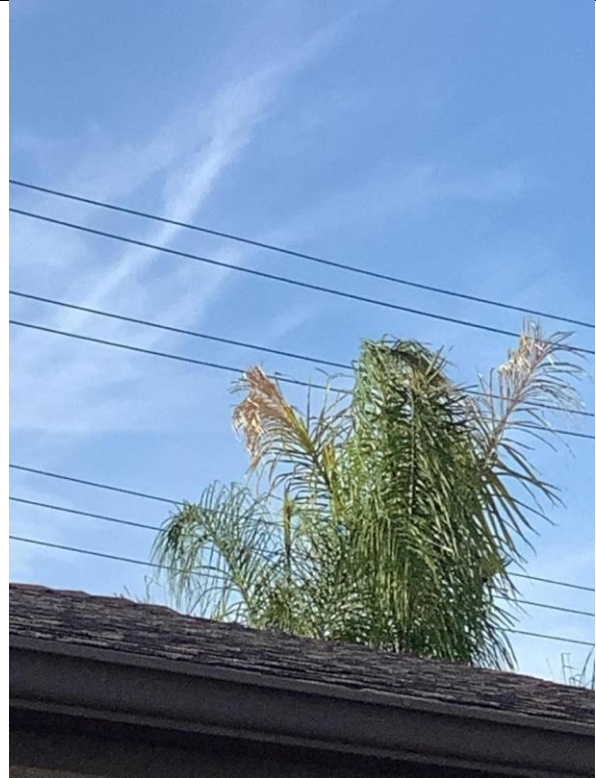
Item9IA1Img4: Palm fronds contacting conductors
