NOTICE OF DEFECT

Energy Safety Inspection Report

Report Name: SCE_GCA_2021116-01

Date(s): November 16, 2021

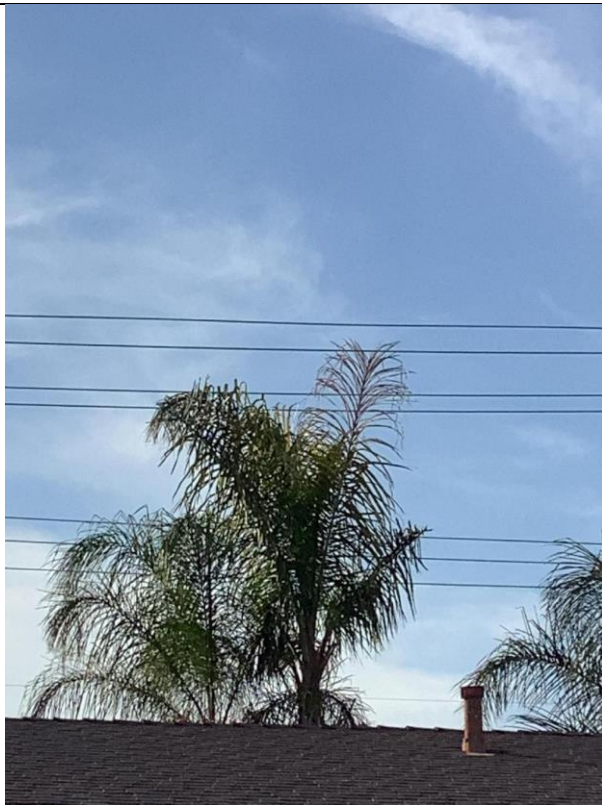
Item	Structure ID	HFTD	Initiative Number	Violation Type	Risk Category	Violation Description
1	1473452E	Tier 3	7.3.5.20	Adherence to Protocol	Severe	Palm fronds in contact with conductors.

Item9IA1Img1: Palm fronds contacting the conductor.

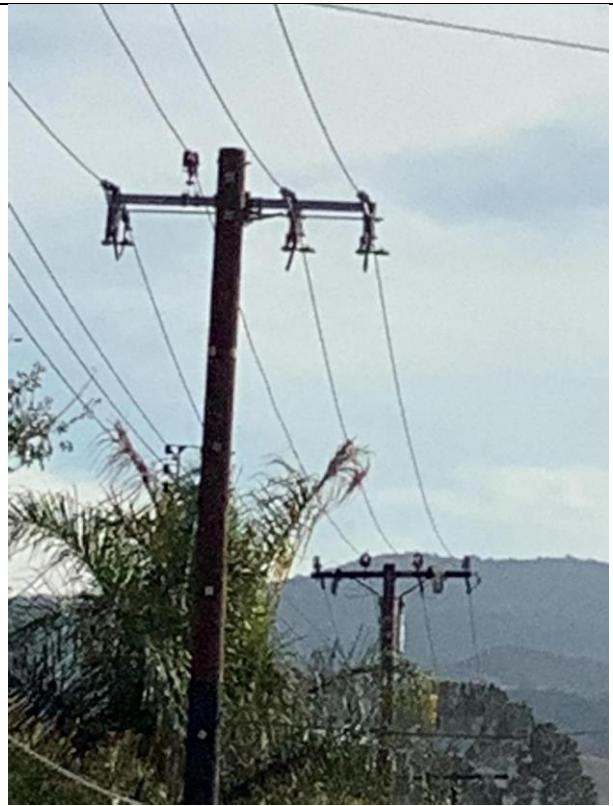
Item9IA1Img2: Palm fronds contacting the conductor.

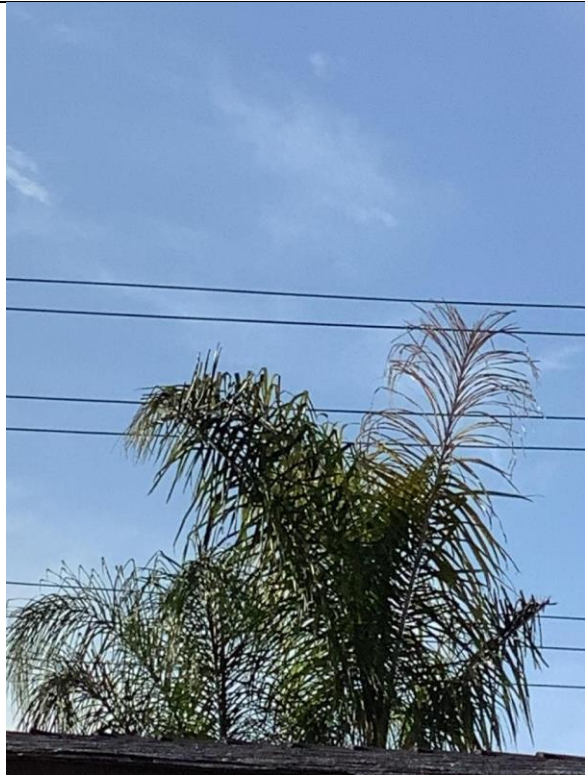
Item9IA1Img3: Palm fronds contacting conductor

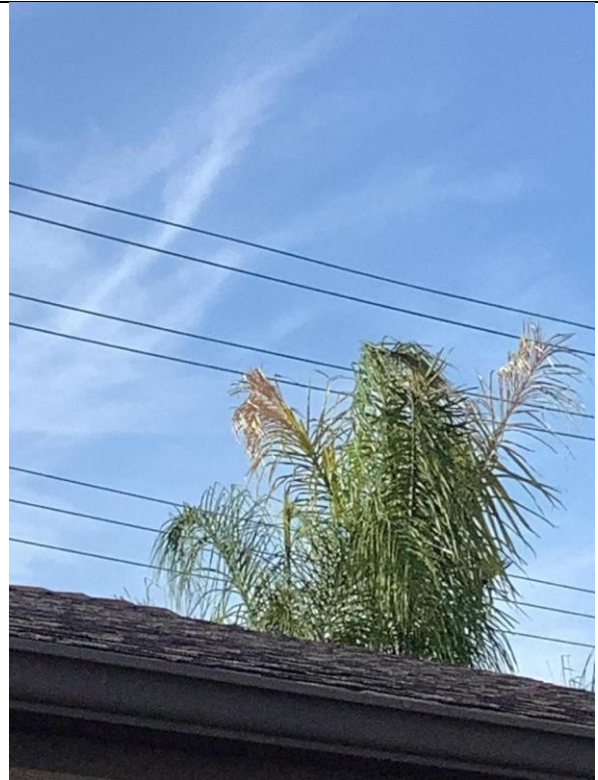
Item9IA1Img4: Palm fronds contacting conductors
