NOD_SCE_GCA_20211209-01

NOTICE OF DEFECT

Energy Safety Inspection Report

Report Name: GCA_SCE_20211209-01
Date(s): December 9, 2021
Inspector: Gary Candelas
Utility: Southern California Edison
Attention: Erik Takayesu, Vice President Asset Strategy and Planning

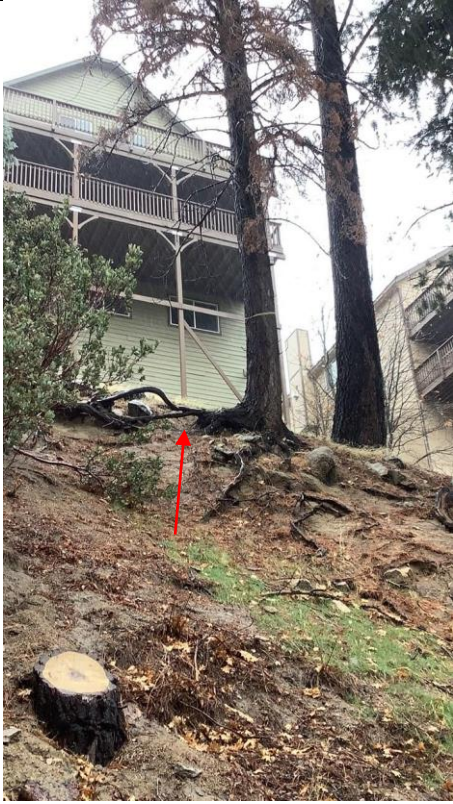
1. Defect 1: Danger Tree present near SCE pole numbered 4748029E. Energy Safety considers this defect to be in the minor risk category due to dying tree foliage, exposed roots, and location on an uphill slope above SCE assets. The tree shows no other visible signs of defect. Danger Trees have a higher probability of failing due to tree conditions, which can increase the risk of ignition should the tree strike a utility asset.

Item	Structure ID	HFTD	Defect Type	Severity	Defect Description
1	4748029E	Tier 3	Danger tree present	Minor	Pine tree approximately 55 feet in height on steep slope elevating above SCE assets. Tree has lean towards SCE assets. Distance from conductors to tree approximately 35 feet. Tree has exposed roots and severe dying foliage.

Item3VG6img1: Base of tree with exposed roots

The subject danger tree is approximately located at 26642-26898 Modoc Ln., Lake Arrowhead, CA, 92352. The subject danger tree was accessed from Brentwood Dr, Lake Arrowhead, CA, 92352. Photos in the appendix below show a visual representation of the pole and the subject danger tree. During the inspection, Energy Safety noted that the subject danger tree had a yellow marking on its trunk. Energy Safety followed up with SCE regarding this marking and was notified that the subject danger tree was previously inspected under SCE’s Dead and Dying Tree Removal Program and was scheduled for removal in January 2022. Energy Safety agrees with SCE’s assessment that the removal of this subject danger tree is necessary to mitigate ignition risk due to potential tree failure and contact with SCE assets.

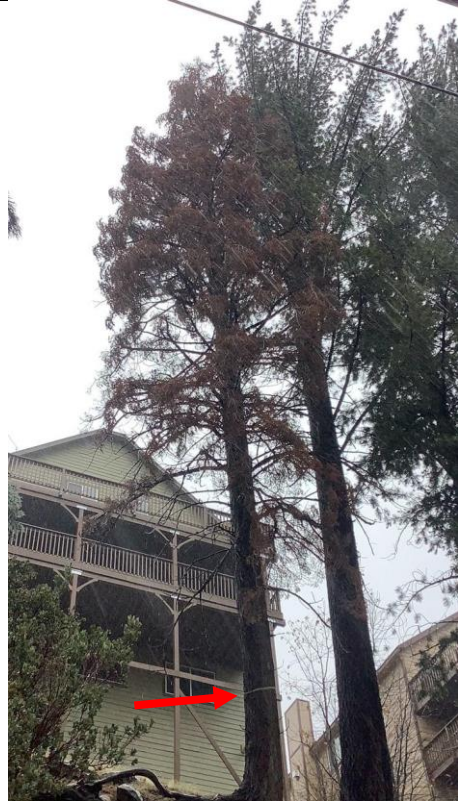
Item3VG6img2: Tree with yellow marking around trunk

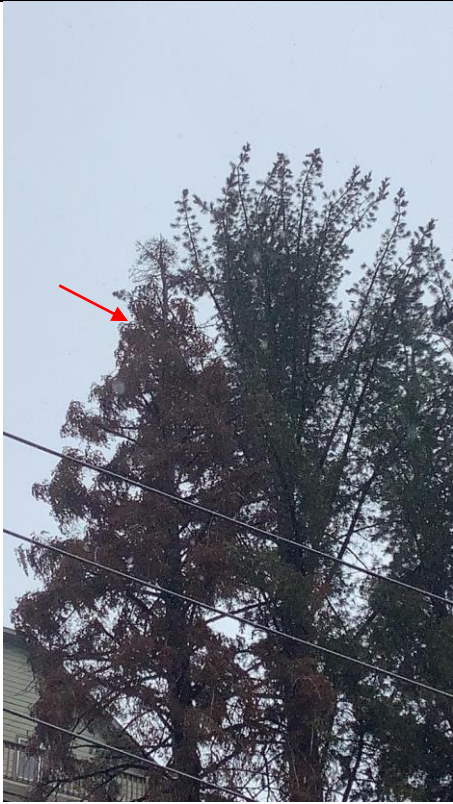
Item3VG6Img3: Dying foliage in tree canopy

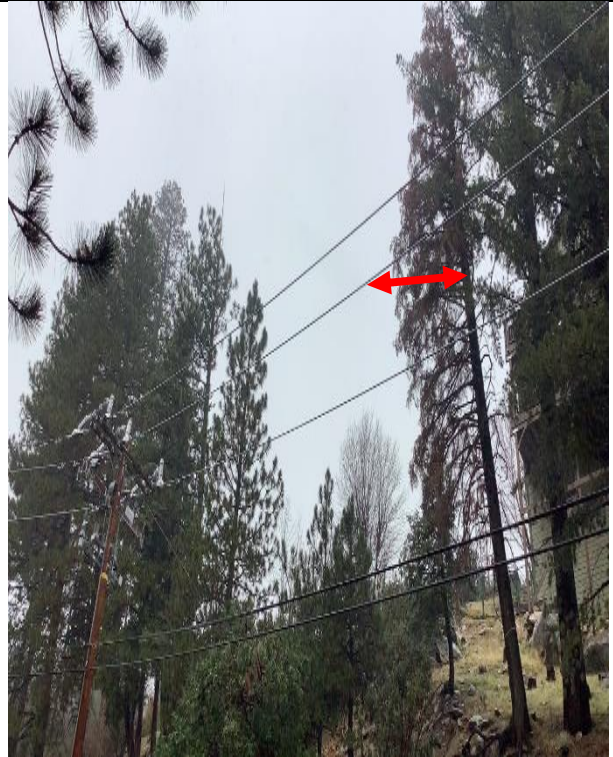
Item3VG6Img4: Proximity of tree to SCE assets
