NOD_SCE_GCA_ 20220404-01

NOTICE OF DEFECT

Energy Safety Inspection Report

Report Name: GCA_SCE_20220404
Date(s): April 4, 2022
Inspector: Gary Candelas
Utility: Southern California Edison
Attention: Erik Takayesu
Principal Manager Compliance Assurance

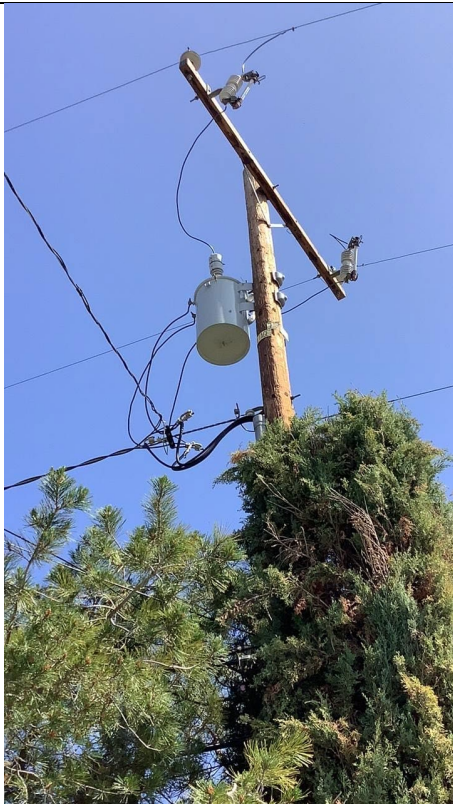
Item1GImg1: Pole assets

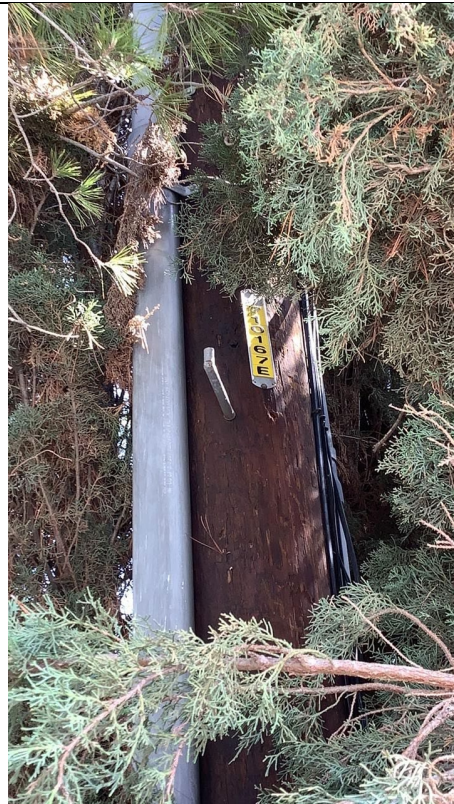
Item1GImg2: Pole ID

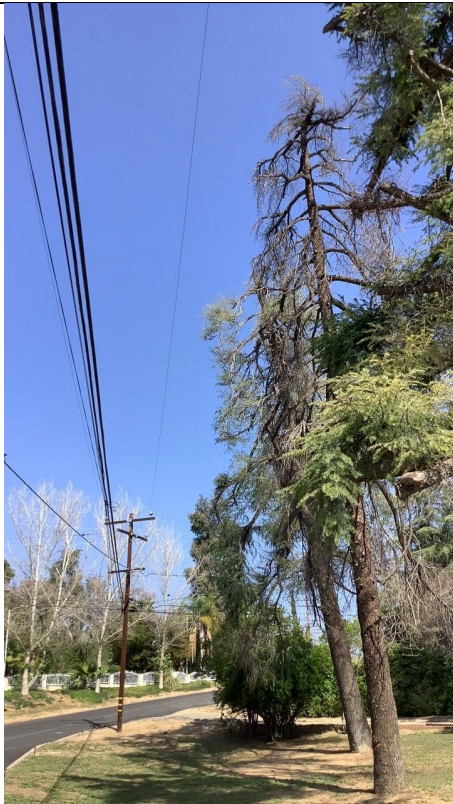
1. Defect 1: Danger Tree present near SCE pole numbered 710167E. Energy Safety considers this defect to be in the minor category due to dying foilage and subject danger tree approximately 15 feet from SCE assets. The tree shows no other signs of defects. Danger Trees have a higher probability of failure due to tree conditions, which can increase the risk of ignition should the tree strike a utility asset.

Item	Structure ID	HFTD	Defect Type	Severity	Defect Description
1	710167E	Tier 2	Danger tree present	Minor	Deodar Cedar, Danger tree observed with potential to strike conductor and/or pole nearby. The subject tree is in the front yard of property North East of the conductor, approximately 15ft from the conductors. The tree has no foliage, and neighboring trees show foliage. The tree has no other wounds or cavities. Unable to make contact with the homeowner.

Item1VG6Img1: danger tree near conductor

In accordance with the Energy Safety Compliance Process, outlined in Table 1 below are the correction timelines for identified defects relative to their risk category. Within 30 days from the issuance date of this notice of defect (NOD), July 18, 2022, advise Energy Safety of corrective actions taken or planned by SCE to remedy the above-identified defect(s) and prevent a recurrence. This response shall be filed in the Energy Safety e-Filing system under the

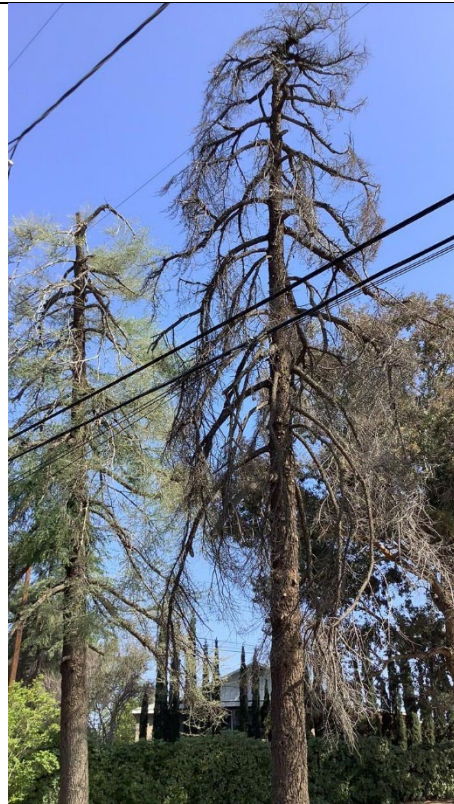
Item1VG6Img2: Side view of danger tree and conductor

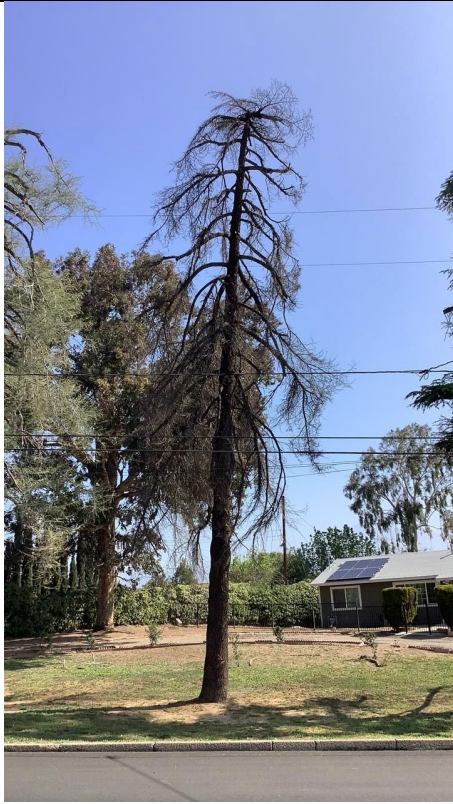
Item1VG6Img3: Front view of danger tree

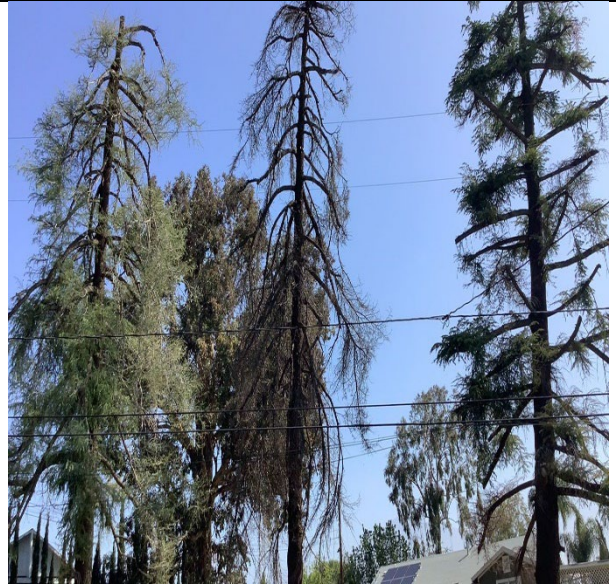
Item1VG6Img4: Neighboring trees
