TRANSMITTED VIA ELECTRONIC MAIL

June 15, 2022

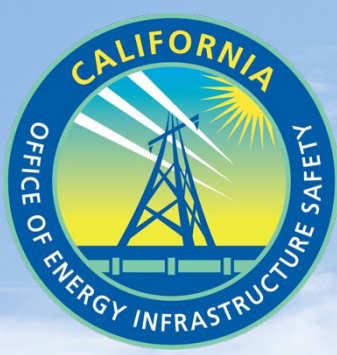
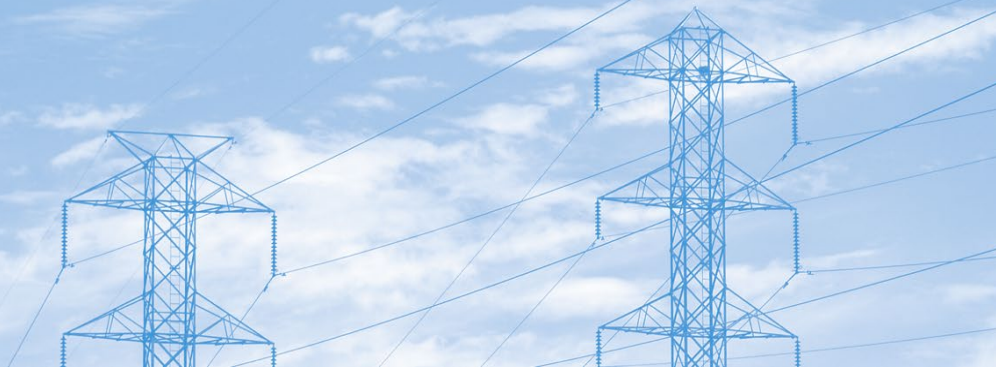
"General Wildfire Safety Inspections" and findings are detailed in Table 2 below. Issues discovered during these inspections are categorized as defects and are accompanied by a notice of defect (NOD).

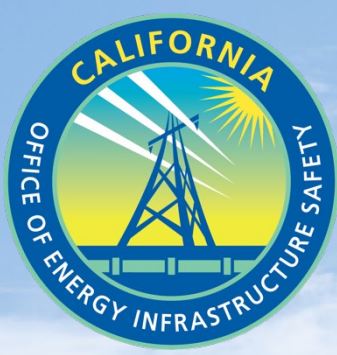
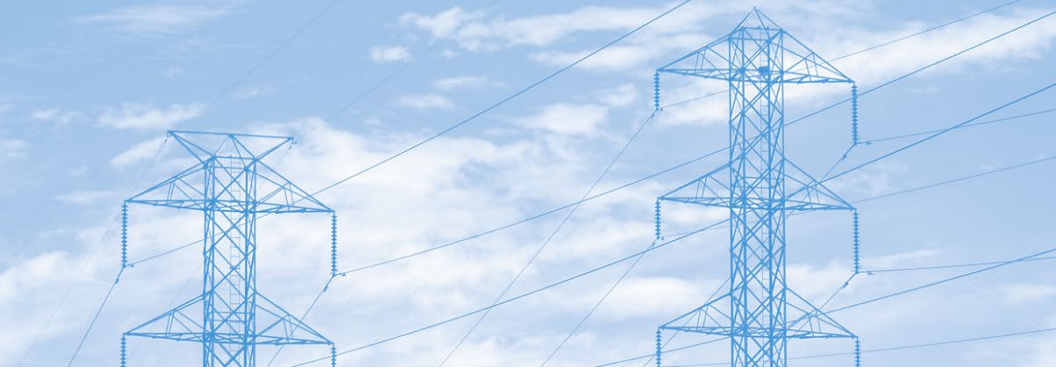
correction timelines. The correction timelines identified below apply to the results of both WMP initiative inspections as well as general wildfire safety inspections.

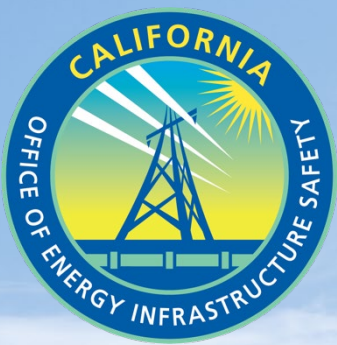
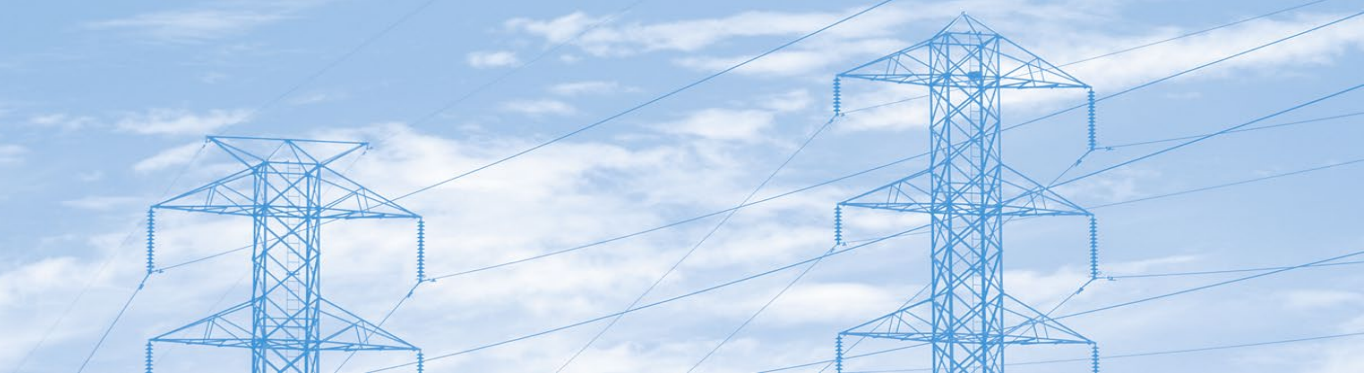
Table 2. General Wildfire Safety Inspections

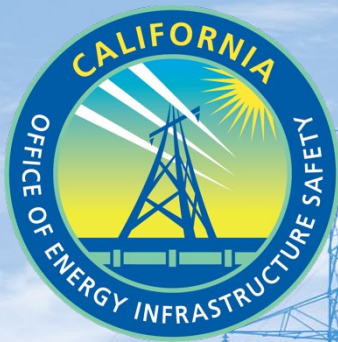
Structure ID	HFTD	Defect Type	Severity	Defect Description
1	4495329E	Tier 3	Vegetation near supply conductor w/radial clearance requirements	Moderate	Lateral Oak Tree branch within 4 feet of conductors.
2	1603964E	Tier 3	Vegetation contacting guy wire above insulator	Minor	Vegetation (vine) contacting guy wire above insulator.
3	1603964E	Tier 3	Vegetation near supply conductor w/radial clearance requirements	Moderate	Vegetation (vine) at cross-arm and signs of wrapping around pole.

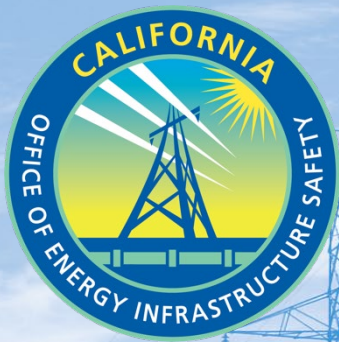
Pursuant to its objectives and statutory obligations, Energy Safety has completed the above-referenced inspection and discovered violations and/or defects by Southern California Edison. Southern California Edison's required response to these non-compliances and options for hearing are detailed in the associated notice of violation and/or defect, respectively.
