To: The Public, Local and State Agencies, and Stakeholders for San Diego Gas and Electric's 2021 Wildfire Mitigation Plan Independent Evaluator Annual Report on Compliance

July 15, 2022

FINAL INDEPENDENT EVALUATOR ANNUAL REPORT ON COMPLIANCE

SDG&E

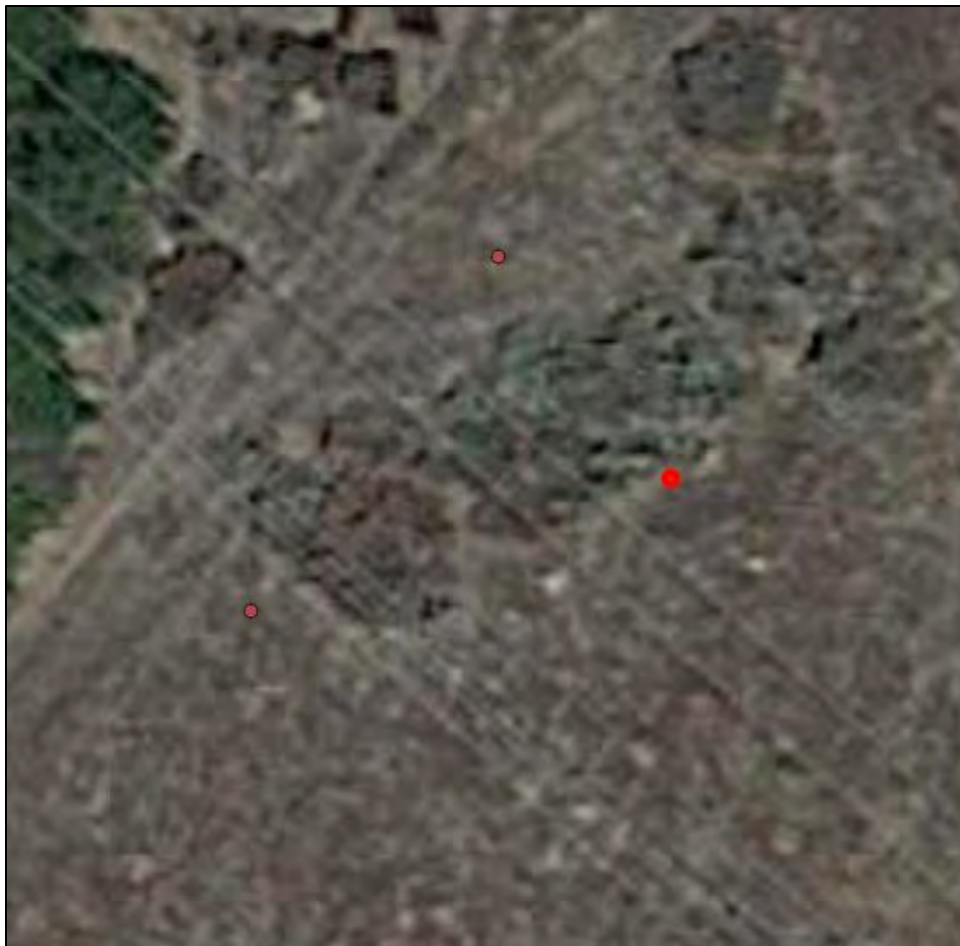
Image 2: 3 Duplicated vegetation inspection points without vegetation

Another example is initiative 7.3.5.20. located at lat. 33.27472686, long.-117.08299255, which is marked as completed both in Q2 and Q3.

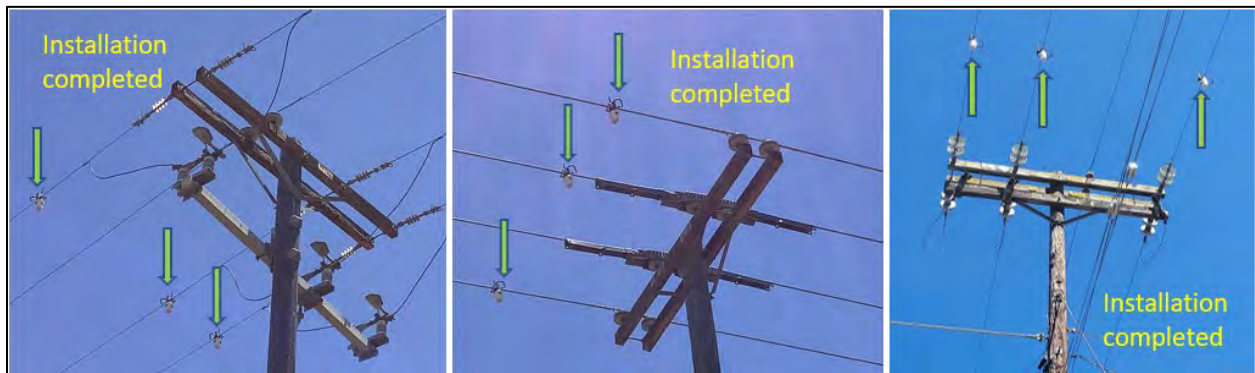
- No Fault indicator issues/Other Issues
 - Vegetation encroaching the infrastructure. Vegetation is within 10-feet of the clearance radius around the pole.
 - Poles show signs of physical degradation at two sample locations. Poles were installed in 2005 and 1989
- Unable to access and inspect the asset
 - The assets could not be inspected because it was behind a locked gate

Image 3: Fault Indicators installed correctly

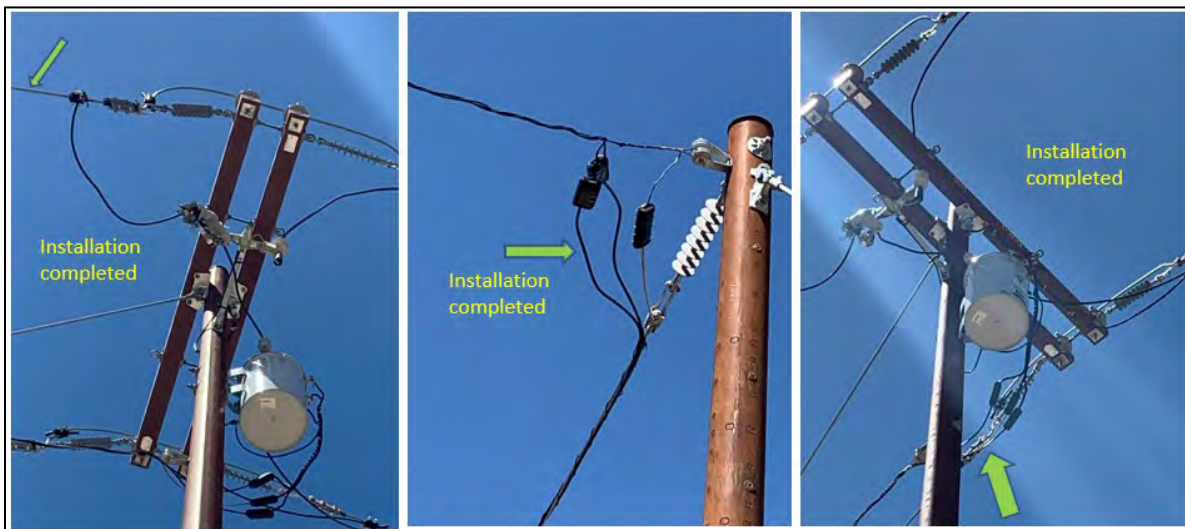
Image 5: Covered conductors installed

The sample is statistically applicable to the full population and provides useful feedback to SDG&E. In 55% of these installations, covered conductors were observed with no issues. In 12% of these inspections, however, issues were observed—in 9% of the inspections, no conductor was observed. In 3%, the covered conductor was not observed, and other issues were observed. Thus, 12% of the sample showed quality issues, while an additional 27% of the sample could not be accessed for inspection.

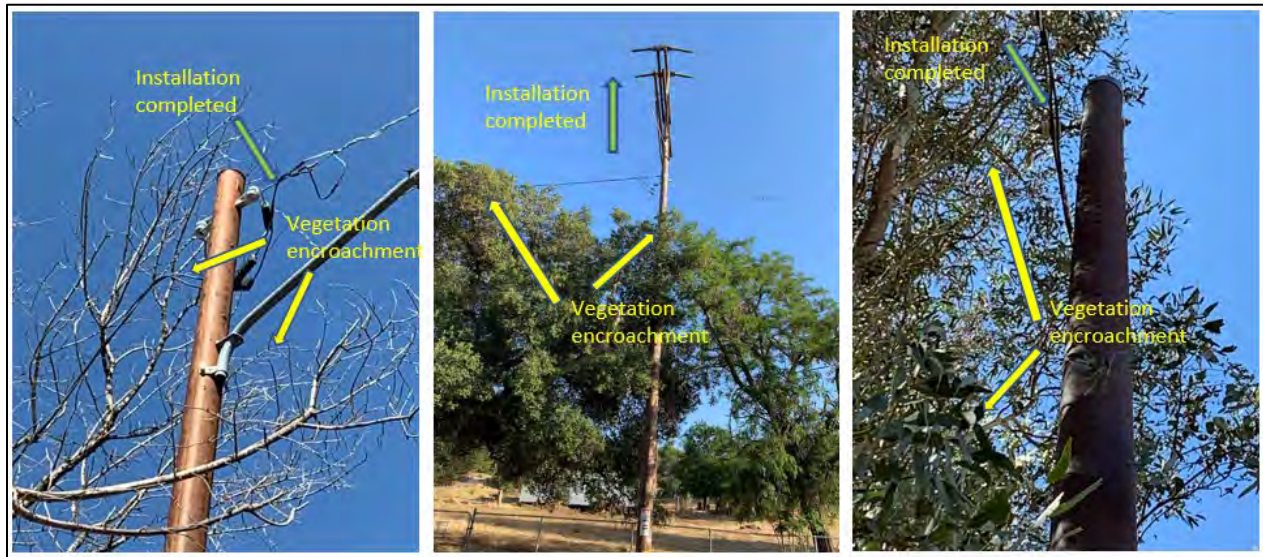
Image 6: Covered conductor issues observed.

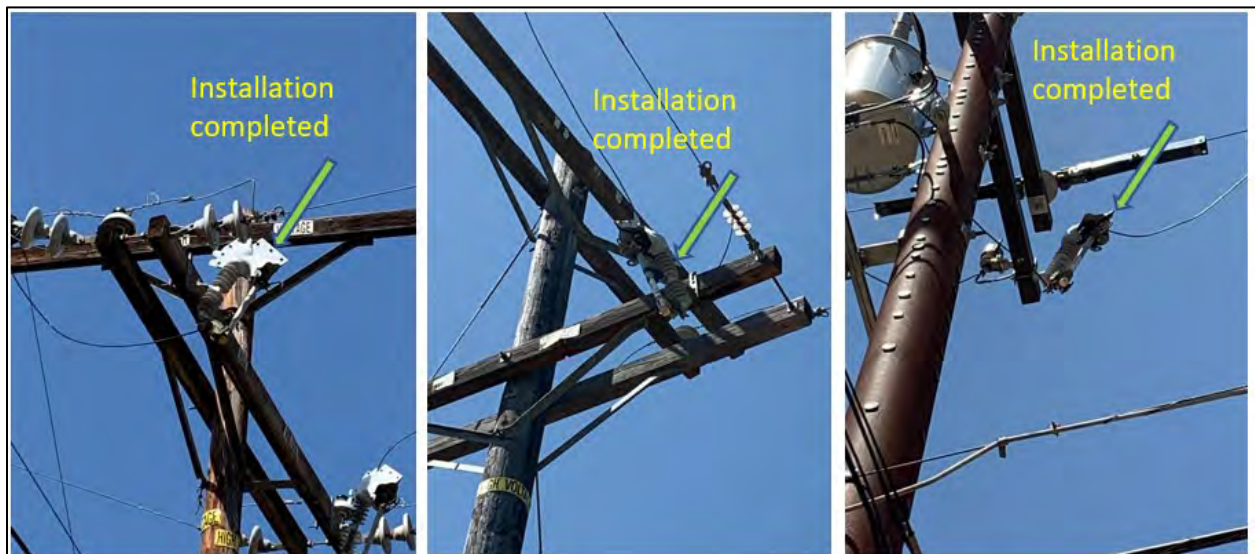
Image 8: No issues observed.

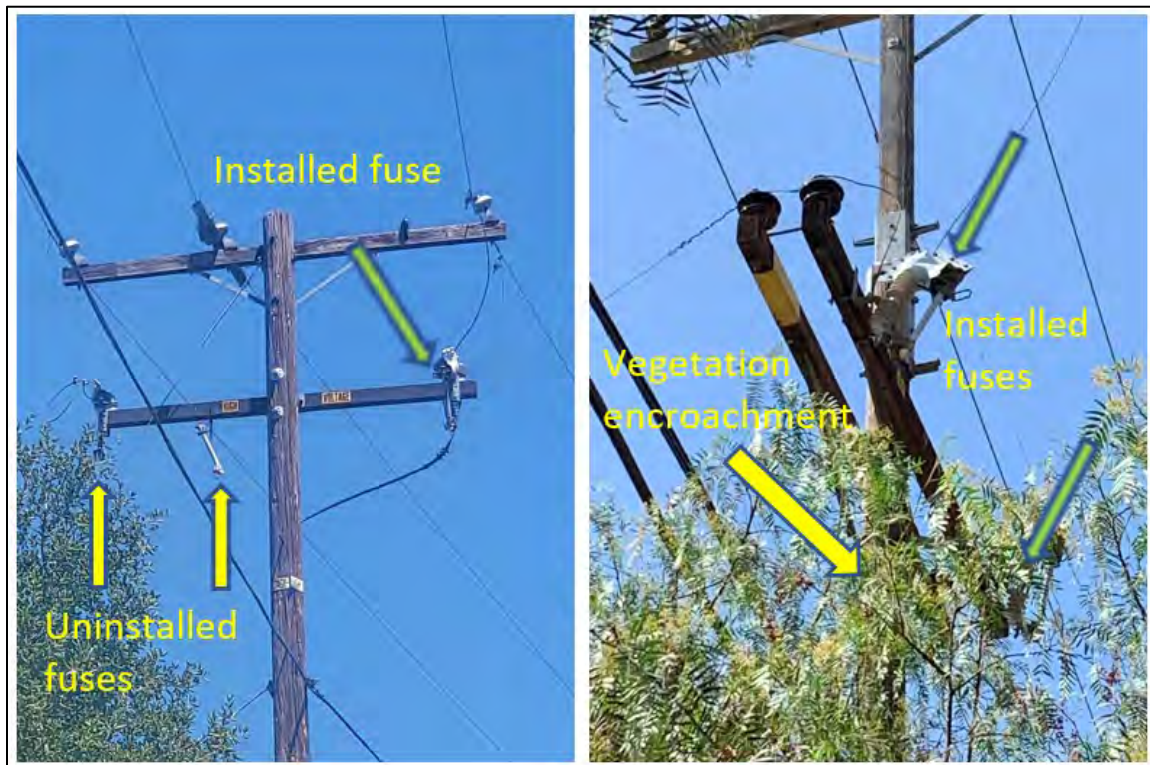
- Fuses issues observed:
 - In two sample locations fuses were not installed
 - In one sample locations fuses show signs of physical degradation
- No fuses issue observed/Other issues observed
 - In one sample location the base of the pole was eroding
 - Vegetation encroachment was observed in several sample locations. Vegetation is within 10-feet of the clearance radius around the pole.
 - In two sample locations the poles integrity show signs of physical degradation
 - Lightning arrestors show signs of physical degradation in one sample location
- Asset could not be located
 - Multiple sample locations with the same coordinates
 - No poles in place for the given coordinates on three sample locations
- Unable to access and inspect the asset
 - The assets were behind a locked gate

Image 9: Fuse-related issues.

SDG&E met their installation target for replacement expulsion fuses, exceeding the target of 3,970 fuses by installing 3,976. The 3% fraction of the sample that showed quality issues has the effect of discounting the achieved total by 5% or 119 fuses.

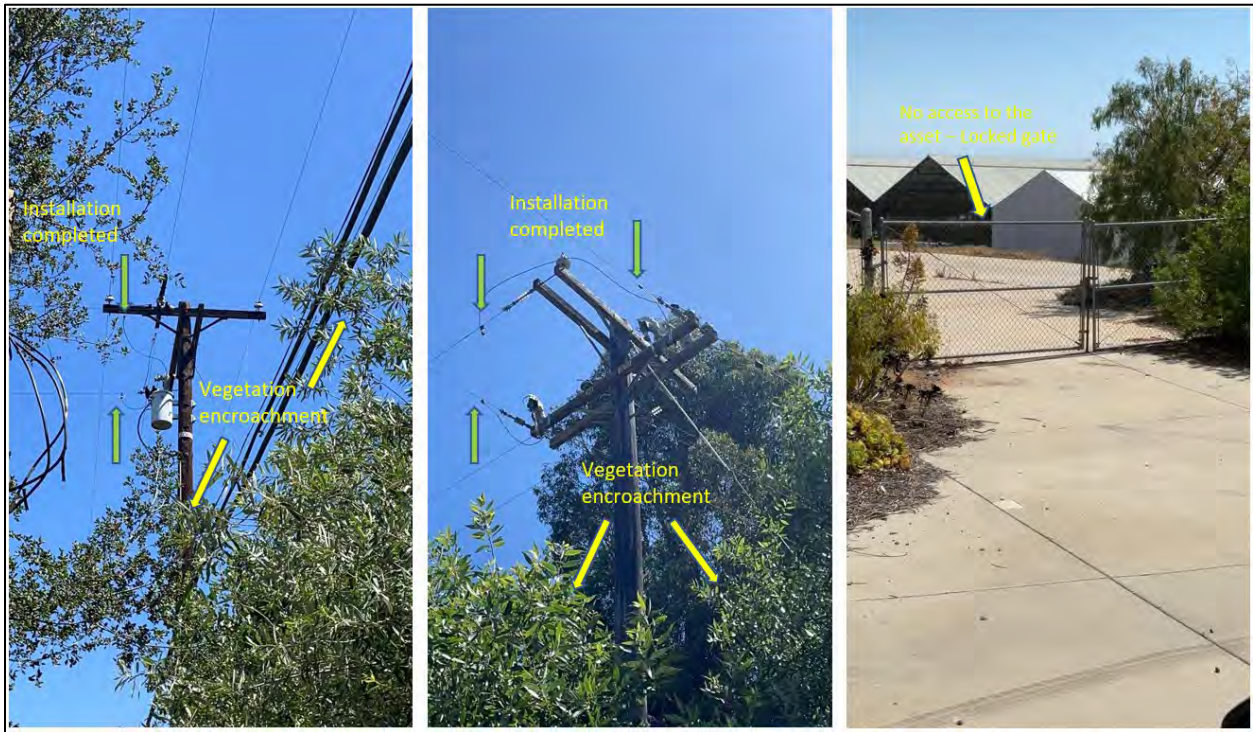
- No Hotline Clamp issues/Other issues
 - Vegetation encroachment observed in two locations. Vegetation is within 10-feet of the clearance radius around the pole.
- Asset was unable to locate
 - The poles were unable to locate at two sample locations
- Unable to access and inspect the asset
 - The assets were behind locked gates at four sample locations

Image 11: Hotline clamps findings

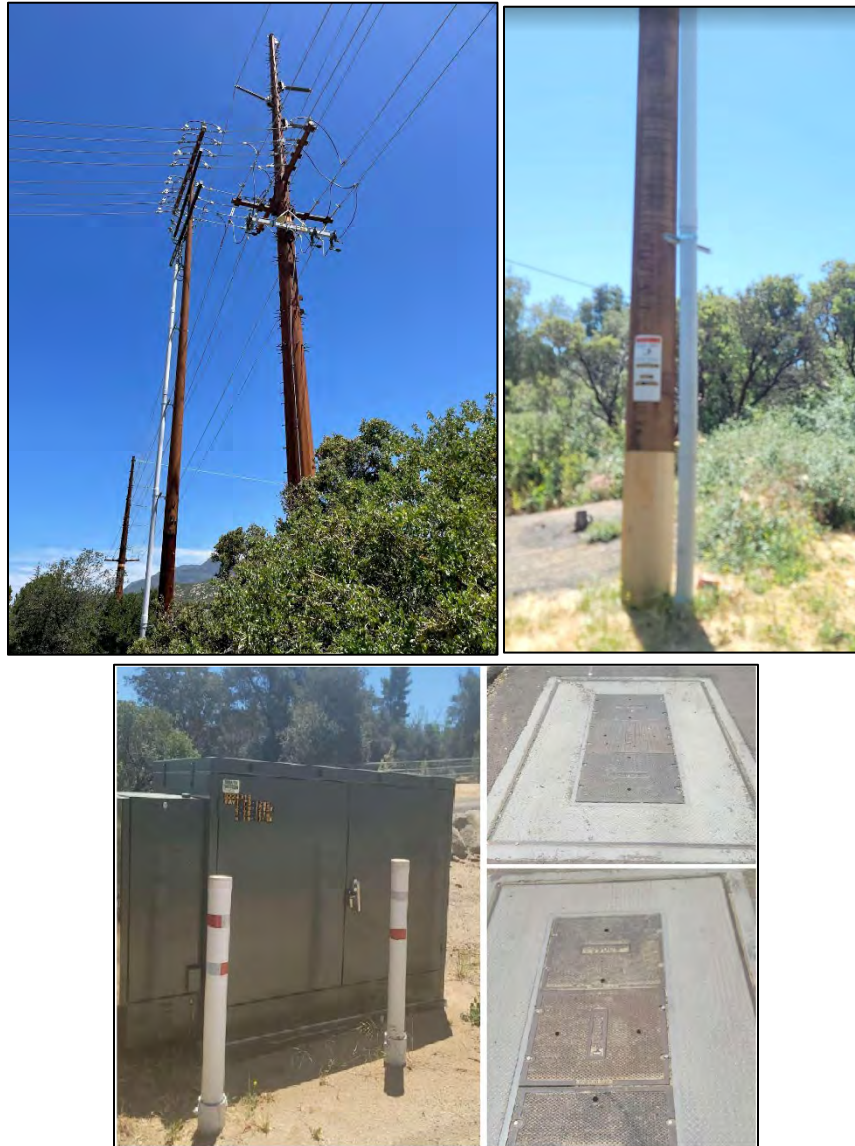
- In transition point P294891, no significant findings were observed. This location was physically verified.

Image 12: No significant findings on transition pole P294891.

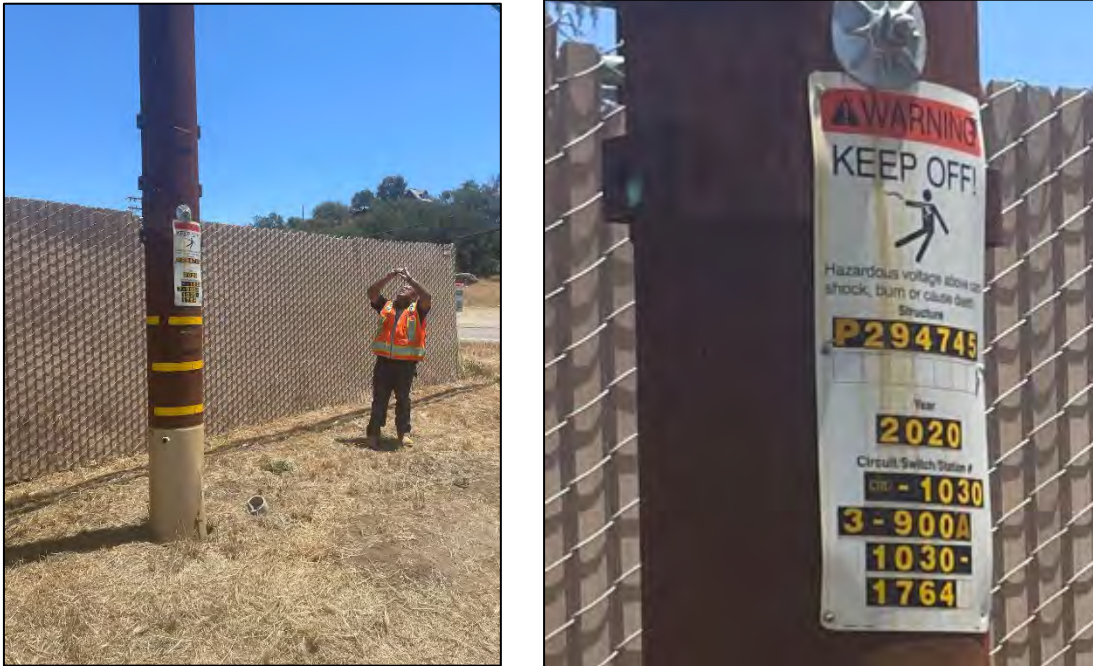
- At transition point P294745, there was no evidence of undergrounding. All installations are overhead and the pole at this location was replaced in 2020.

Image 13: No undergrounding installation observed at P294745.

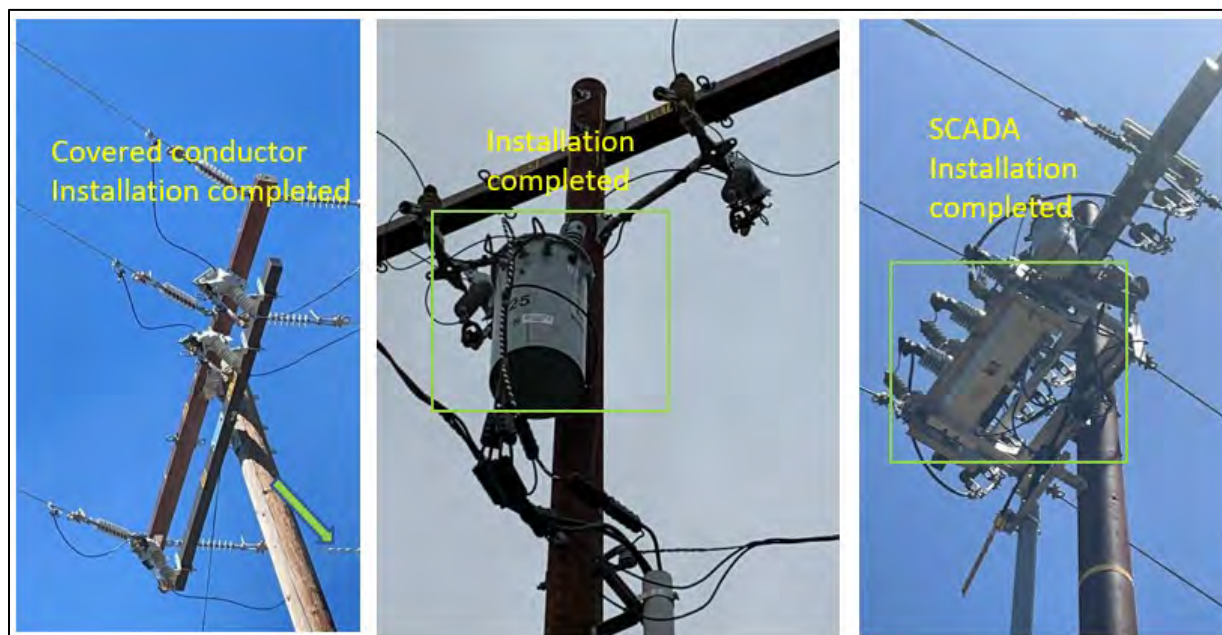
Image 14: Overhead hardening verification with no issues reported.

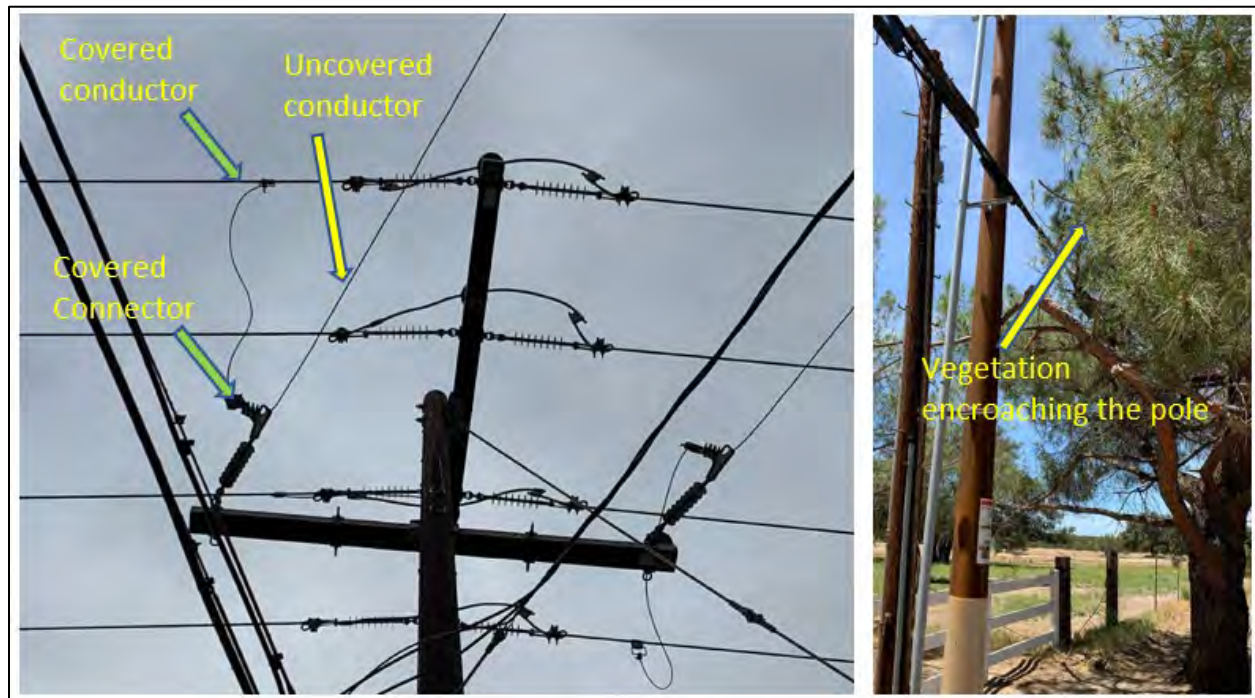
Image 15: Overhead hardening verification with observations.

The final verification sample size of 34 is statistically valid for the final population of 2,247 poles. The fraction of the sample size with quality issues constitutes 32%, that is 11 out of 34. By extrapolating this percentage to the general population, 728 out of 2,247 poles are anticipated to have the similar quality issues, as described above. This results in an adjusted total of 1,519 poles of overhead hardening activities successfully completed in 2021.

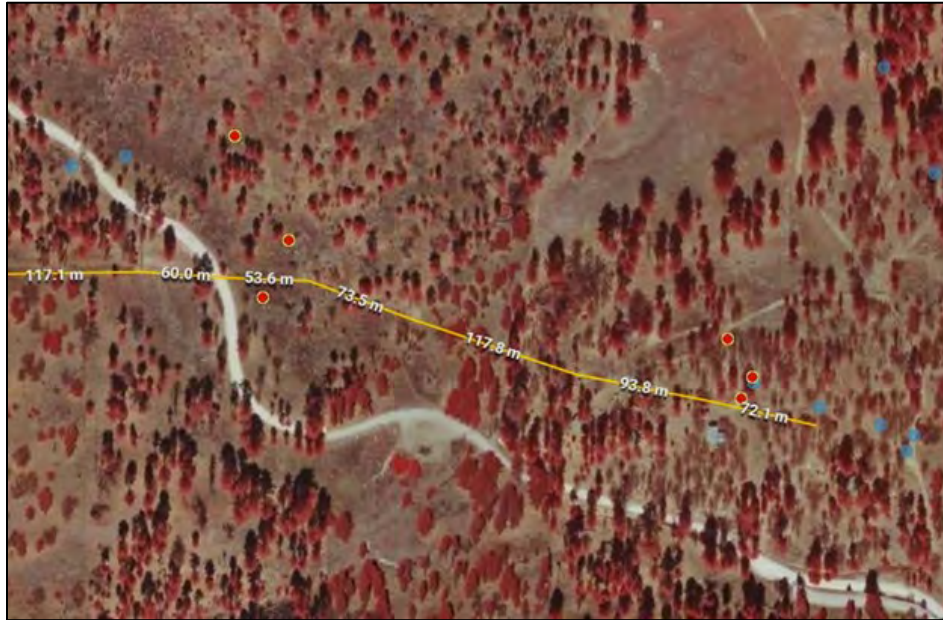
Discussion of Pole Locations – In some areas where reported work took place, it was found that points lie in areas no poles could be found. Often, the connection between poles and points could not be established, as distances between power lines and points were sometimes over 100 meters (Image 11).

Image 17: Powerline locations, pole locations and locations of grid hardening work.

In Image 17, the yellow line shows the new powerline between the locations of poles visible on images. The yellow-rimmed red points indicate poles where work has been reported as performed by SDG&E while the blue points represent poles without grid hardening work. Yellow-rimmed red points should represent locations of a poles, but IE could not verify the existence of a poles on those locations. Pole locations that do not intersect with the yellow line of the powerline itself suggest the inaccuracy of the GPS pole locations which denied IE the possibility to tie the observed poles with reported new poles.

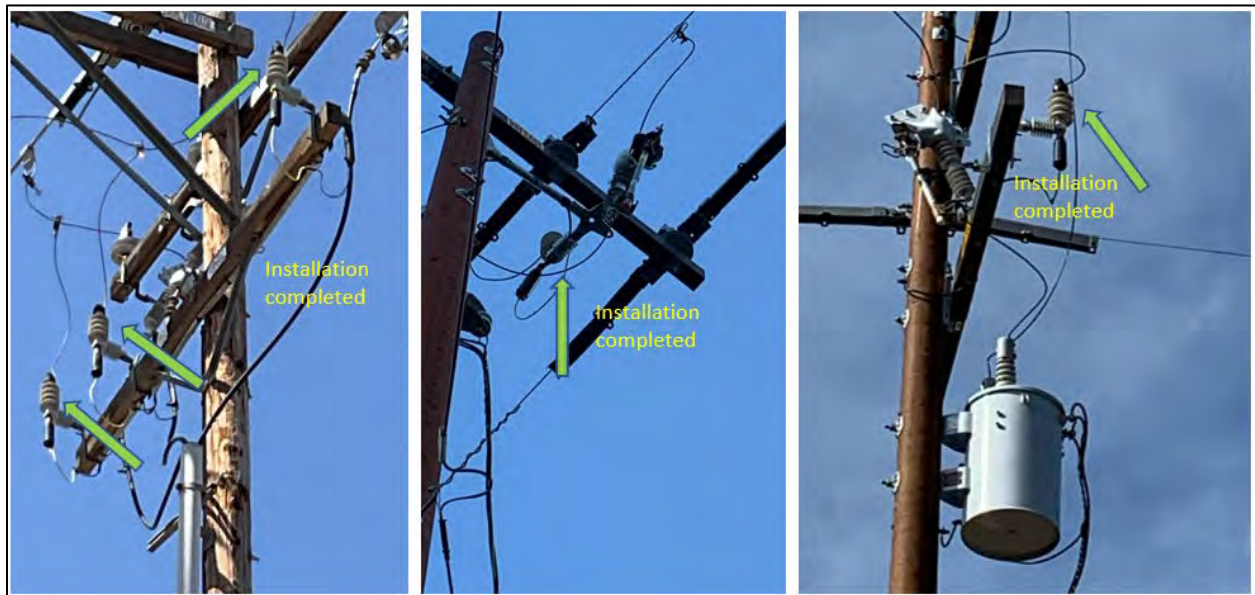
Image 20: No significant findings observed.

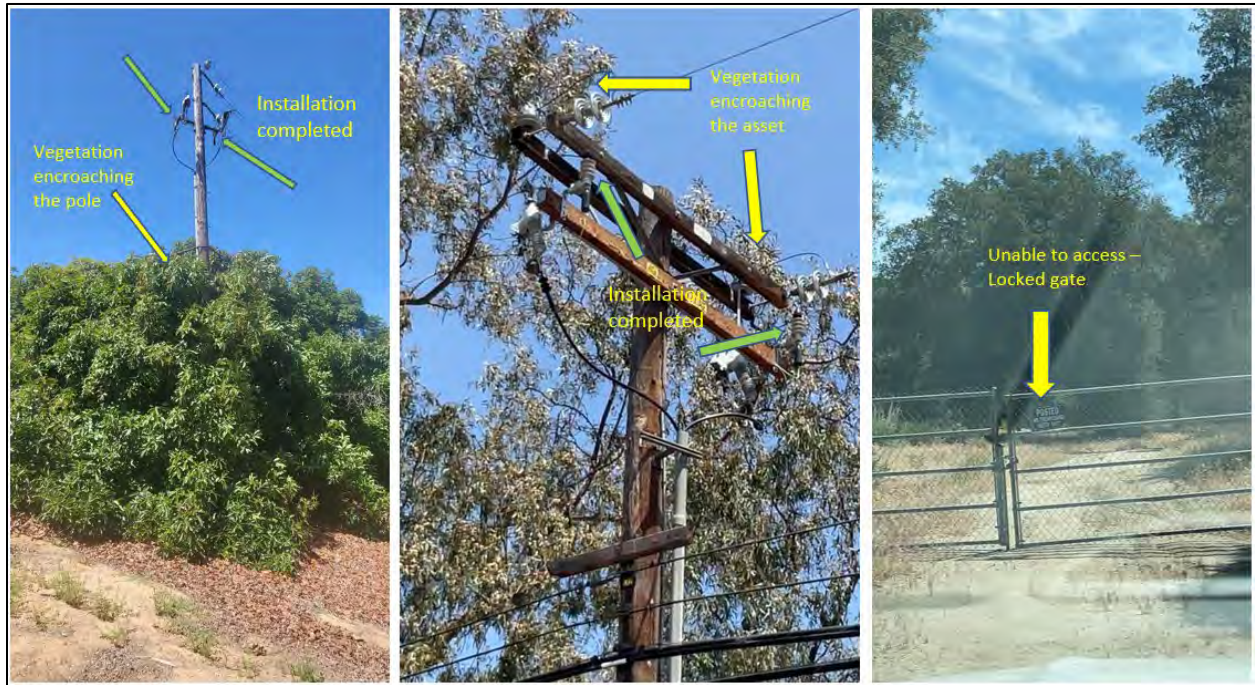
Image 21: Issues on lightning arrestor inspections.

SDG&E set the target to remove and replace 1789 new lightning arrestors in 2021. By year-end, however, the effort had fallen short of its target by 865 (48%) coming in at 924 lightning arrestors replaced for the year.

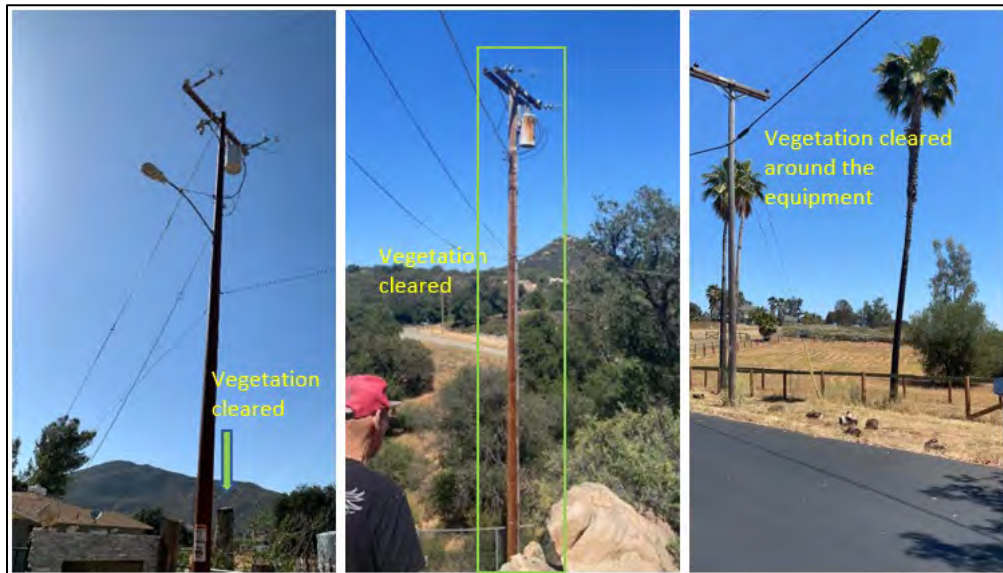
Image 23: Exceptional vegetation clearance quality.

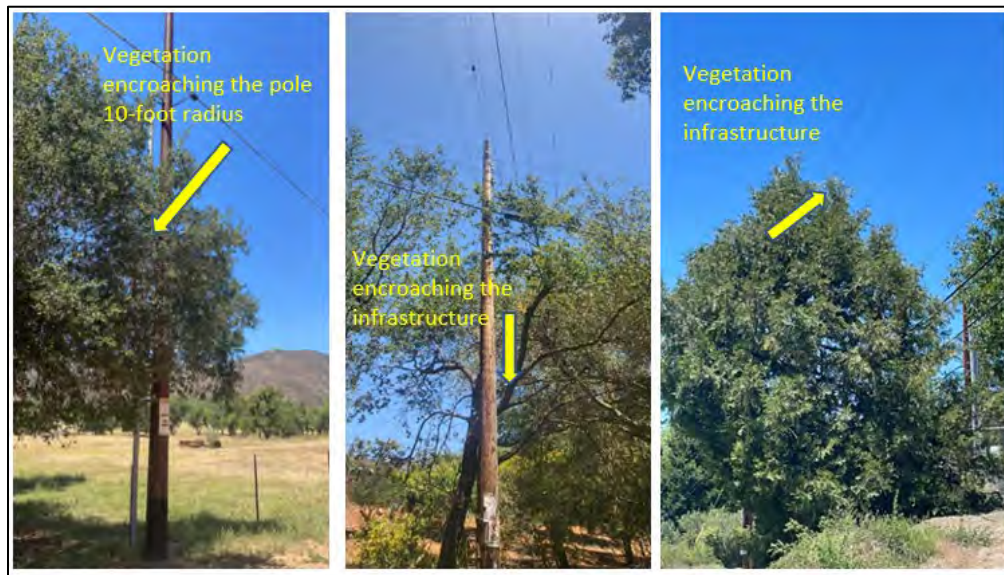
Image 24: Vegetation encroachment visible in field inspections.

The IE’s analysis documented that 13% of the sample demonstrated unacceptable vegetation management and thereby failed to meet the required standards for this initiative. Applying that percentage to SDG&E’s reported performance of 502,132 detailed inspections around distribution lines suggests that 65,277 of the inspections in that total also did not meet the standards. Discounting the reported total by the unacceptable fraction leaves SDG&E with 436,855 detailed inspections that met the required standards. This total falls short of the 455,000 2021 target. Despite all internal audits on subcontractor’s quality of vegetation management work, the IE finds substandard subcontractor’s performance, including trimming crews, arborists, and even auditors.

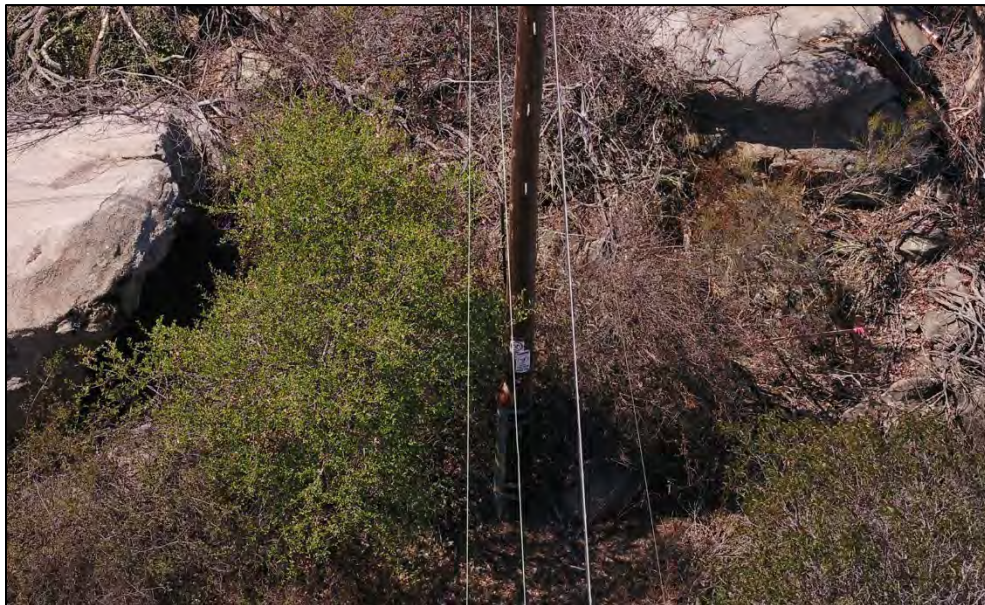
Image 28: Base of pole P612045

In addition to inspection of sampled poles, IE observed a pole which was not in a sample pool that raised a concern. The pole P612045, is located between poles P115804 and P115803. These two poles have been subject to vegetation and fuel management, while the P612045 wasn't. Pole P612045 has a substantial amount of vegetation around it, both live and dry (please see image below). but that pole was not even subjected to vegetation inspection, even though the closest vegetation inspection point was 14 meters from it. For a complete description of this analysis, please see the Analysis Report prepared for this initiative.

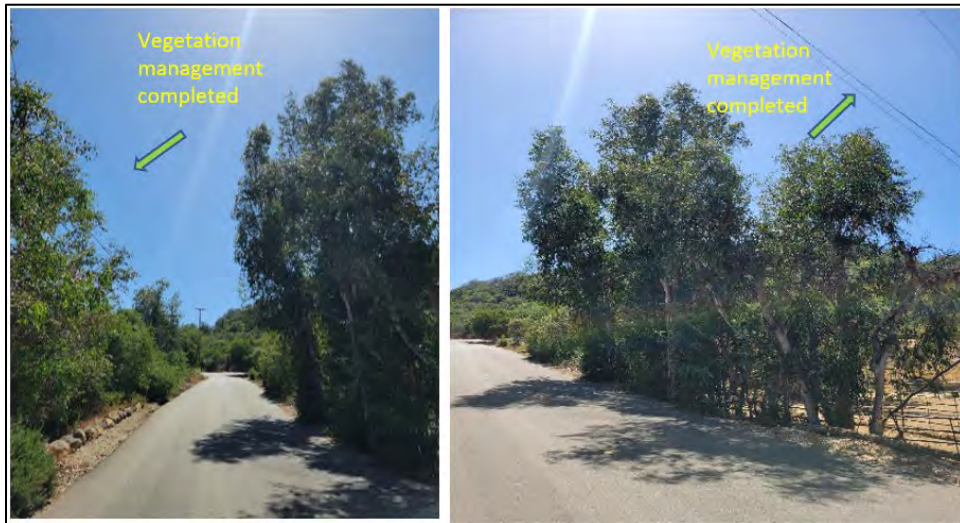
Image 30: Exceptional vegetation clearance quality.

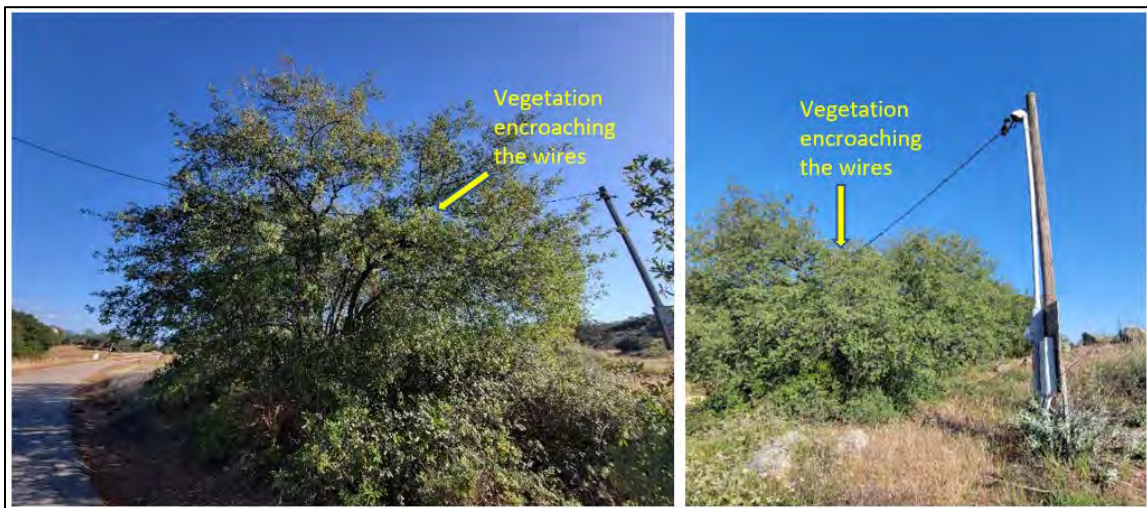
Image 31: Vegetation encroachment observed.

The IE’s analysis revealed that discretionary inspections frequently occur on private property, falling “beyond inspections mandated by rules and regulations.” While the resulting sample is too small to be statistically valid, the information gleaned suggested that the majority of discretionary inspections meet high standards of quality. However, based on SDG&E’s reported outcomes, which were shy of their target by over 400 trees, the IE verifies that that SDG&E did not their objective for this initiative.

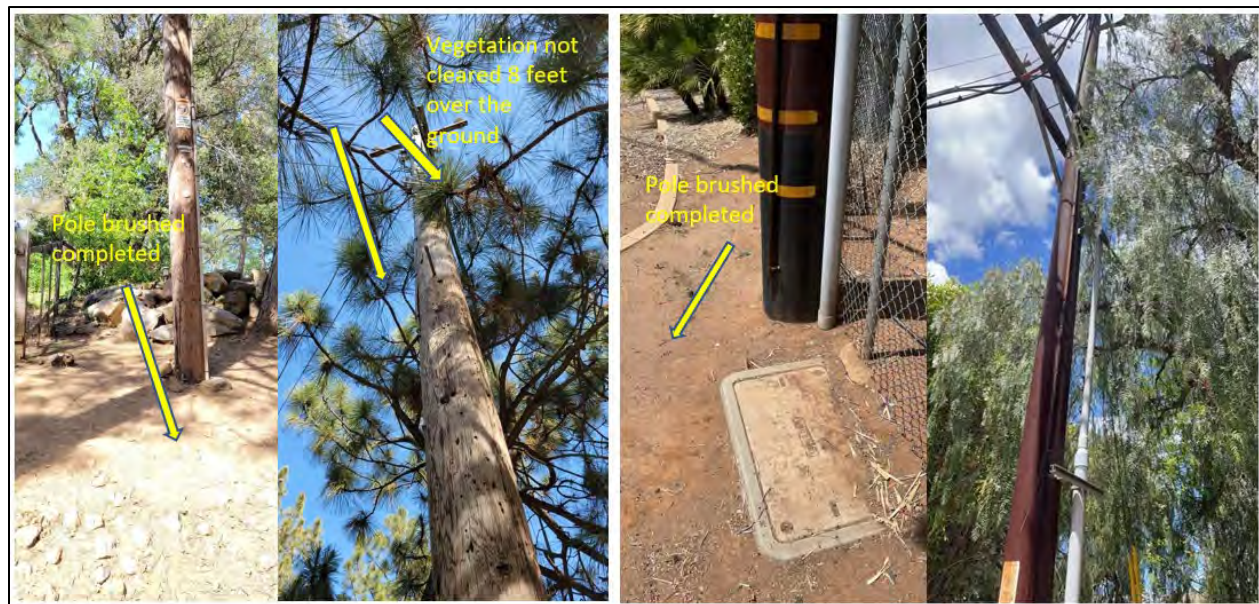
Image 33: Vegetation encroaching on the pole.

The IE’s analysis showed high quality standards for pole brushing, such that, in the majority of cases where inspectors were able to reach the pole and complete the inspection, vegetation had been fully cleared around the pole. In a small subset, however as described above, the IE’s inspectors observed that encroachment was visible.

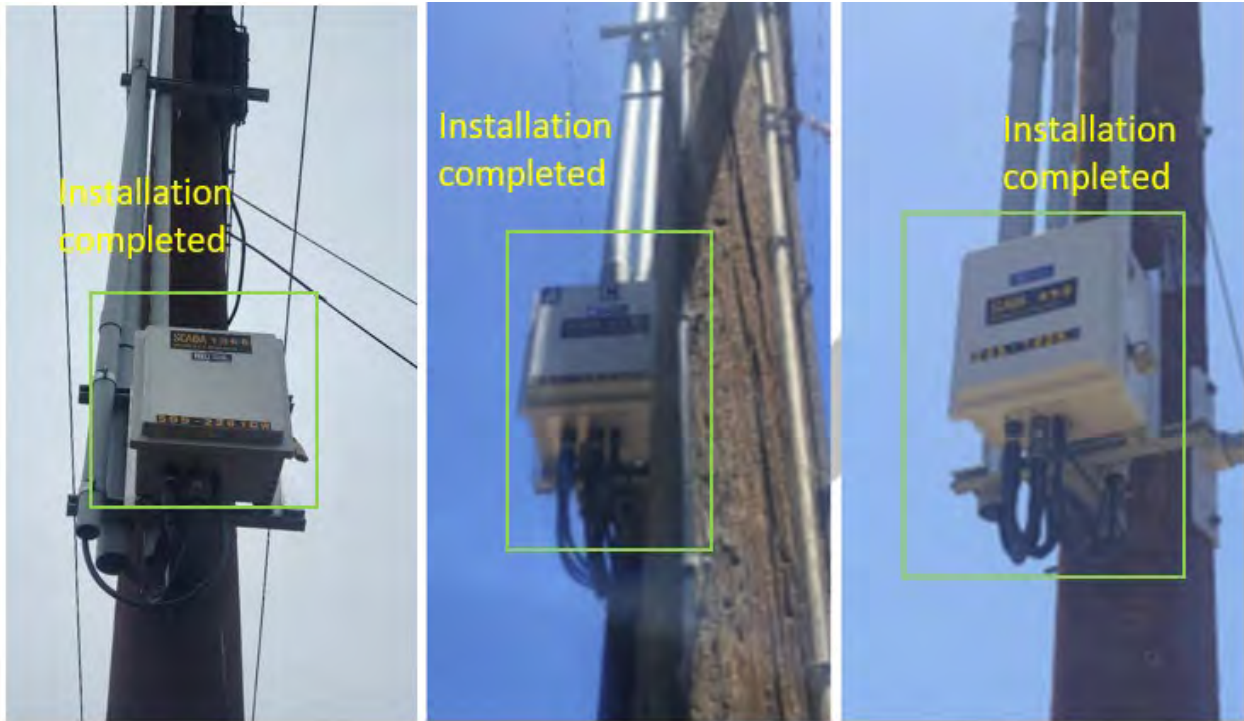
Image 42: SCADA capacitor inspected with no issues.

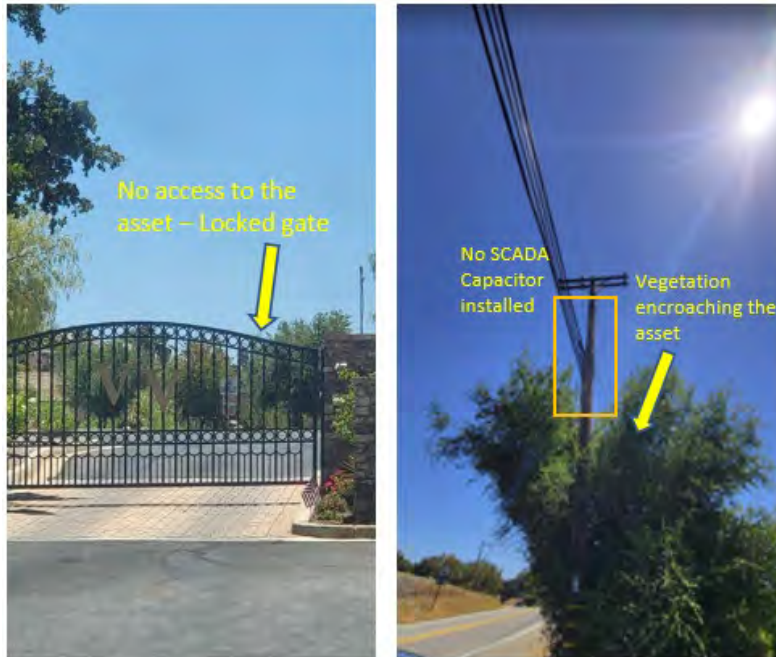
Image 43: No SCADA capacitor installed on the pole.

SDG&E exceeded their 2021 installation target for SCADA capacitors. Given the small population of these units installed in 2021 (35), a statistically valid sample consists of 16 inspections, which the IE secured. Following analysis of the inspection results, however, it can be seen that only one installation (6% of the sample) found issues with the SCADA installation, in this case absence of the unit to be verified. Another 13% of the sample was not accessible so no inspection could be conducted. As a result, the IE found that 19% of the sample could not be verified.

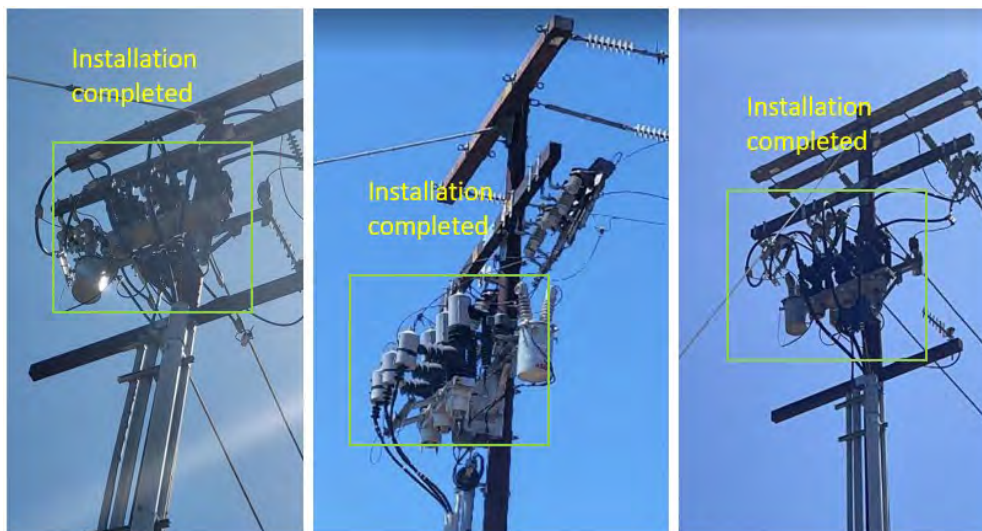
Image 44: Sectionalizing Enhancements with no issues.

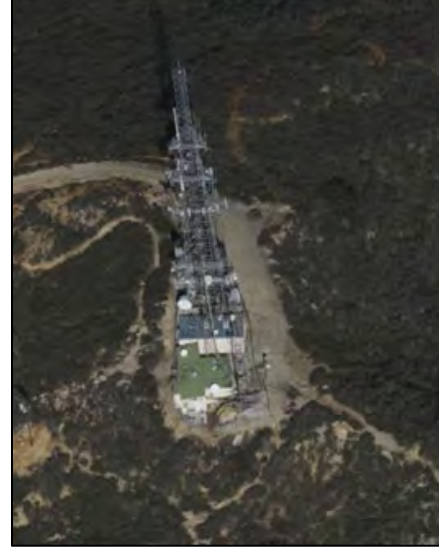
*Image 49: DCRI - 000005 with multiple antennas.*

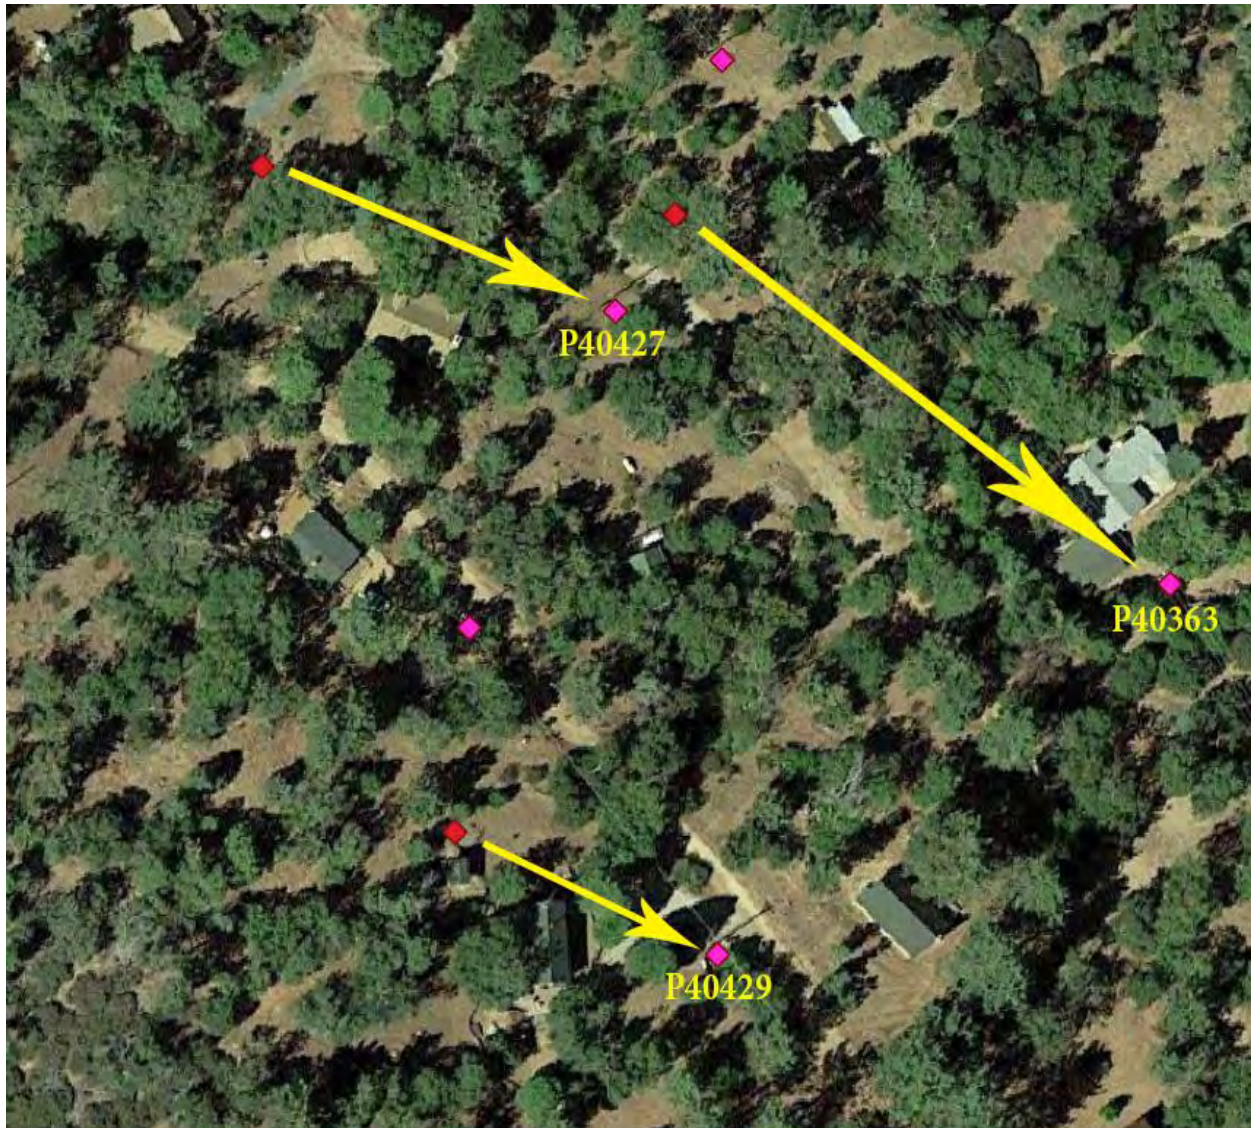
Three (3) poles, P40427, P40429, and P40363 which were tested for precision showed a very high mismatch between the position of the presented work and the position of the actual poles. In Image 2 red diamonds are positions of work reported in DR15, while purple diamonds represent the actual position of poles. Both GPS locations were provided by SDG&E. This level of error in a forested area could potentially mean loss of time and inaccuracy of fieldwork. Images 3 and 4 show poles P40427 and P40429 in CIR taken in spring 2022. In image 3 pole P40427 is presented by a lower blue dot, while the red dot placed among high vegetation should present the location of P40363. The upper blue dot in image 3 represents pole P40426.

Image 2. Mismatch of positions

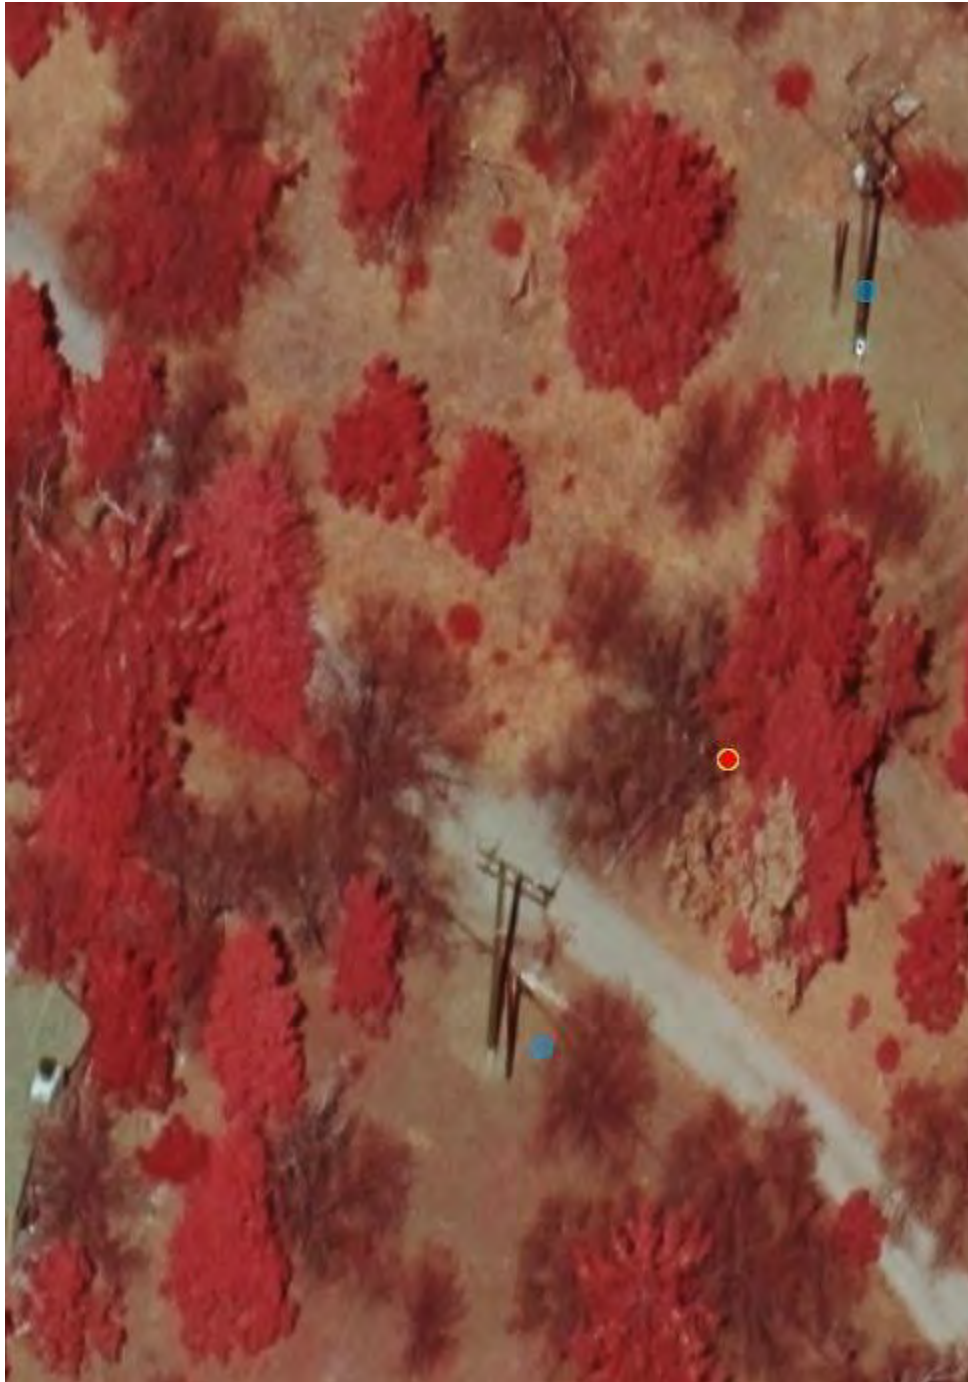
Image 3. CIR image of pole P40427 (lower blue dot)
