To: The Public, Local and State Agencies, and Stakeholders for San Diego Gas and Electric's 2021 Wildfire Mitigation Plan Independent Evaluator Annual Report on Compliance

July 15, 2022

FINAL INDEPENDENT EVALUATOR ANNUAL REPORT ON COMPLIANCE

SDG&E

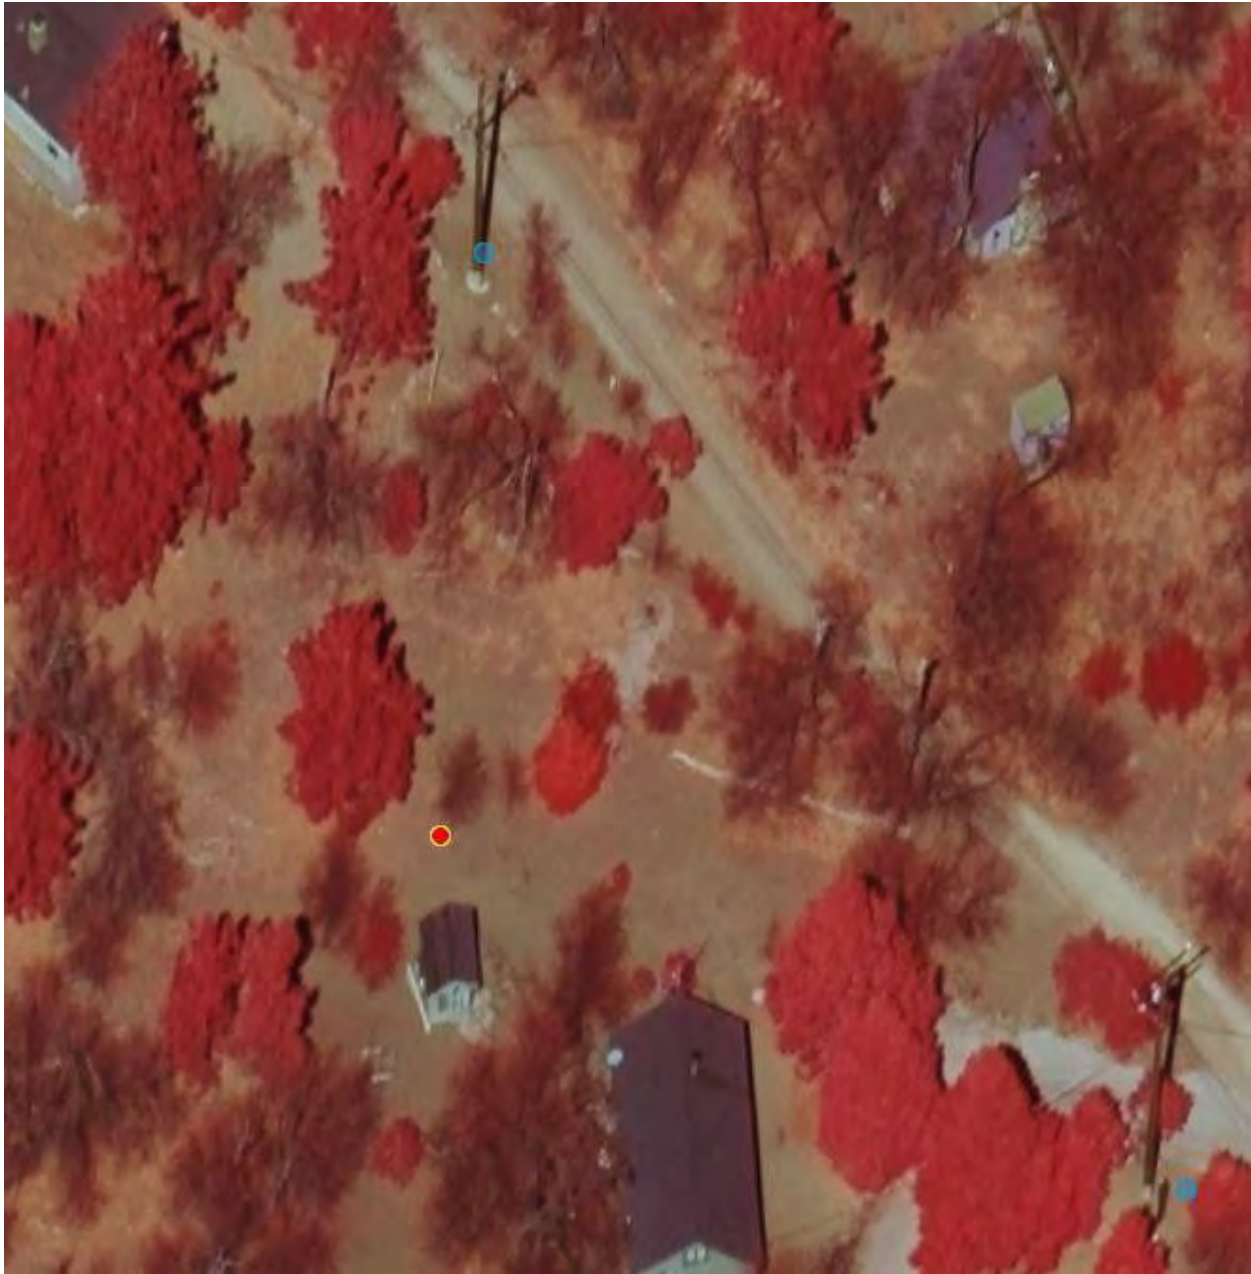
Image 4. CIR image of pole P40429 (lower right corner)

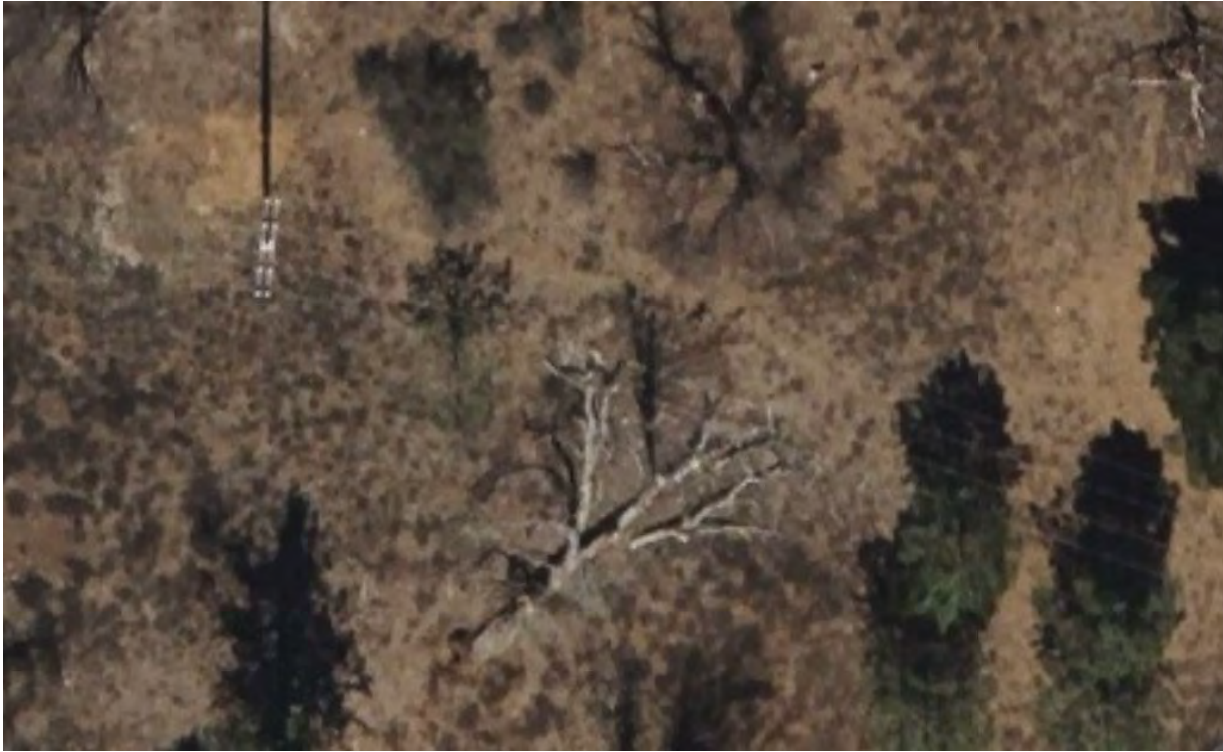
Image 21. Dead tree beneath the powerlines

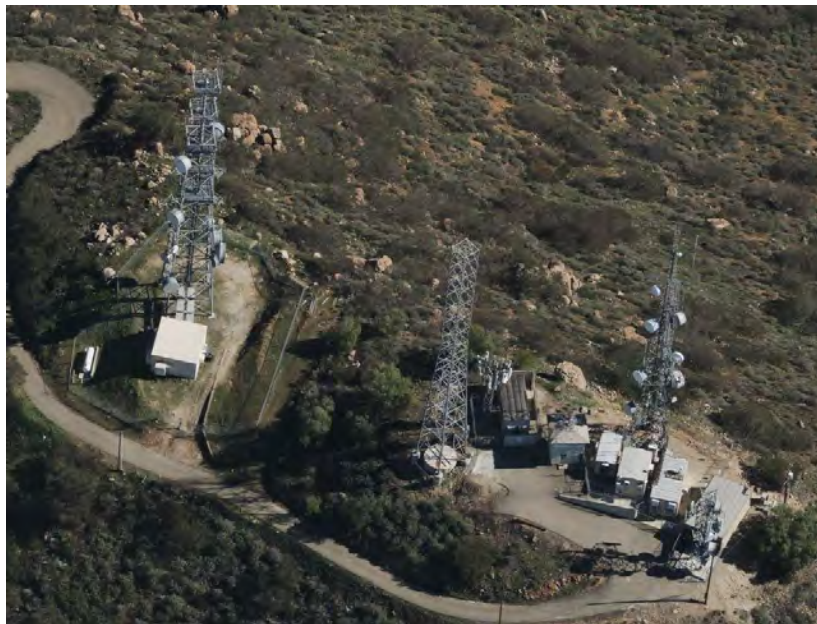
Image 3. DCRI – 000006 Multiple towers with multiple antennas

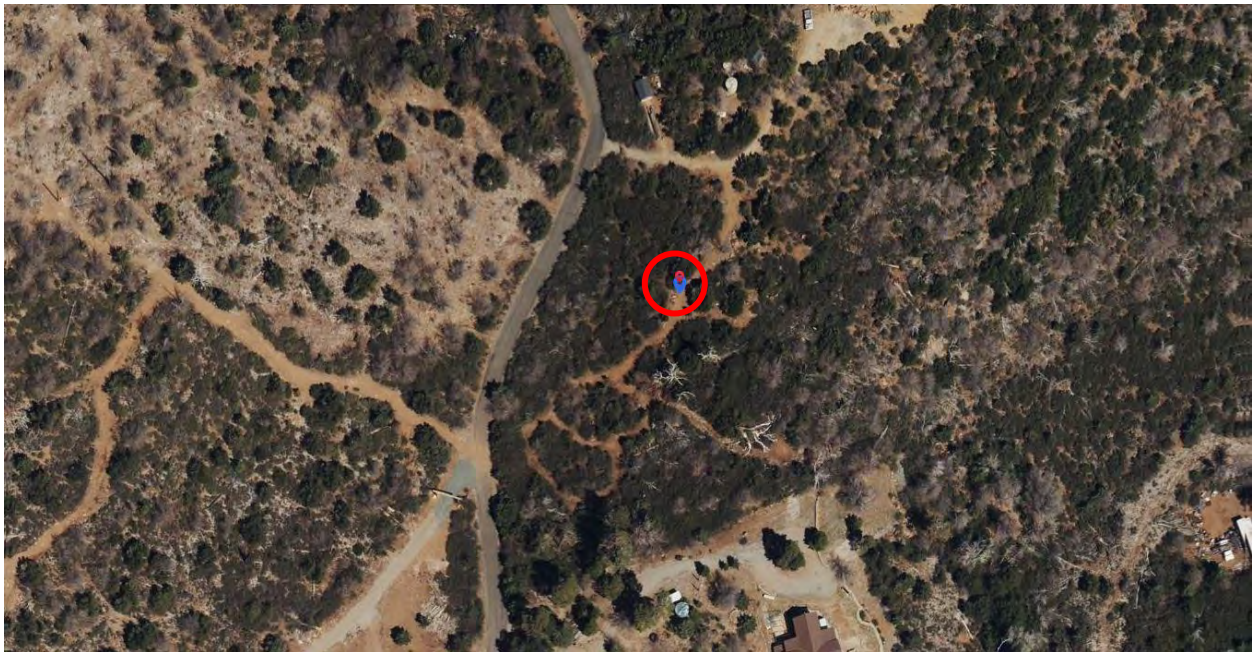
Image 5. DCRI-000009 No base station

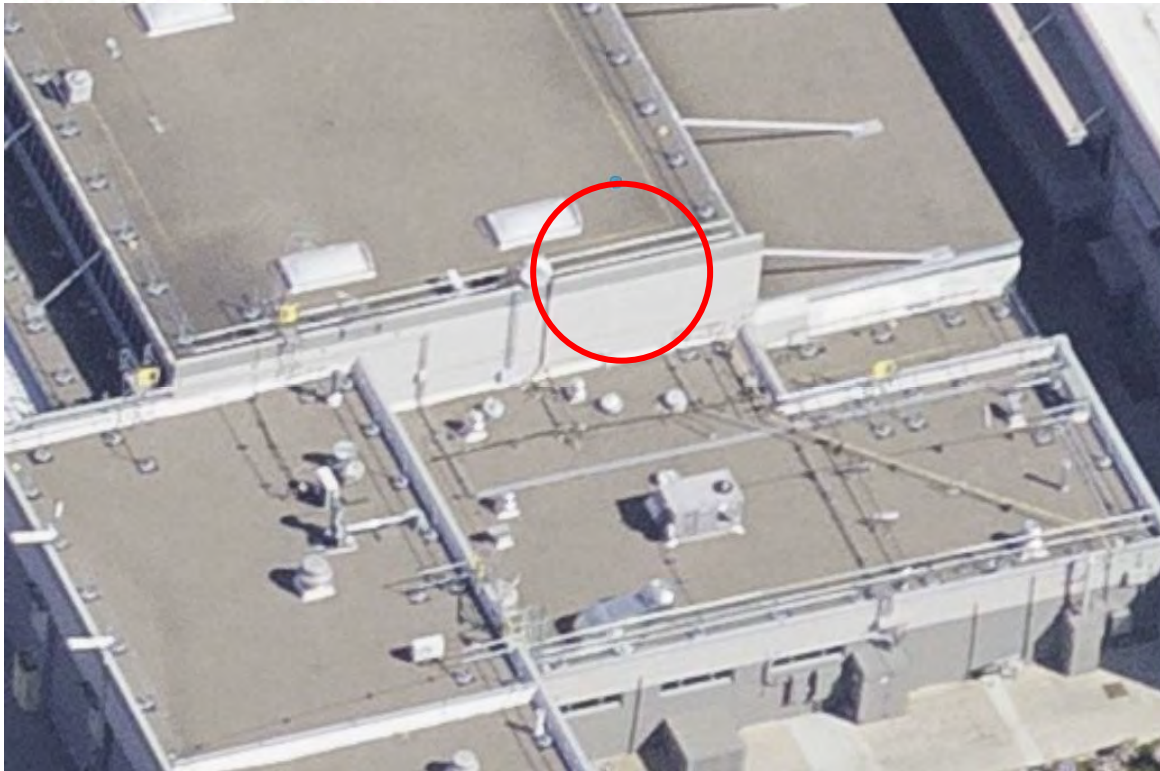
Image 6. DCRI-000001, Red circle shows the only object resembling an antenna
