OFFICE OF ENERGY INFRASTRUCTURE SAFETY

NOD_SCE_ATJ_20220414-01

NOTICE OF DEFECT

Energy Safety Inspection Report

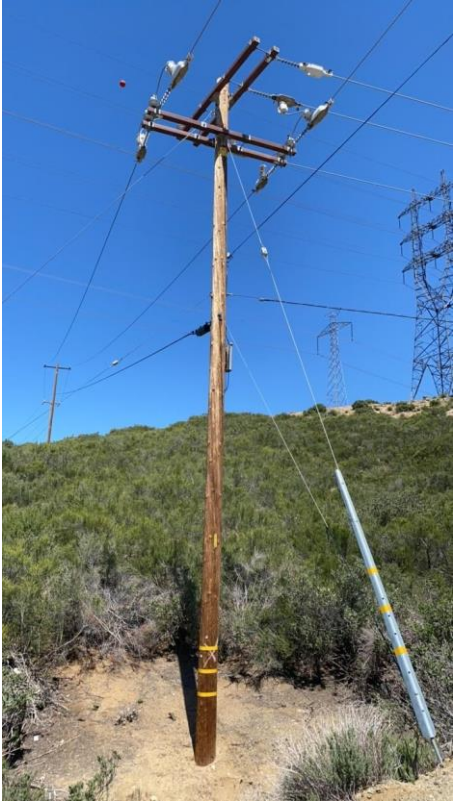
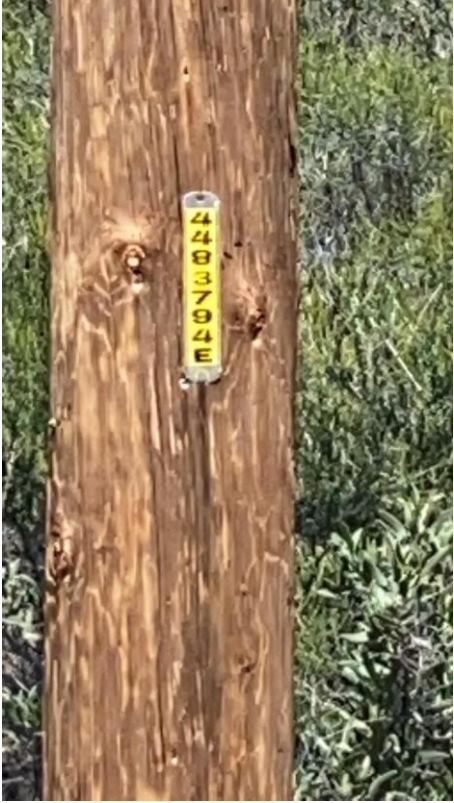
Structure ID: 4483794E

<p>Item1Gimg1: Overall photo</p>	<p>Item1Gimg2: Pole ID</p>

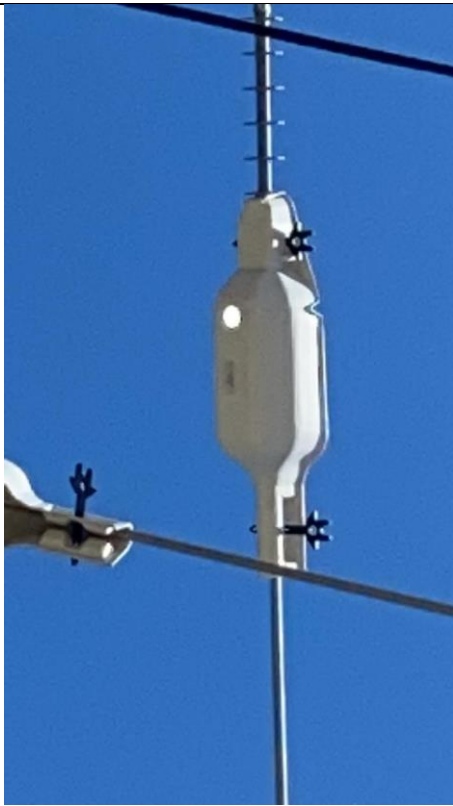
1. Defect 1: Pole numbered 4483794E had a dead-end cover that was upside down and did not have anti-rotational clip installed. The primary purpose of an equipment cover is to prevent contact between the equipment and foreign objects. When a dead-end cover rotates and exposes the top of the connection, it increases the risk of ignition. Energy Safety considers this defect to be in the Minor risk category.
2. Defect 2: Pole numbered 4483794E showed six dead end covers not having anti-rotational clips. Per SCE's DOH, Table DC 535-1: Wildlife Protection Material, SCE

Energy Safety staff performed an opportunistic inspection on previously installed covered conductor and found the following. Per SCE's DDS, Section 10, 5.7.C.1.f. states, "Covered conductor systems shall be an all-covered system." Per SCE's DOH, Section CC 150.4, page 5 of 5, "All overhead equipment shall utilize appropriate wildlife covers. This means that wildlife covers shall be installed on dead-ends, terminations, connectors, equipment bushings, and any partially covered exposed conductor." Energy Safety observed a phase where a dead-end cover was upside down. This structure is noted in Table 2 above.

Upside down dead-end cover

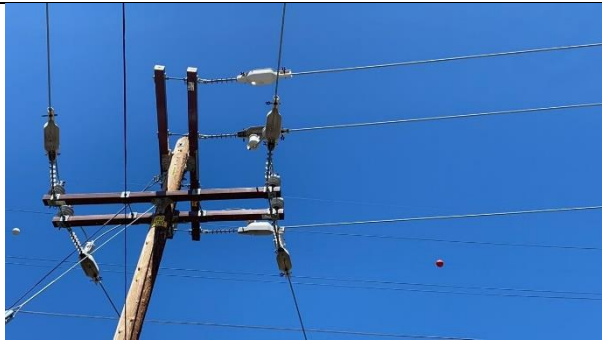
Overall photo of structure

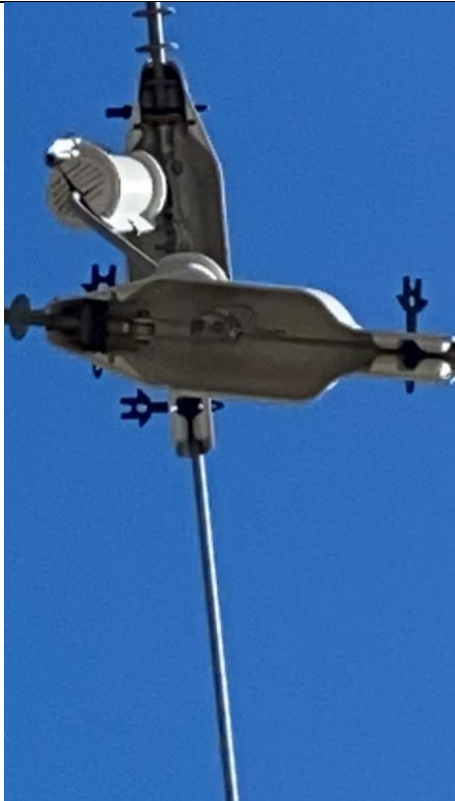
At the same structure, there were six dead-end covers that were missing anti-rotational devices. Per SCE's DOH, Table DC 535-1: Wildlife Protection Material, SCE requires that anti-rotation clips be used with Dead-End Clamp Covers.⁴ Structures where this protocol was not followed are noted in Table 2 above.

Close up of dead-end cover having no anti-rotational device

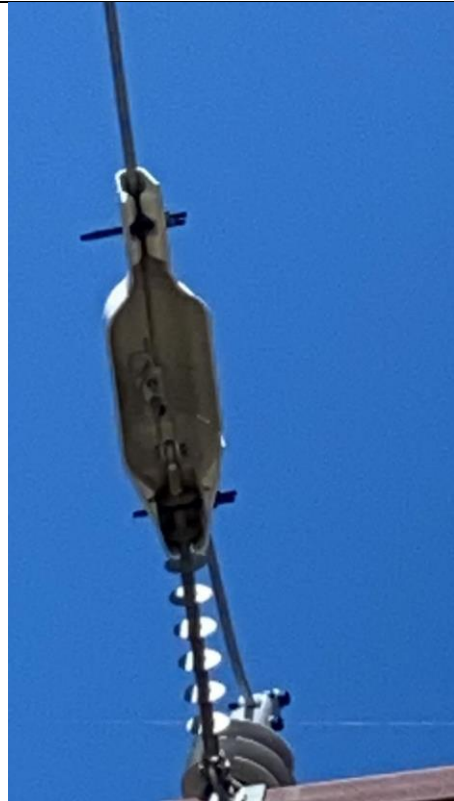
Close up of another dead-end cover having no anti-rotational device
