NOV\_SCE ATJ\_20220420-01

## **NOTICE OF VIOLATION**

# Energy Safety Inspection Report

Report Name: SCE\_ATJ\_ 20220420-01  
Date(s): April 20, 2022  
Inspector: Anthony Trujillo  
Utility: Southern California Edison  
Attention: Erik Takayesu, Vice President Asset Strategy and Planning

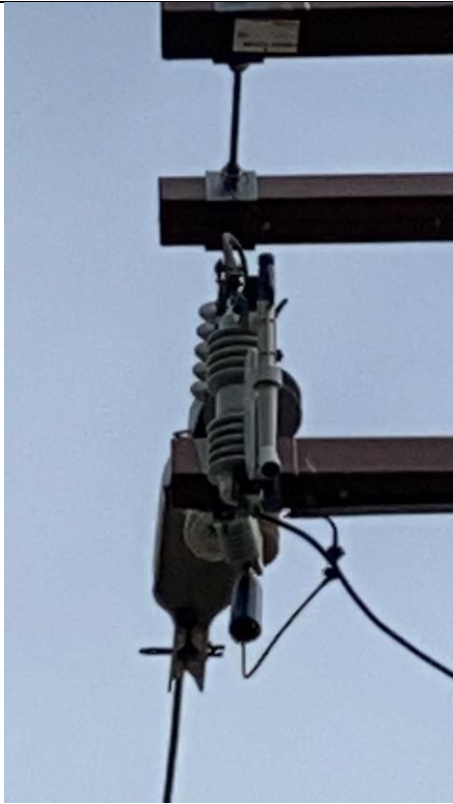
1. Violation 1: Per SCE’s Distribution Overhead Construction Standards (DOH), Section CC 150.4, All overhead equipment shall utilize appropriate wildlife covers.” Pole number 4346696E had a fuse cover that fell off and was found approximately 50 feet from the pole. Energy Safety considers this a violation for failure of adhering to protocol and in the Minor risk category.

Per SCE's DOH, Section CC 150.4, page 5 of 5, "All overhead equipment shall utilize appropriate wildlife covers." Also, DDS, Section 10, 5.7.C.1.f., "Covered conductor systems shall be an all-covered system. This means that wildlife covers shall be installed on dead-ends, terminations, connectors, equipment bushings, and any partially covered exposed conductor." Energy Safety staff found one instance where a wildlife fuse cover was missing and found about 50 feet from the structure. The structure where this violation was observed is noted in Table 2 above.

**Item4IA1Img1:** Missing fuse cover

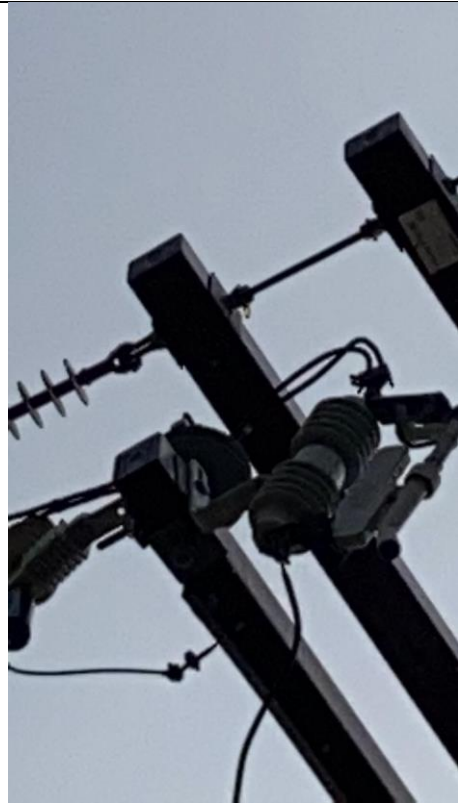
**Item4IA1Img2:** Missing fuse cover

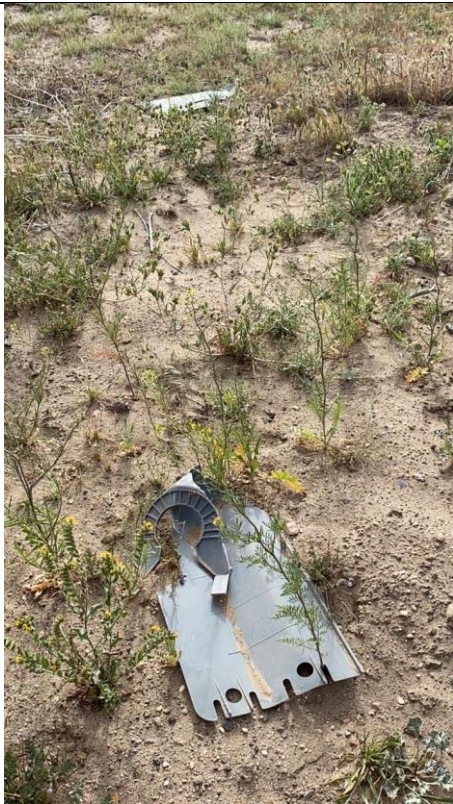
**Item4IA1Img3:** Fuse cover found on floor

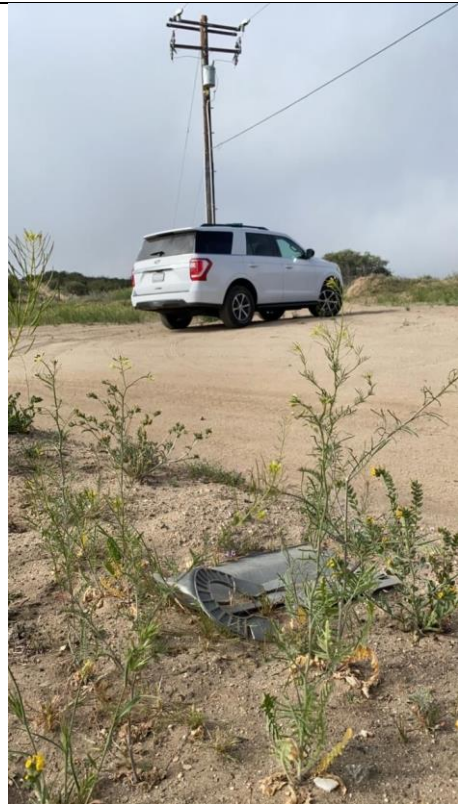
**Item4IA1Img4:** Fuse cover location relative to pole

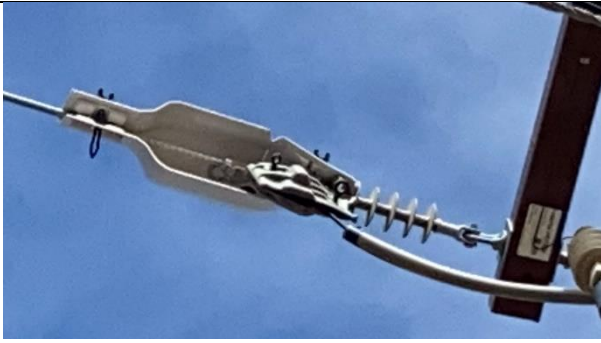
2. Violation 2: Per SCE’s DOH, Table DC 535-1: Wildlife Protection Material, SCE requires that anti-rotation clips be used with Dead-End Clamp Covers.<sup>1</sup> Pole numbered 4071366E did not have an anti-rotational clip installed in a dead-end cover. Energy Safety considers this violation for failure of adhering to protocol to be in the Minor risk category.

Per SCE's DOH, Table DC 535-1: Wildlife Protection Material, SCE requires that anti-rotation clips be used with Dead-End Clamp Covers.<sup>1</sup> Energy Safety discovered a dead-end cover that was missing an anti-rotational device. The structure where this violation was observed is noted in Table 2 above.

**Item71A2Img2:** No anti rotation clip installed, jumped underneath cover

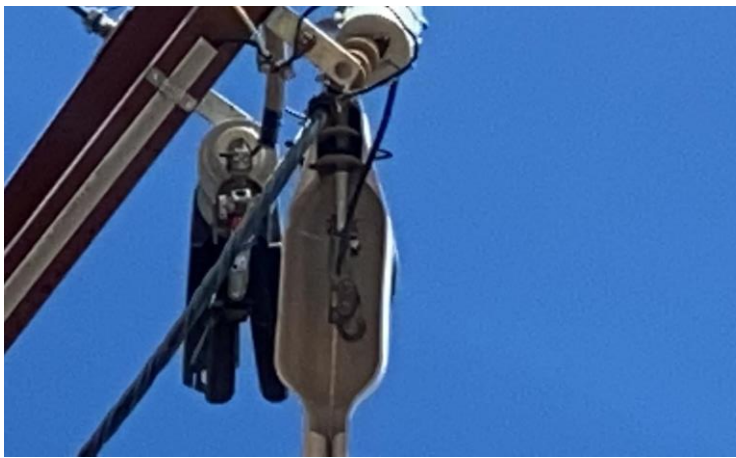
**Item71A2Img3:** Northwest dead-end cover with no anti-rotational clip installed

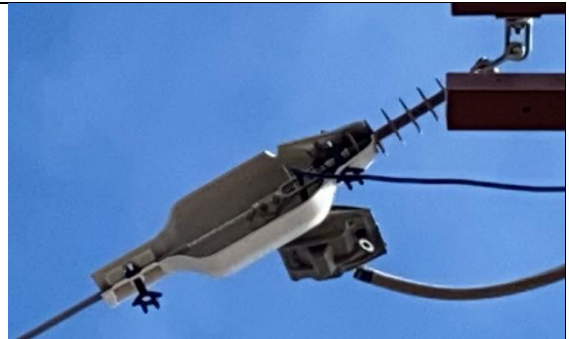
**Item71A2Img4:** Other, Northwest dead-end cover with anti-rotational clip installed

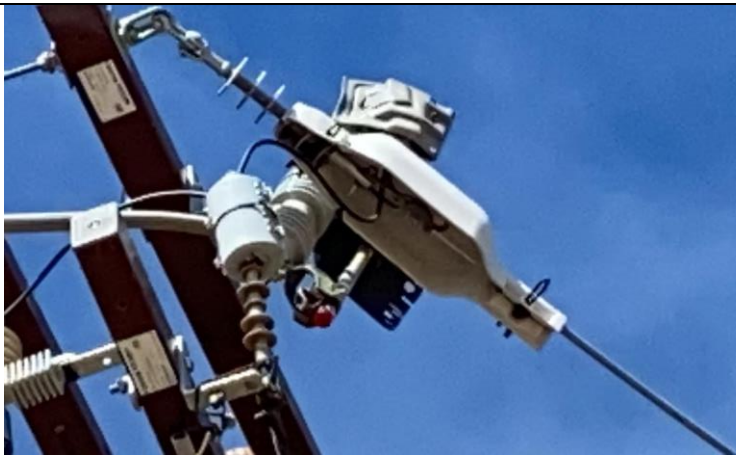
3. Violation 3: Per SCE’s DOH, Section CO 100, page 3 of 4, “When dead-ending, the tail of the conductor shall be oriented in the direction that the conductor is intended to be routed. Efforts should be made to ensure that the tail and/or connector does not make contact with the dead-end rails/legs.” Poles numbered 4071366E and 4135843E had

jumpers not connected in the direction that the conductor was routed. Energy Safety considers this violation for failure of adhering to protocol to be in the Minor risk category.

Per SCE's DOH, Section CO 100, page 3 of 4, "When dead-ending, the tail of the conductor shall be oriented in the direction that the conductor is intended to be routed. Efforts should be made to ensure that the tail and/or connector does not make contact with the dead-end rails/legs." Energy Safety discovered two instances where dead-end jumpers (i.e., conductor) were not oriented in the direction that the conductor was routed. The structures where this violation was observed is noted in Table 2 above.

Jumper is not oriented in the direction that the conductor is intended to be routed

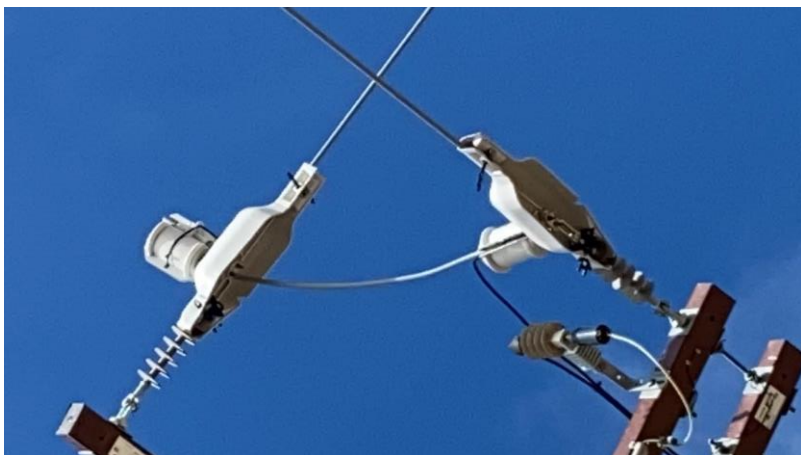
Item8IA1Img1: Jumper is not oriented in the direction that the conductor is intended to be routed
