NOV_SCE ATJ_20220411-01

NOTICE OF VIOLATION

Energy Safety Inspection Report

Report Name: SCE_ATJ_ 20220411-01
Date(s): April 11, 2022
Inspector: Anthony Trujillo
Utility: Southern California Edison
Attention: Erik Takayesu, Vice President Asset Strategy and Planning

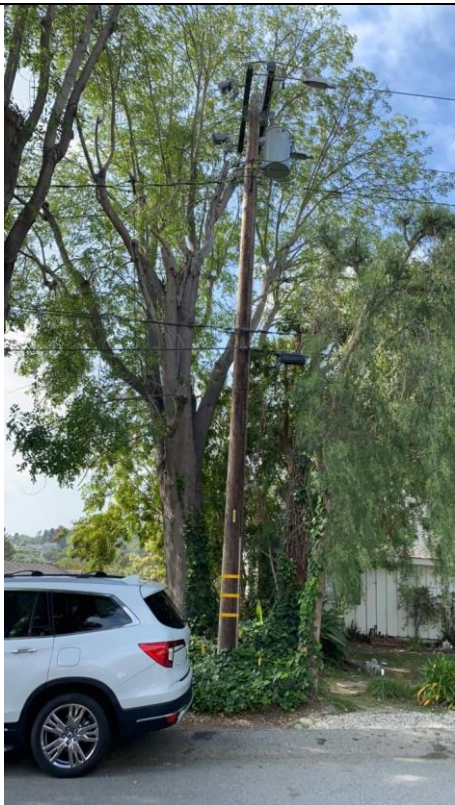
A close-up photograph of a yellow identification tag attached to a wooden utility pole. The tag has the number "683849E" printed vertically in black.
<p>Item1GImg1: Overall Pole</p>	<p>Item1GImg2: Pole ID</p>

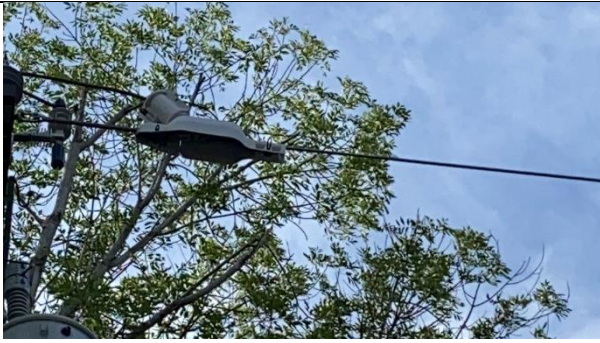
1. Violation 1: Per SCE's 2021-Q2 quarterly data report (QDR), covered conductor was installed and terminated one structure over from structure numbered 683849E. However, upon inspection, it was found that covered conductor work terminated at this structure. Energy Safety considers this violation for data accuracy to be in the Minor risk category.

In its 2021, Q1-Q4 quarterly data reports (QDR) submissions, SCE provided initiative data indicating that a covered conductor installation project (WMP initiative number 7.3.3.3.1) in the city of Rolling Hills, CA was completed. This QDR submission represented the reporting periods of January through December (i.e., Q1-Q4) of 2021. Based on this information received from SCE, Energy Safety planned an inspection of select structures in this area to assess the accuracy of SCE data, the completeness of SCE's work, and whether SCE followed its protocols for covered conductor installation. Upon arriving to the inspection location, Energy Safety observed that covered conductor did not terminate at the reported structure, but at one structure over. This structure is noted in Table 2 above.

Item1IA1Img1: Covered conductor installed at this pole

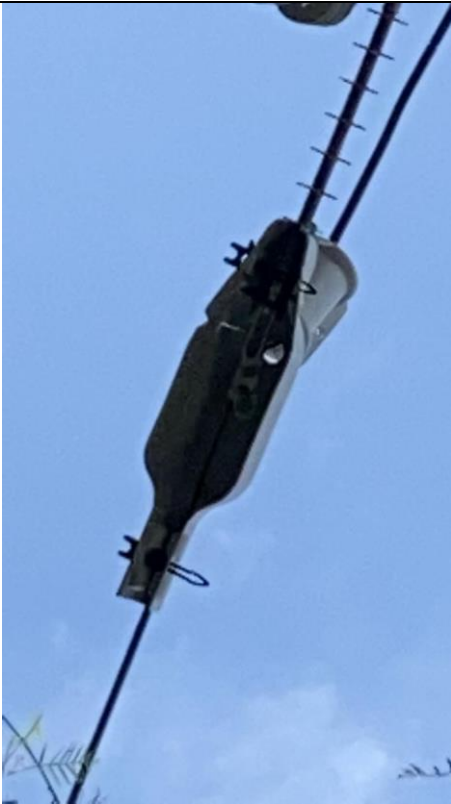
2. Violation 2: Per SCE's DOH, Table DC 535-1: Wildlife Protection Material, SCE requires that anti-rotation clips be used with Dead-End Clamp Covers.¹ Pole numbered 683849E did not have an anti-rotational clip installed on dead-end cover. Energy Safety considers this violation for failure of adhering to protocol to be in the Minor risk category.

Energy Safety discovered a dead-end cover that was missing an anti-rotational clip. Per SCE's DOH, Table DC 535-1: Wildlife Protection Material, SCE requires that anti-rotation clips be used with Dead-End Clamp Covers.¹ Structures where this protocol was not followed are noted in Table 2 above.

Item1IA2Img1: No anti-rotational clip installed on dead-end cover

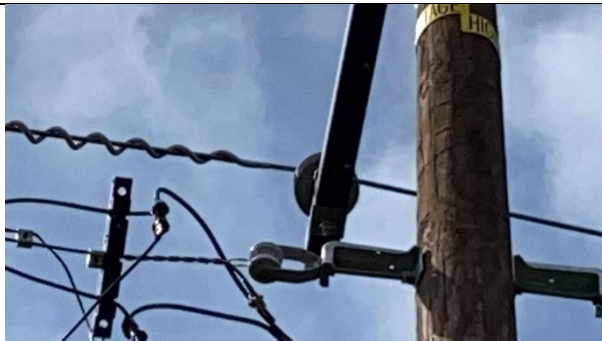
3. Violation 3: Per SCE's Distribution Overhead Standards (DOH), section CC 190, page 3 of 11, install the "vibration damper onto the conductor by wrapping the damping section onto the conductor in a clockwise fashion. Maintain a minimum of 6 inches away from

the splice side on the opposite side to the structure, or on the other end of the span." Pole number 683848E had a vibration damper installed but was found to be within six inches of an insulator. Energy Safety considers this violation for failure of adhering to protocol to be in the Minor risk category.

Per SCE's Distribution Overhead Standards (DOH), Section CC 190, 3 of 11, the vibration damper must be installed to maintain a minimum of 6 inches away from the splice on the opposite side to the structure, or on the other end of the span. This structure is noted in Table 2 above.

Item2IA1img1: Vibration dampener within 6 inches of insulator
