NOV_SCE ATJ_20220405-01

NOTICE OF VIOLATION

Energy Safety Inspection Report

Report Name: SCE_ATJ_ 20220405-01

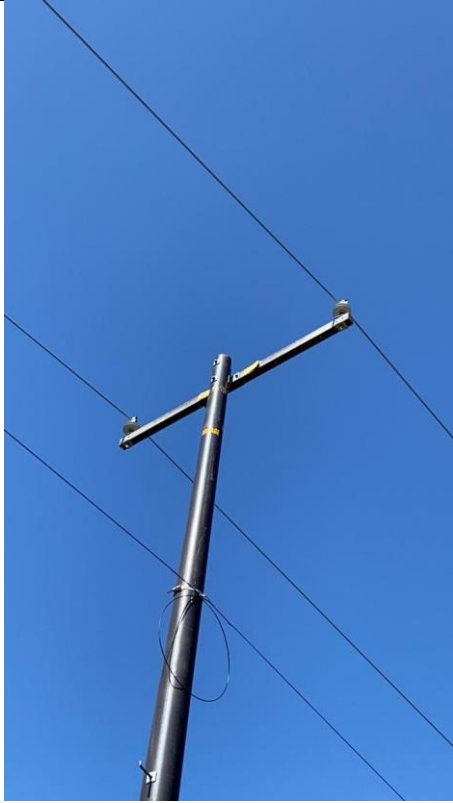
Structure ID: 4541503E

Per SCE's DDS and DOH, when installing covered conductor, vibration dampers must also be installed.¹ Energy Safety staff found that vibration dampers were not installed at multiple structures where covered conductor was completed. The structures missing vibration dampers where covered conductor was installed are identified in Table 2 above. On November 19, 2021, SCE submitted a memo to Energy Safety titled, "Interim Deviation from Standards on Vibration Damper for Covered Conductor" (hereafter, "Memo").² This Memo was dated August 18, 2021, and indicates that due to supply chain issues, SCE will suspend the installation of vibration dampers until December 31, 2021. On March 25, 2022, SCE sent an earlier version of that Memo that was dated May 18, 2021.³ However, Energy Safety finds that SCE is still in violation of its protocols requiring the installation of vibration dampers as part of covered conductor installations.

Item1IA1mg1: No vibration dampers

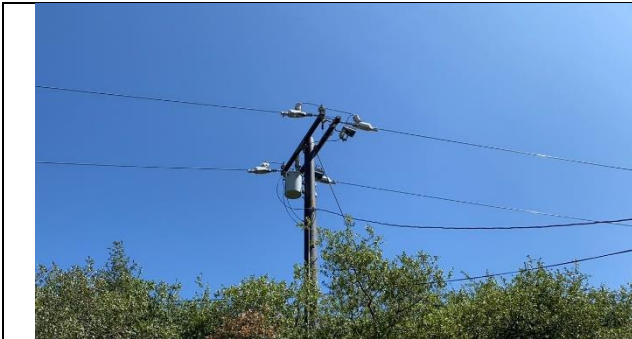
Structure ID: 4465113E

Item2IA1Img1: No vibration dampers on span

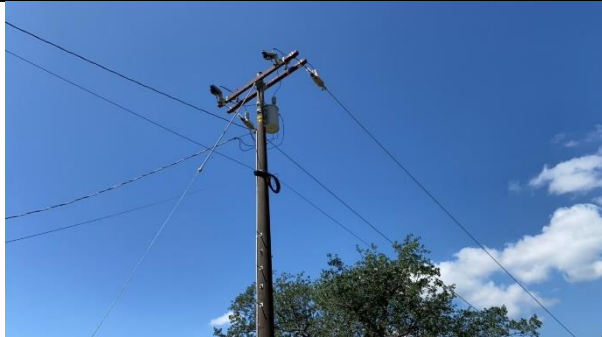
Structure ID: 4541505E

Item3IA1Img1: No vibration dampers

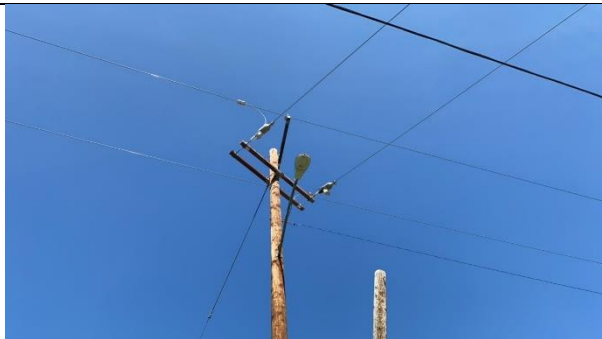
Structure ID: 2081054E

Item4IA1img1: No vibration dampers

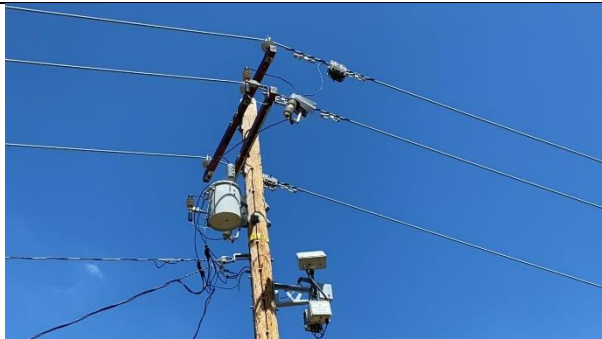
Structure ID: 4291960E

Item5IA1img1: No vibration dampers

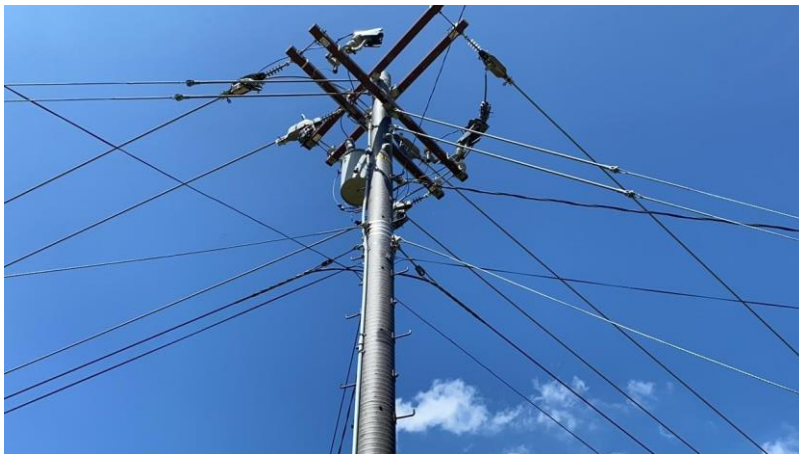
Structure ID: 4477480E

Item6IA1Img1: No vibration dampers

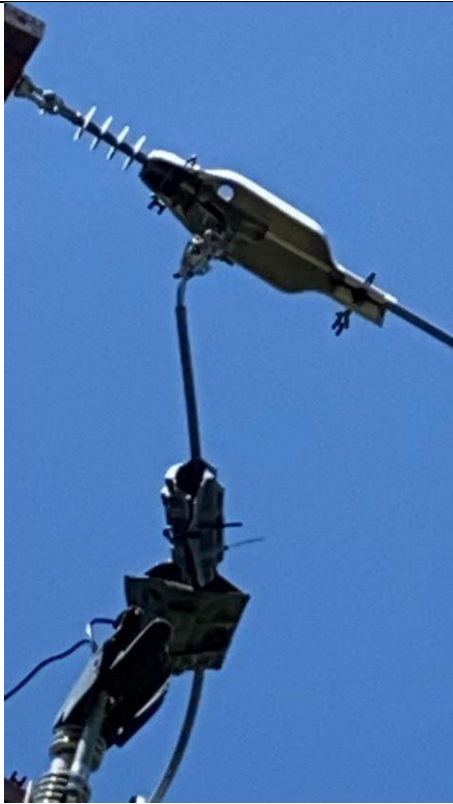
In accordance with SCE's protocols for covered conductor installation, DOH CC 180, "If conductor is exposed, install bolted wedge connector cover" and "If overhead equipment is located at a pole transition from bare wire to covered conductor, the equipment is considered part of the covered conductor system." During the inspection, Energy Safety found one instance where a bolted wedge connector cover was missing, possibly falling off or not installed, and a pothead cover that was excessively split open. Covers are designed to prevent contact between energized equipment and foreign objects.⁴ A loosely attached cover is at higher risk of detaching and exposing the connector to contact with foreign objects. The structures where these violations were observed are noted in Table 2 above.

Item6IA2Img1: Bolted wedge connector cover not installed or fell off

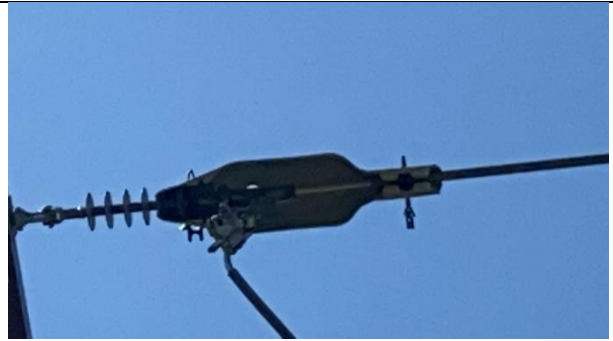
Item6IA2Img2: Close up of exposed conductor

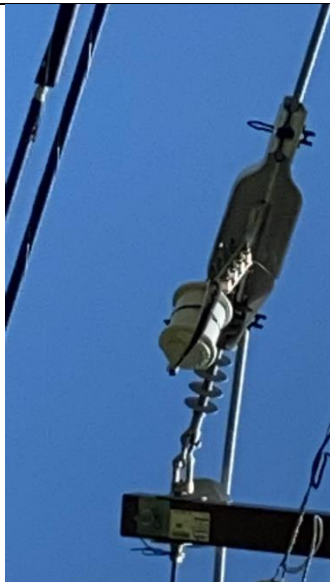
Structure ID: 4843041E

numbered 4843041E had a split open pothead cover. Energy Safety considers this violation for failure of adhering to protocol to be in the Minor risk category.

Item10IA1img2: Connector cover split open

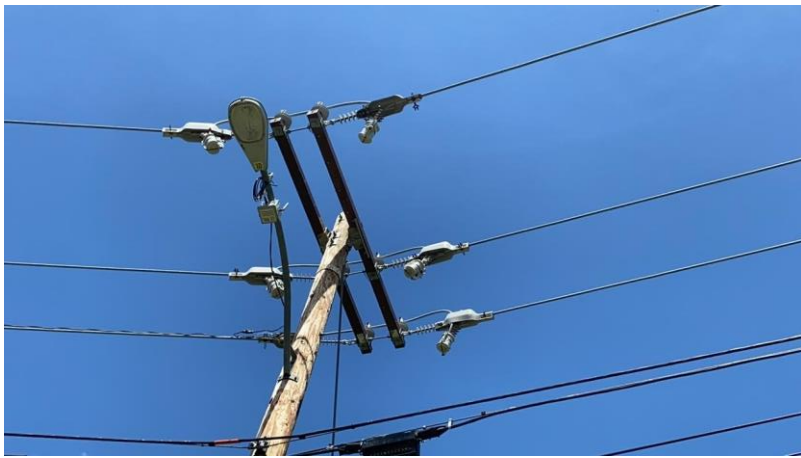
Item10IA2Img1: No vibration dampers
