## **NOTICE OF VIOLATION**

# Energy Safety Inspection Report

Report Name: MYU\_SCE\_20220406-01  
Date(s): April 6, 2022  
Inspector: Matthew Yunge  
Utility: Southern California Edison  
Attention: Erik Takayesu, Vice President Asset Strategy and Planning

On April 6, 2022, I performed a walking inspection of Southern California Edison's (SCE) covered conductor installations, 2021 WMP initiative number 7.3.3.3.1, near or in the Tule River Reservation. Detailed findings from this field inspection are laid out in Section II below.

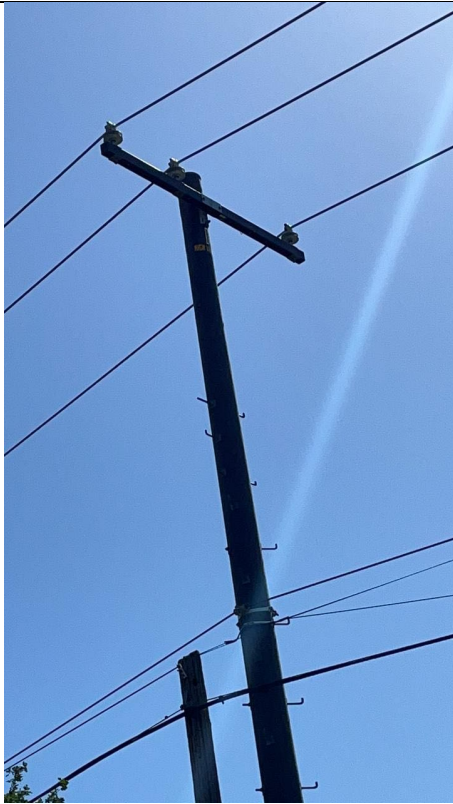
Structure ID: 4465118E

1. Violation 1: Per SCE's DDS, section DDS-10, pages 10-82, "Vibration dampers shall be installed on every span in light loading areas." Also, SCE's Standards DOH, section CC 190, page 1 of 11, indicates that vibration dampers are required when installing covered conductor in light loading areas. Poles numbered 4465118E, 4477325E, 4363990E, 4360581E had covered conductor installed in a light loading area but failed to install vibration dampers. Energy Safety considers this violation for failure of adhering to protocol to be in the Minor risk category.
2. Violation 2: "Per SCE's Standards DOH, section PO 300, page 3 of 9, and DDS, section DDS-10, pages 10-26, installation of a fiberglass guy strain insulator is required for distribution guying applications and repairs in high fire risk areas (HFRAs) and shall be installed in

**Item1IA1Img1:** Missing vibration dampers

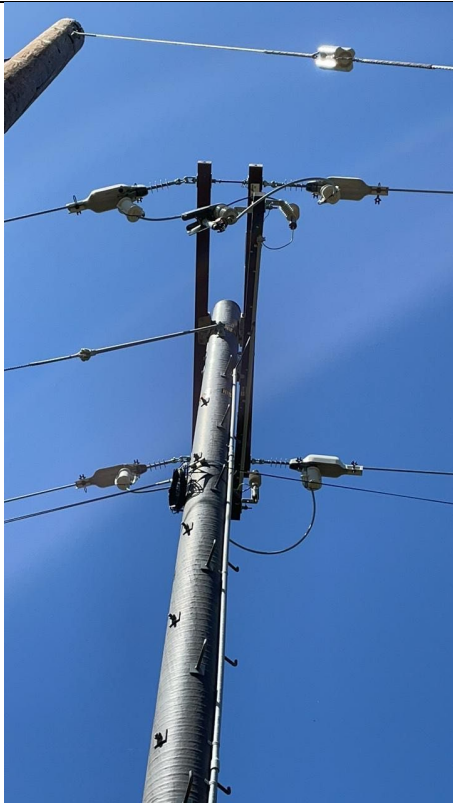
Structure ID: 4477325E

Item2IA1Img1: Missing vibration damper

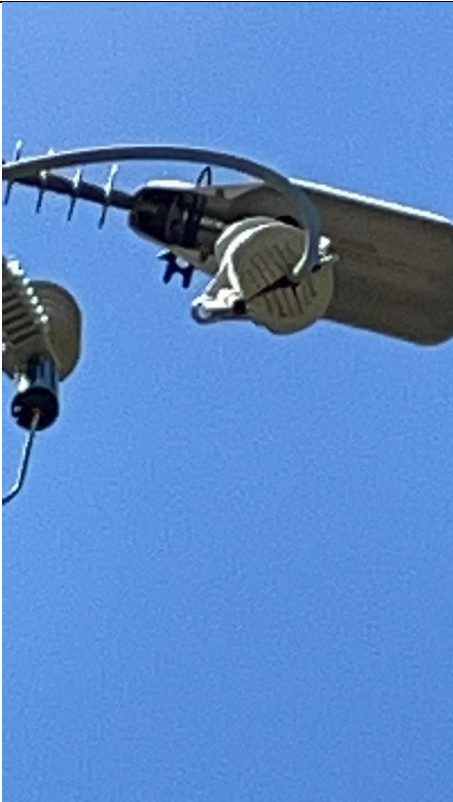
- 3. Violation 3: Per SCE's DOH, Table DC 535-1: Wildlife Protection Material, SCE requires that anti-rotation clips be used with Dead-End Clamp Covers.<sup>2</sup> Pole numbered 4477325E did not have anti-rotational clips installed in dead-end clamp covers. Energy Safety considers this violation for failure of adhering to protocol to be in the Minor risk category.

Energy Safety discovered a dead-end cover that was missing an anti-rotational device. Per SCE's DOH, Table DC 535-1: Wildlife Protection Material, SCE requires that anti-rotation clips be used with Dead-End Clamp Covers.<sup>7</sup> Structures where this protocol was not followed are noted in Table 2 above.

**Item2IA2Img1:** Missing anti-rotational device at outer notch under dead uncover

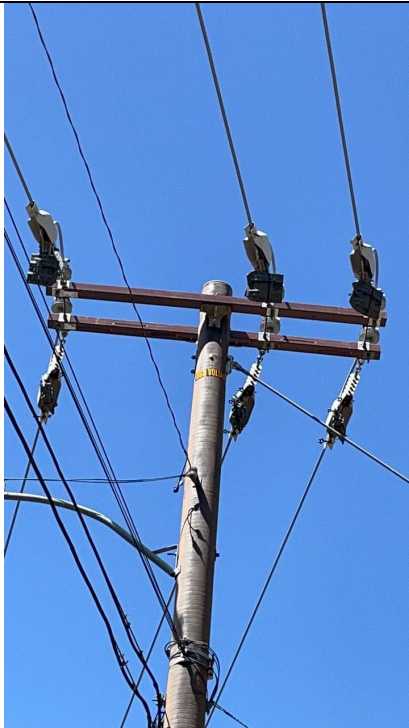
Structure ID: 4363990E

Item4IA1Img1: Missing vibration dampers

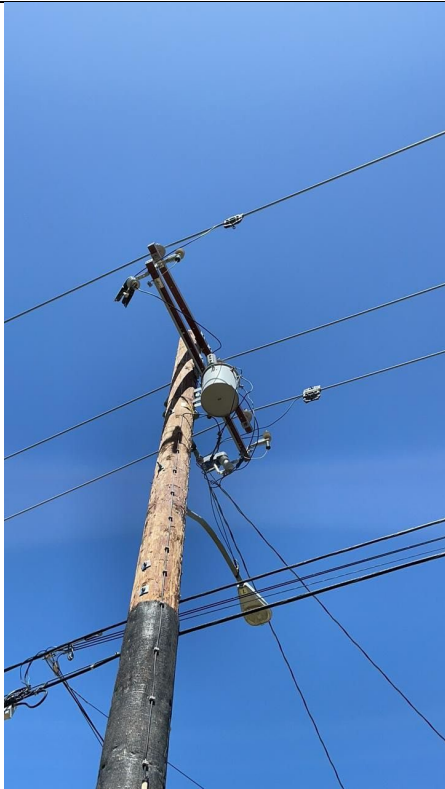
Structure ID: 4360581E

**Item5IA1Img1:** Missing vibration damper

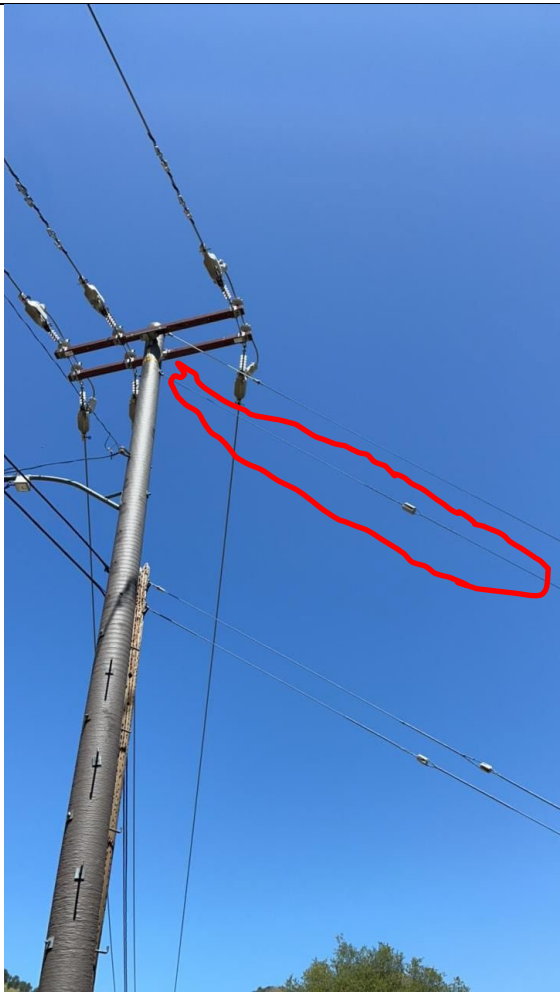
Structure ID: 4465131E

conjunction with covered conductor installation.<sup>1</sup> Pole numbered 4465131E had covered conductor installed but failed to install fiberglass guy strain insulator, in accordance with SCE protocol. Energy Safety considers this violation for failure of adhering to protocol to be in the Minor risk category.

In accordance with SCE's protocols for covered conductor installation, Standards DOH PO section 300, SCE states, " For new guy installations, guy remediation, and/or pole replacements that require guying in High-Fire Risk Areas (HFRA), the fiberglass guy strain rod shall be used."<sup>4</sup> In addition, SCE's DDS, section DDS-10 indicate that, "Beginning July 2020, SCE has transitioned to a standard requirement in guying to utilize the fiberglass guy strain insulators where traditional porcelain guy strain insulators have been applied."<sup>5</sup> Further, in response to Energy Safety Data Request (DR-030), SCE stated "In HFRA installations of covered conductor it is required to... upgrade down guy/span guy installation to include Fiberglass Guy Strain Insulators."<sup>6</sup> During the inspection, Energy Safety found one instance where fiberglass guy wire strain insulators were not installed where covered conductor work was completed, per SCE's protocols. Structures where this protocol was not followed are noted in Table 2 above.

**Item6IA1Img1:** One of the down guy insulators incorrect type
