NOV_SCE_MYU_20220406-01_Revised

NOTICE OF VIOLATION

Energy Safety Inspection Report

Report Name: MYU_SCE_20220406-01_Revised

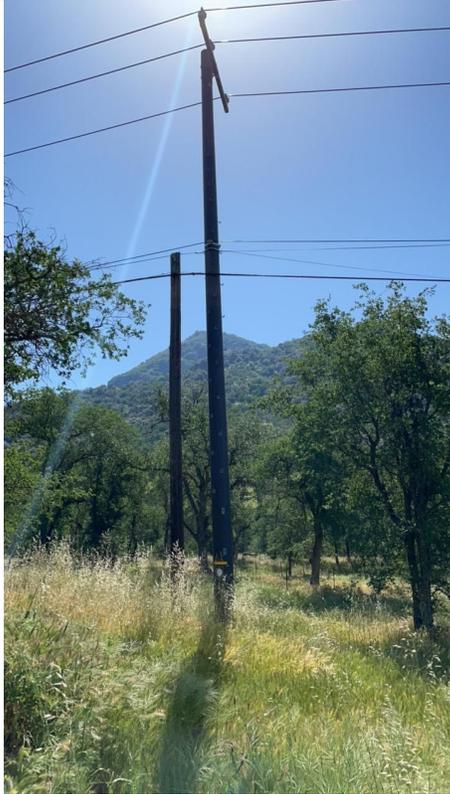
Structure ID: 4465118E

Item1Gimg1: Overall

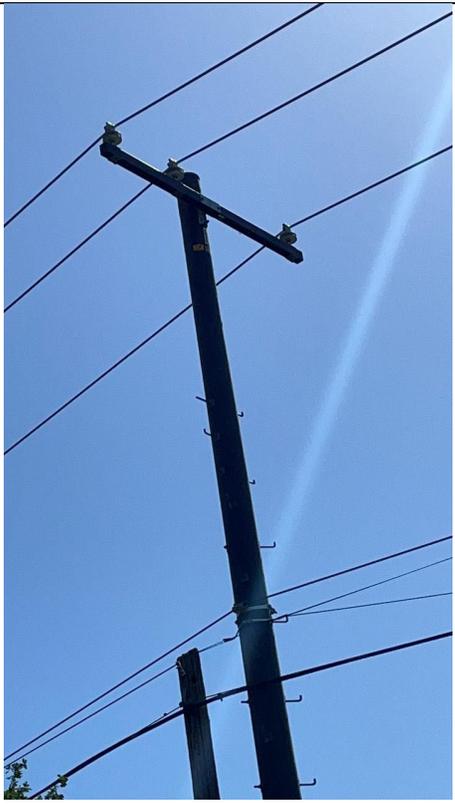
1. Violation 1: Per SCE's DDS, section DDS-10, pages 10-82, "Vibration dampers shall be installed on every span in light loading areas." Also, SCE's Standards DOH, section CC 190, page 1 of 11, indicates that vibration dampers are required when installing covered conductor in light loading areas. Poles numbered 4465118E, 4477325E, 4363990E, 4360581E had covered conductor installed in a light loading area but failed to install vibration dampers. Energy Safety considers this violation for failure of adhering to protocol to be in the Minor risk category.

Item1IA1Img1: Missing vibration dampers

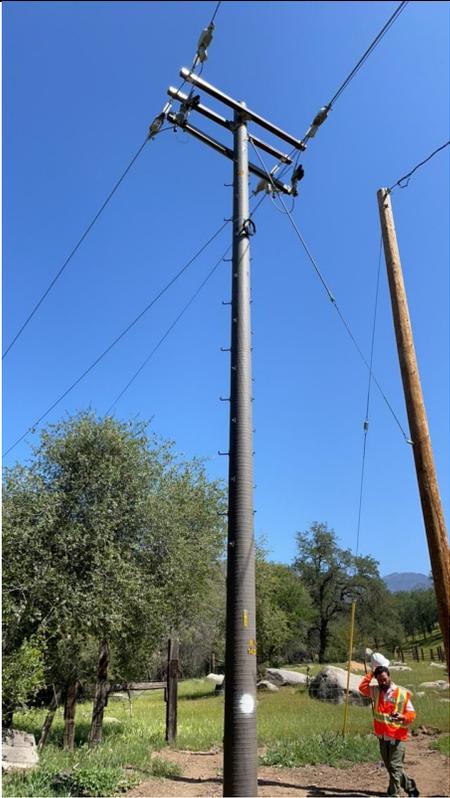
Structure ID: 4477325E

Item2GImg1: Overall pole

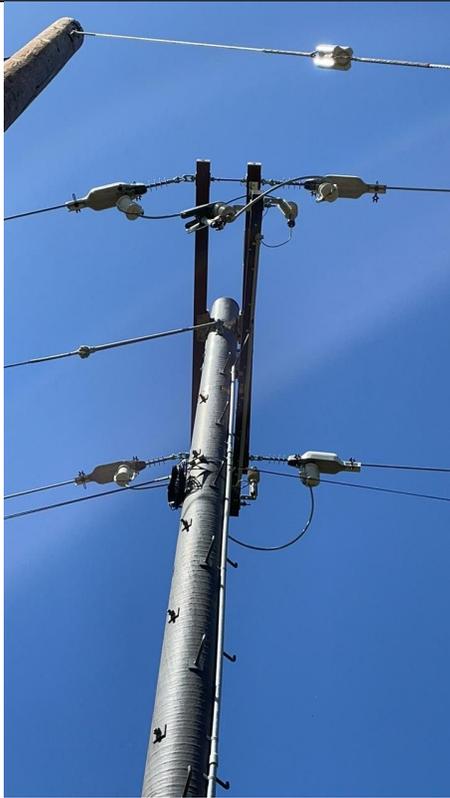
Item2IA1Img1: Missing vibration damper

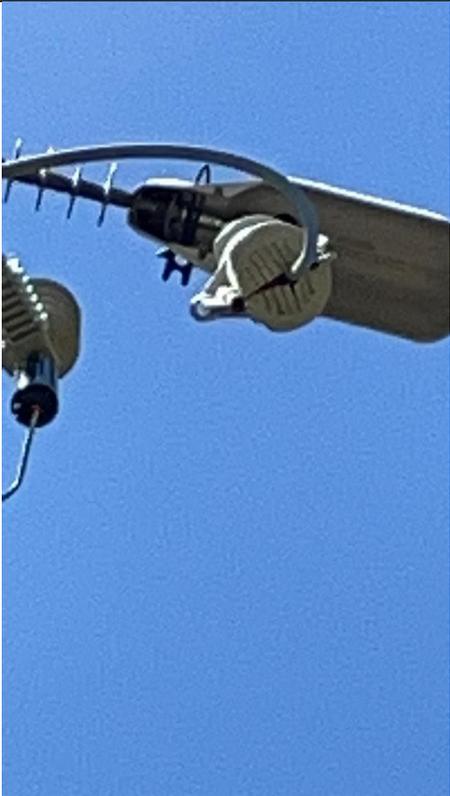
2. Violation 2: Per SCE's DOH, Table DC 535-1: Wildlife Protection Material, SCE requires that anti-rotation clips be used with Dead-End Clamp Covers.¹ Pole numbered 4477325E did not have anti-rotational clips installed in dead-end clamp covers. Energy Safety considers this violation for failure of adhering to protocol to be in the Minor risk category.

Energy Safety discovered a dead-end cover that was missing an anti-rotational device. Per SCE's DOH, Table DC 535-1: Wildlife Protection Material, SCE requires that anti-rotation clips be used with Dead-End Clamp Covers.⁴ Structures where this protocol was not followed are noted in Table 2 above.

Item2IA2Img1: Missing anti-rotational device at outer notch under dead uncover

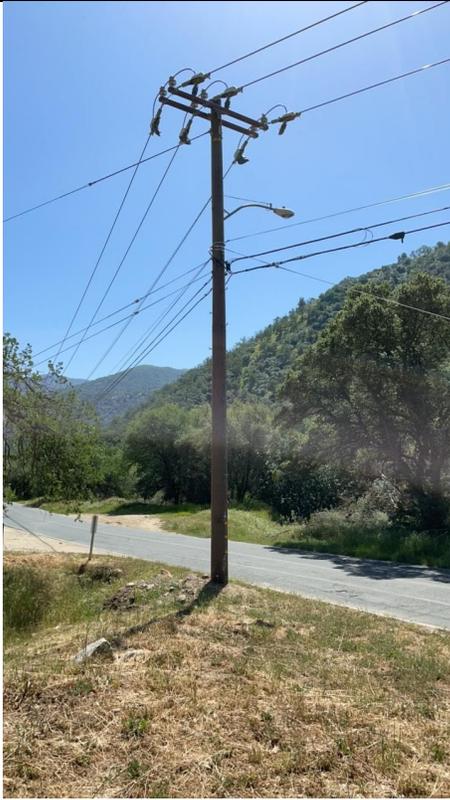
Structure ID: 4363990E

Item4GImg1: Overall pole

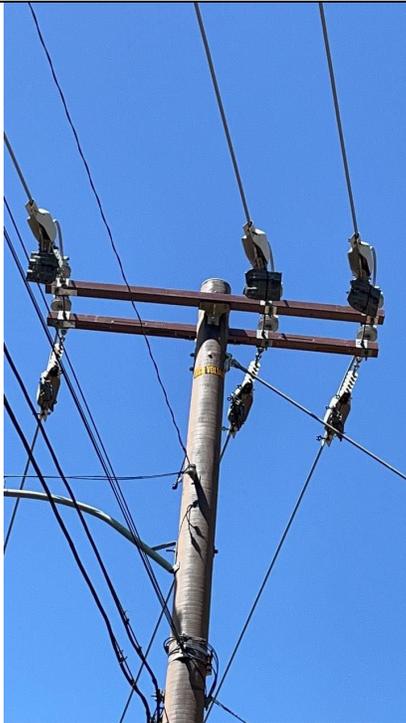
Item4IA1Img1: Missing vibration dampers

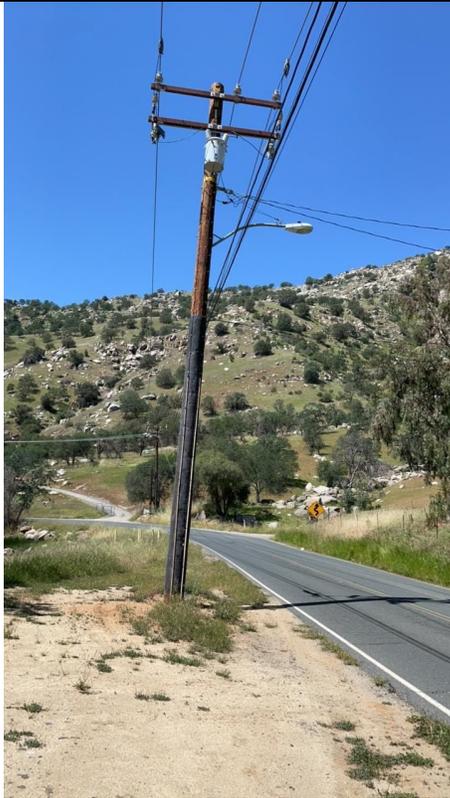
Structure ID: 4360581E

Item5GImg1: Overall pole

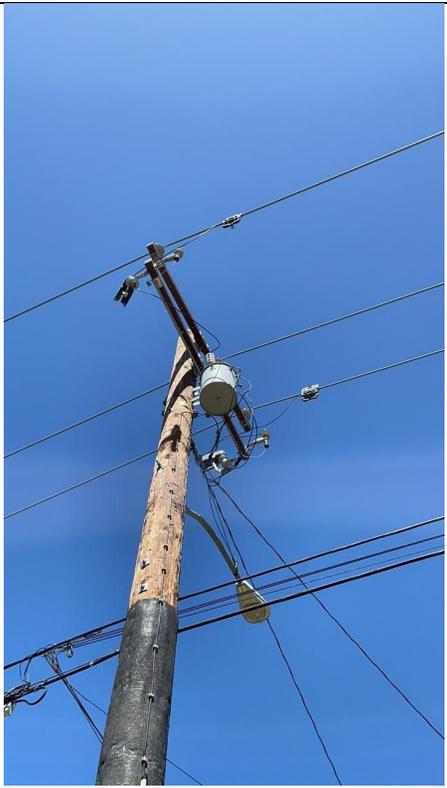
Item5IA1Img1: Missing vibration damper
