August 22, 2022

SUBJECT: Southern California Edison Company's Response to Notices of Defect -
SCE ATJ 20220406-01, SCE ATJ 20220414-01, and SCE ATJ
20220622-01¹

SOUTHERN CALIFORNIA EDISON COMPANY INTRODUCTION

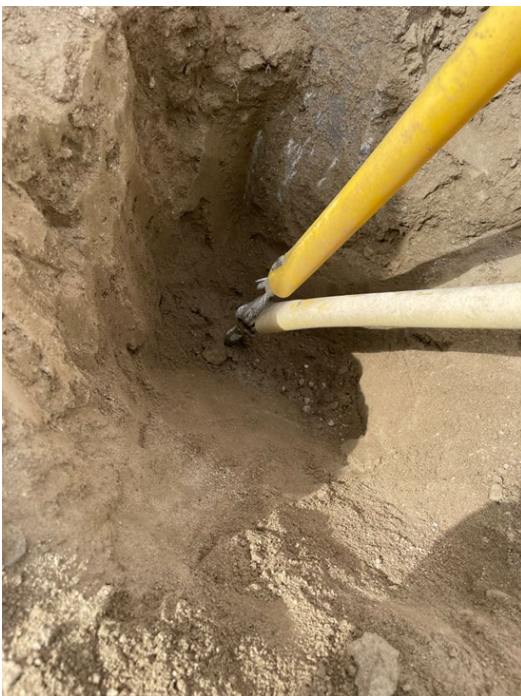
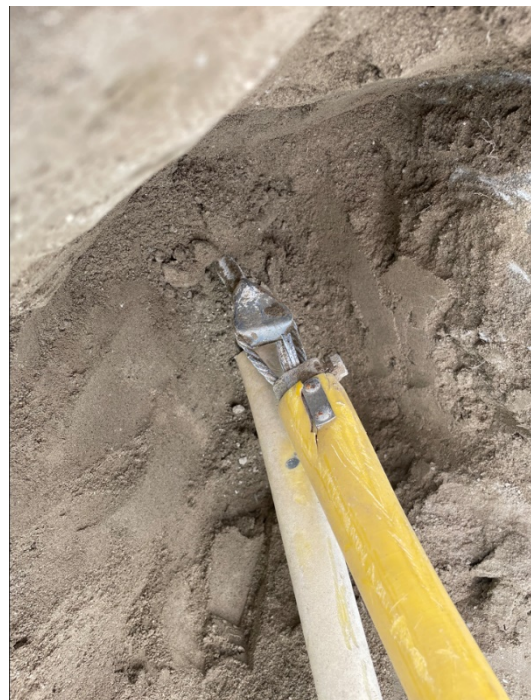
Notice	Finding #	Structures
NOD SCE ATJ 20220622-01	3	1564552E 4003373E

Summary of Findings: “Pole numbered 1564552E and 4003373E had buried guy anchors. Energy Safety considers this defect to be in the Minor risk category.”

The condition for pole 4003373E was remediated on August 4, 2022, see photos below.
