SUBJECT: Southern California Edison Company's Response to Notice of Violation
- SCE ATJ 20220405-01, SCE ATJ 20220406-01, SCE ATJ 20220411-
01, and SCE ATJ 20220420-01¹ (No Written Hearing Requested)

SOUTHERN CALIFORNIA EDISON COMPANY INTRODUCTION

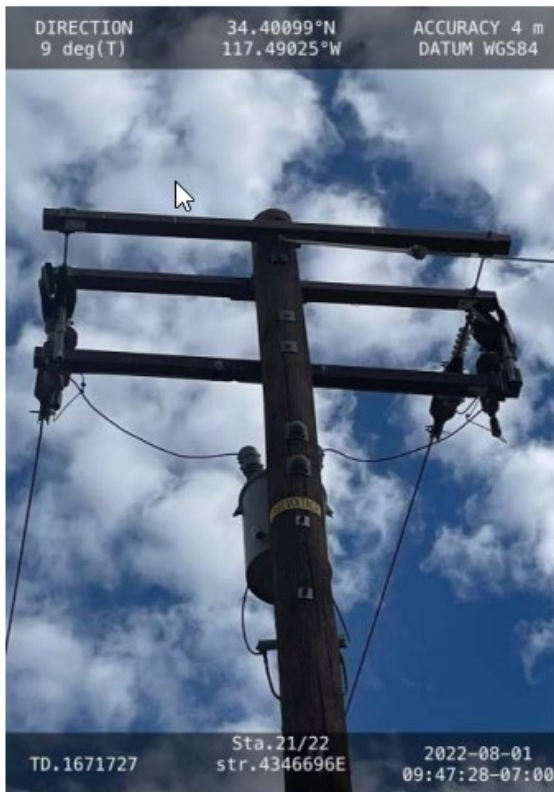
Summary of Finding: "Pole number 4346696E had a fuse cover that fell off and was found approximately 50 feet from the pole. Energy Safety considers this a violation for failure of adhering to protocol and in the Minor risk category."

STR 4346696E FUSE COVER INSTALLED

Response: SCE agrees the condition existed as identified by Energy Safety, which has already been corrected in the field on August 1, 2022. Please see photo below reflecting the corrected condition.

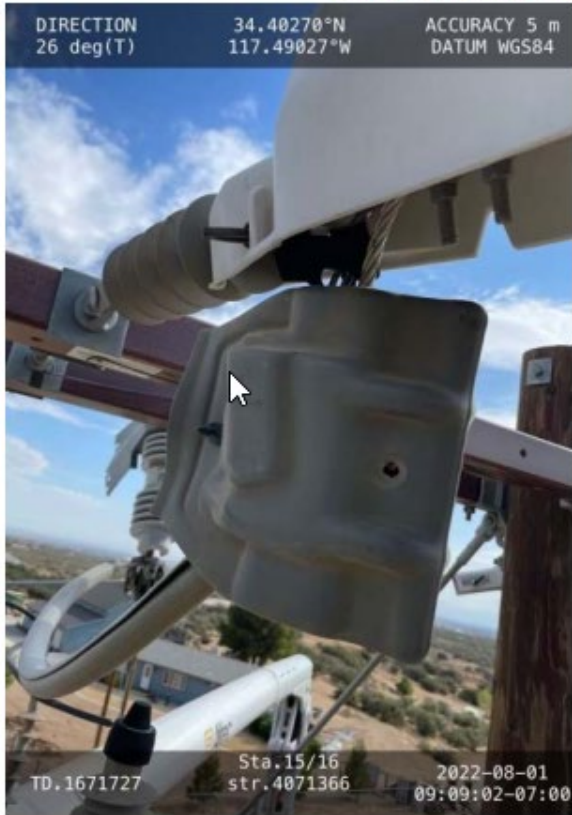
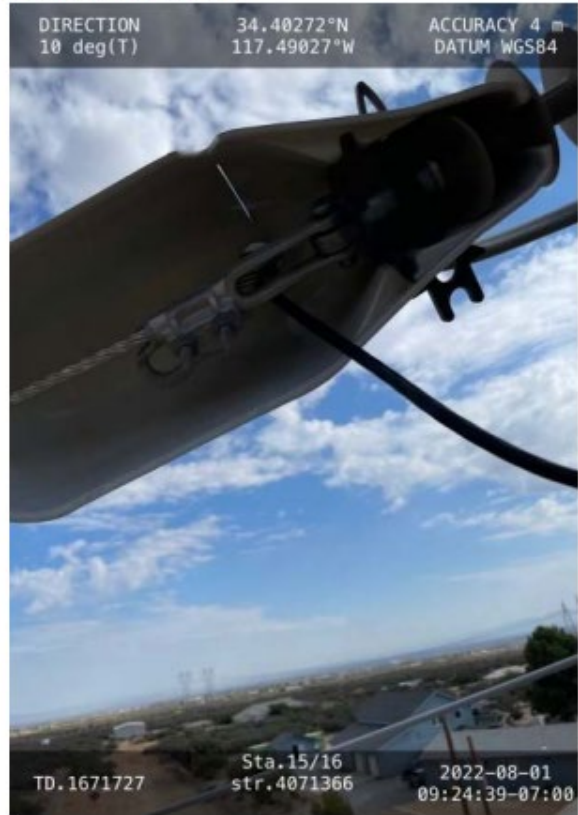
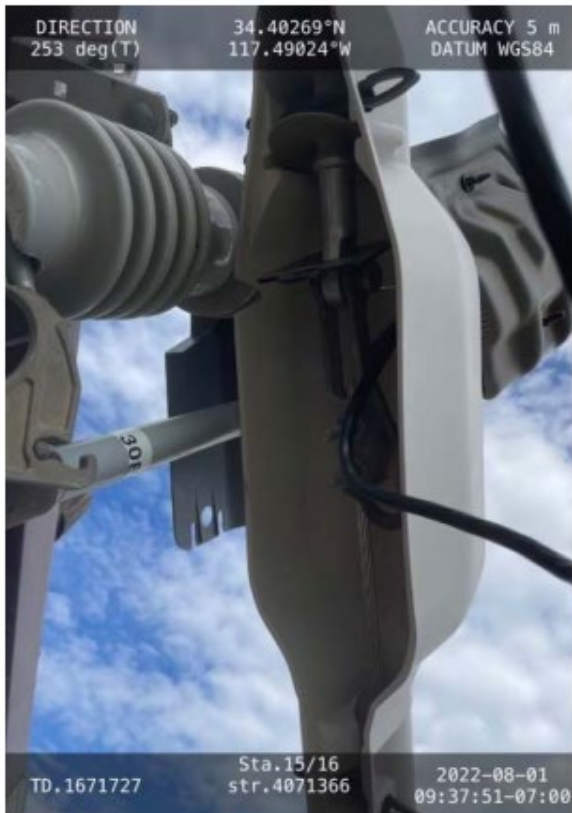
Summary of Finding: “Pole numbered 4071366E did not have an anti-rotational clip installed in a dead-end cover.” Energy Safety considers these findings to be in the Minor risk category.

**STR 4071366E ANTI ROTATION CLIPS INSTALLED
JUMPER RE-ROUTED TO CORRECT POSITION**

Summary of Findings: “Poles numbered 4071366E and 4135843E had jumpers not connected in the direction that the conductor was routed. Energy Safety considers this violation for failure of adhering to protocol to be in the Minor risk category.”

Response: SCE agrees the condition existed as identified by Energy Safety, which has already been corrected in the field on August 1, 2022. Please see photos below reflecting the corrected condition.

Response: SCE agrees the conditions existed as identified by Energy Safety, which have already been corrected in the field on August 1, 2022.

Please see photos above for 4071366E reflecting the corrected conditions.

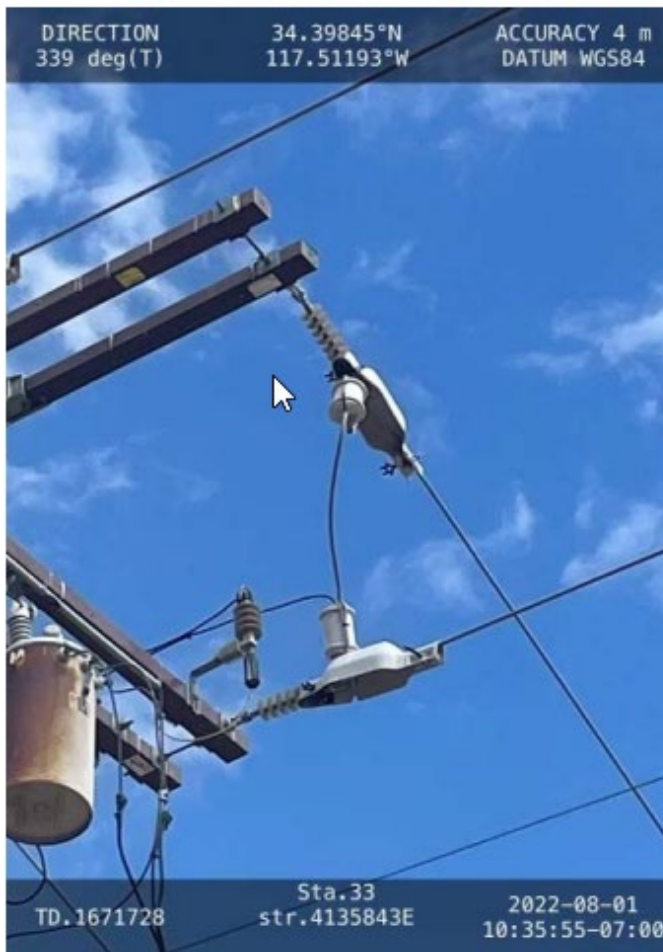
STR 4135843E JUMPER RE-ROUTED TO CORRECT POSITION

Please see photo below for 4135843E reflecting the corrected conditions.
