# Enhanced Vegetation Management (EVM) Work Verification

## Exit Meeting

**2020\_QVVM\_\_460\_EVM Work Verification Audit**

**November 10, 2020**

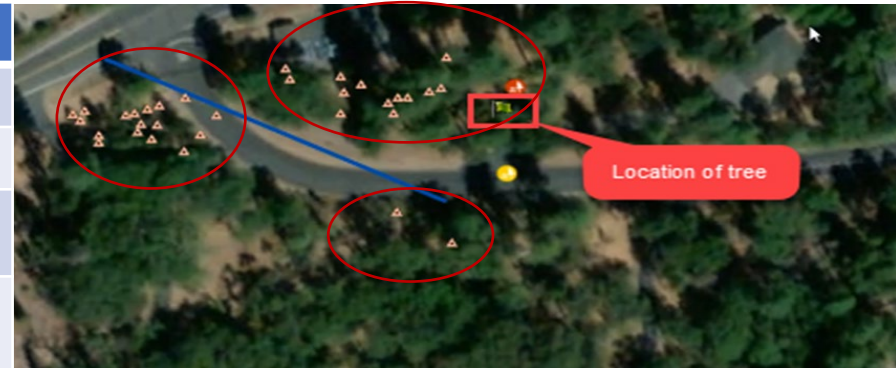
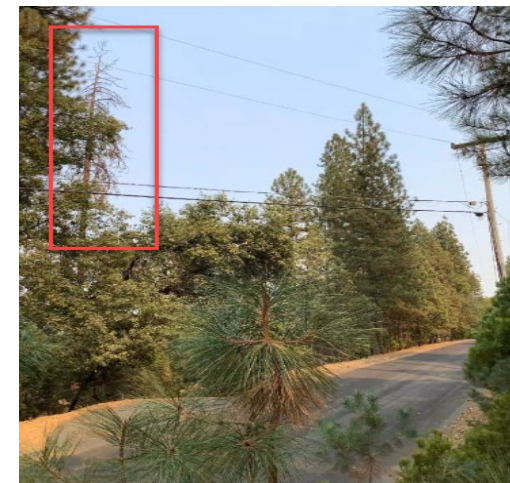
Details
QV Finding	Hazard trees present with strike potential to primary
Quantity	1
Quantity @ time of WV	1
Operations Comments	<p><b>WV failed veg point correctly</b> as it affects and is at the border of two segments. The dead pine had a work identified veg point that is snapped to the neighboring segment, but the tree can impact both segments. WV intended to fail this segment by failing the tree to denote scope was not met on this specific tree at the border of two segments.</p> <p>VP_BB123-F22_1236467_2020 is a work identified veg point and is failed currently, the segment it is clipped to is CIP_BB123-F22_583687 and is <b>not currently passed</b>. It is a yellow line segment "phase 1 inspected".</p>
QV Recommendation	Findings stands. Operations' comments indicate Work Verification Algorithm Limitations per EVM V Responsibility one-pager.

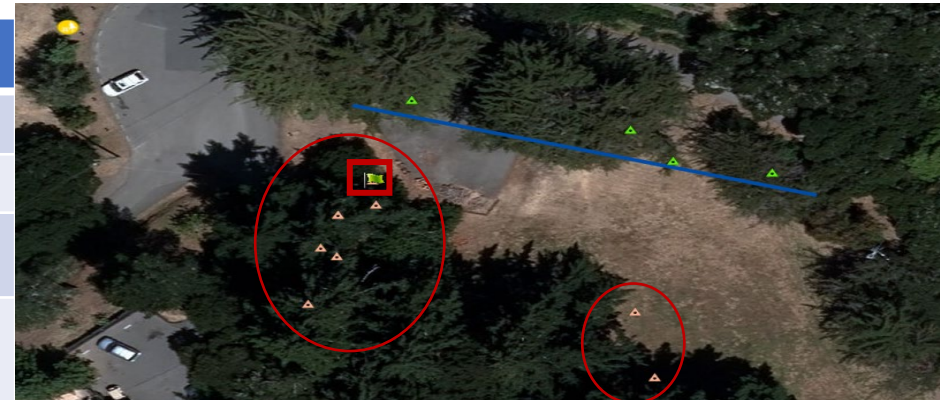
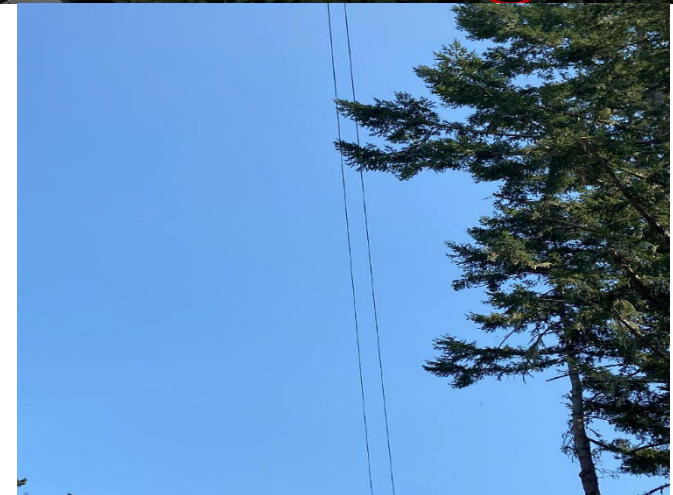
Details
QV Findings	Vegetation within the 4' overhang zone
Quantity	1
Quantity @ time of WV	1
Operations Comments	<p>WV survey data we received shows this segment was failed by WV for not meeting scope. WV most recent survey denotes this segment was never passed due to non listed trees present. The veg point representing this tree was correctly failed by WV. When standing at tree and under limbs gps shows your location in next segment. This tree in question is on the adjacent segment as it shows when standing in the field and comparing your location of gps icon to where segments are shown on collector. Tree is at border of two segments and the QV auditor was inspecting the adjacent segment not this one noted on the finding. When looking at the tree on satellite imagery and compared to gps location when in field it is on the next segment. When using the segment footage data this tree would be very close to the border of the two different segments so it would be very subjective as to what segment one would say the trees limbs actually overhang. The veg point is clipped to the next segment not this one noted on the finding, but WV correctly failed the veg point regardless.</p> <p>VP_AL122-J19_1213774_2020 is a work identified veg point and is currently not passed, the segment it is clipped to is CIP_AL122-J19_92906 and is not passed currently a blue line segment "phase 1 &amp; 2 inspected"</p>

QV Recommendation	Findings stands. Operations' comments indicate Work Verification Algorithm Limitations per EVM V Responsibility one-pager.

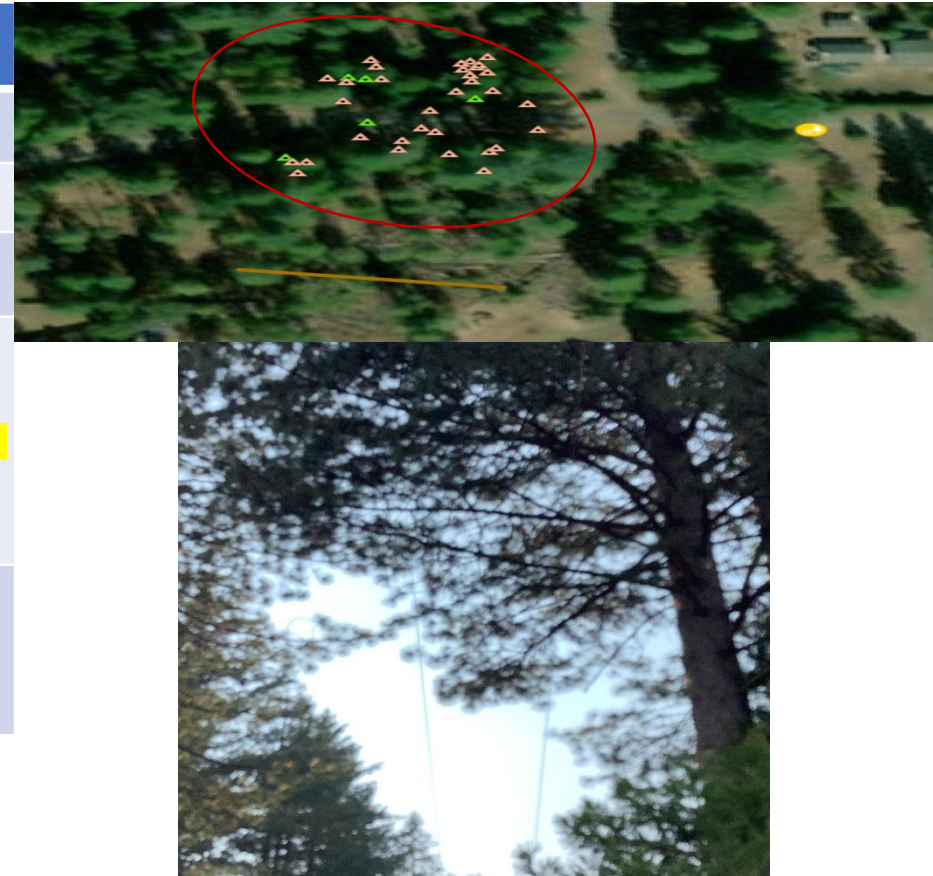
Details
QV Findings	Vegetation within the 4' overhang zone
Quantity	3
Quantity @ time of WV	3
Operations Comments	WV failed the survey for this segment denoting scope was not met. Pines are on neighboring green segment and are not snapped to segment in question. VP_BD124-O20_1440054_2020 is a tree work complete veg point and it is not passed, it is clipped to segment CIP_BD124-O20_597819, which is a green "inspection needed" line segment currently.
QV Recommendation	Findings stands. Operations' comments indicate Work Verification Algorithm Limitations per EVM V Responsibility one-pager.

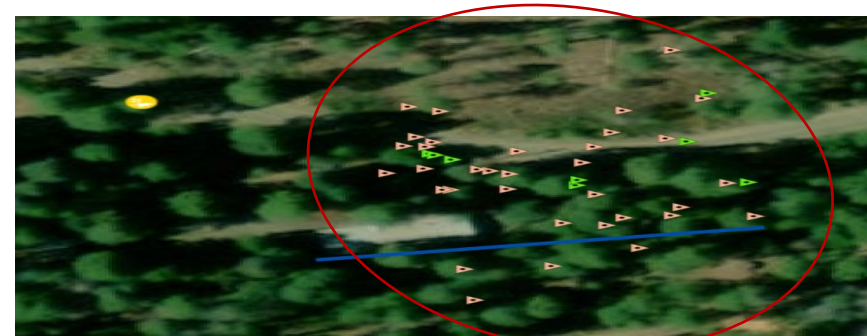
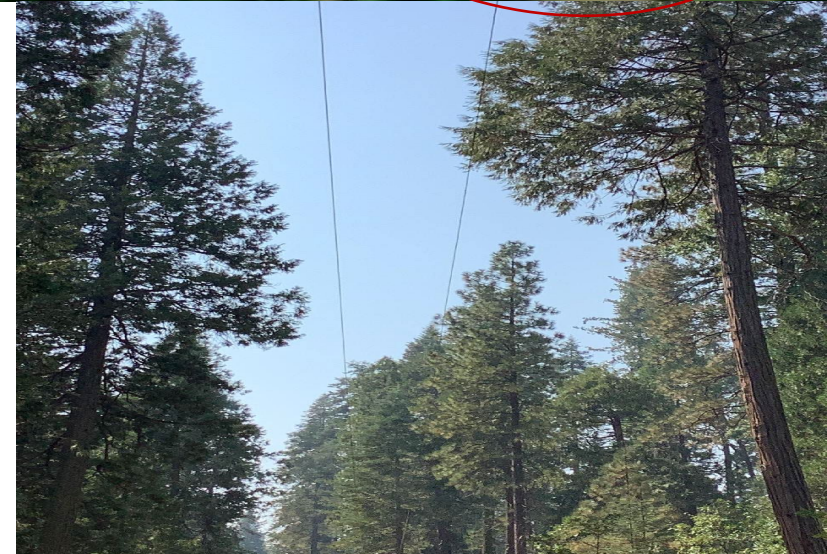
# CIP\_BD124-P21\_597399

Details
QV Findings	Vegetation within the 4' overhang zone
Quantity	4
Quantity @ time of WV	4
Operations Comments	Cedar mid span P4-P5 and cedar 1/4 span P3-P4 are on different segments and are not snapped to segment. However the 2 cedars mid span may be interpreted as overhanging the segment in question. VP_BD124-P21_1482221_2020, VP_BD124-P21_1482243_2020, VP_BD124-P21_1482055_2020 are tree work complete veg points not passed, clipped to segment CIP_BD124-P21_597392, which is not passed and currently a blue line segment "phase 1 & 2 inspected.
QV Recommendation	Findings stands. Operations' comments indicate Work Verification Algorithm Limitations per EVM V Responsibility one-pager.

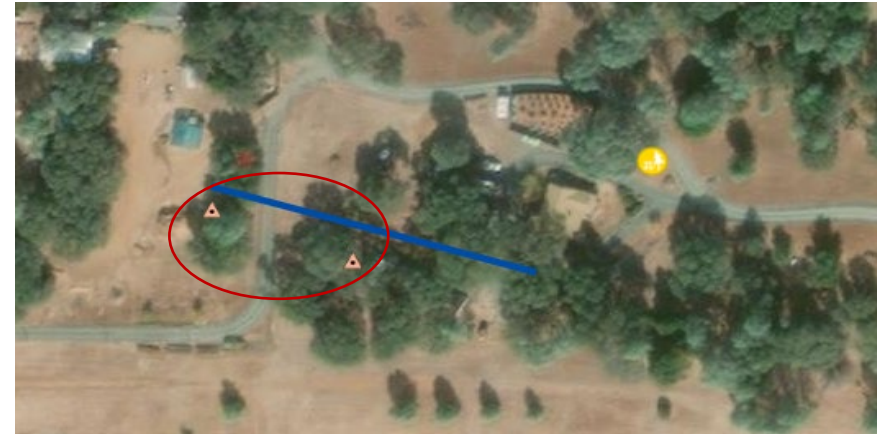
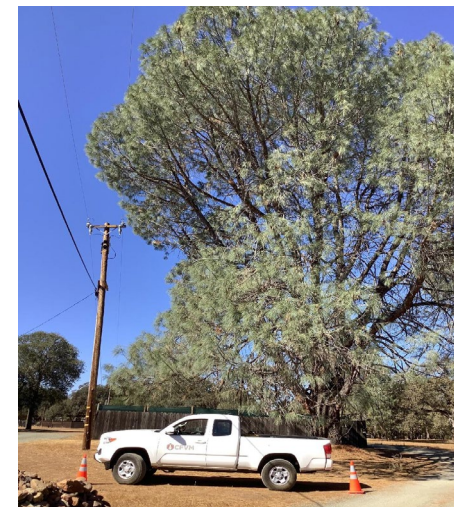
Details
QV Findings	Vegetation within the 4' overhang zone
Quantity	1
Quantity @ time of WV	1
Operations Comments	<p>Veg point is at border of two segments causing clipping data issue where tree affects both segments. <b>WV correctly failed this veg point for not meeting OV scope. There was no way to denote on survey at this point in time that OV scope was not met.</b> WV inspectors did everything correctly. Veg point is clipped to neighboring segment and affects both of them since it is at the border of the two. Tree in question currently does not meet OV scope for both segments it is at the border of.</p> <p><b>VP_AK117-F14_1332315_2020 is a hold/work identified point that is not passed, it is clipped to segment CIP_AK117-F13_48521, which is not passed and is currently a blue segment "phase 1 &amp; 2 inspected".</b></p>
QV Recommendation	Findings stands. Operations' comments indicate Work Verification Algorithm Limitations per EVM V Responsibility one-pager.

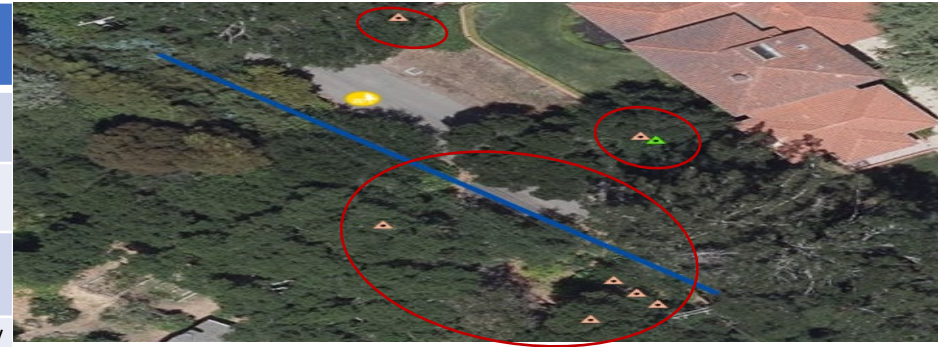
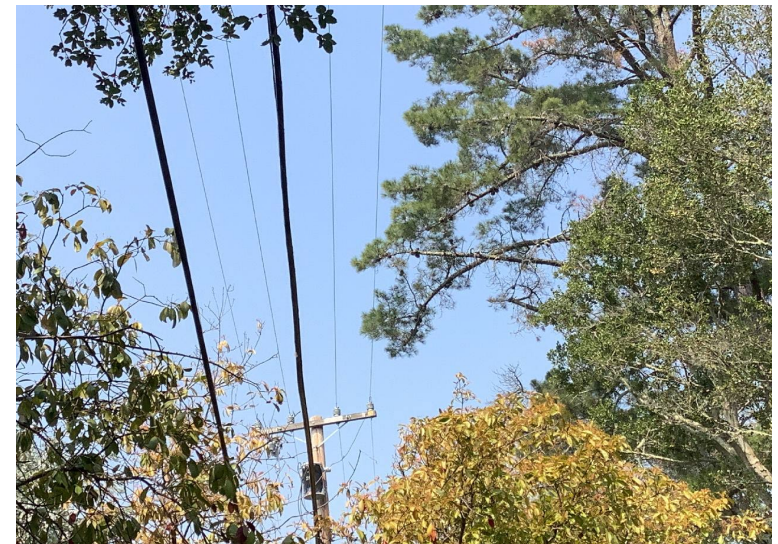
Details
QV Findings	Vegetation within the 4' overhang zone
Quantity	1
Quantity @ time of WV	1
Operations Comments	<p>WV survey data we received shows that WV failed this segment survey by denoting there were non listed trees present. WV never passed this segment survey. <b>WV also failed the veg point correctly</b>, however the tree has overhang on two different segments since it is at the border of both. The VP is tied to the neighboring segment and that is correctly not passed. <b>This probably was from early in the year when there was no survey questions to denote overhang scope was not met. WV intended to fail this segment. Will coach WV inspectors to fail the survey for both segments when tree is at border of both segments with overhang.</b></p> <p>VP_AO123-G08_619088_2019 is a work identified veg point that is not passed, <b>it is clipped to segment CIP_AO123-G08_172446 and is not passed currently</b> a blue line segment "phase 1 &amp; 2 inspected"</p>

QV Recommendation	Findings stands. Operations' comments indicate Work Verification Algorithm Limitations per EVM V Responsibility one-pager.

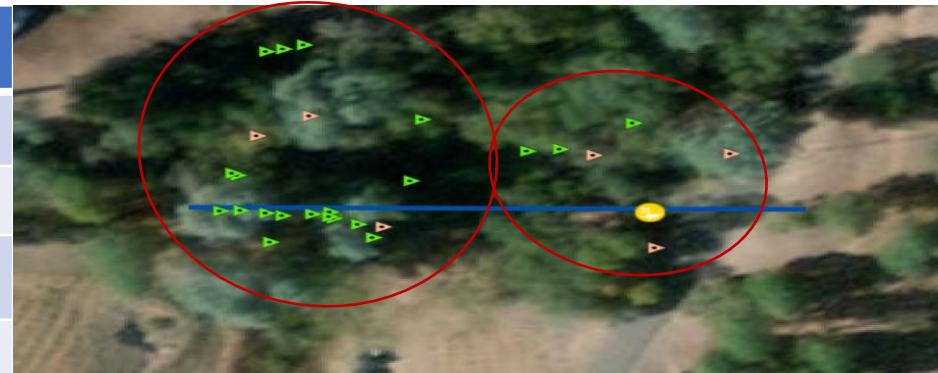
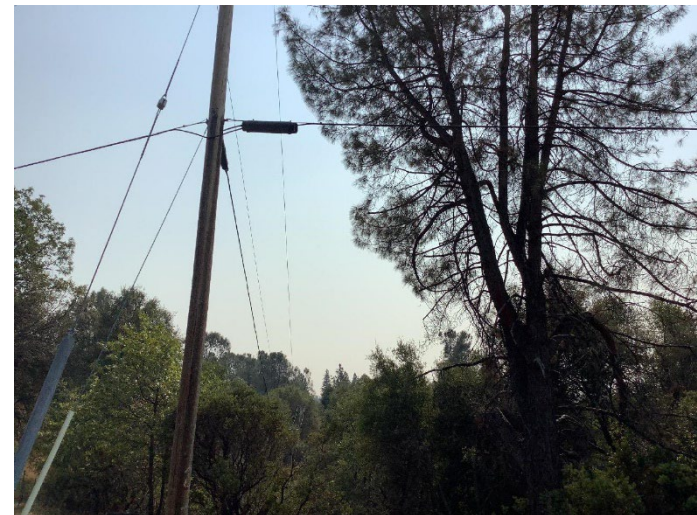
Details
QV Findings	Vegetation within the 4' overhang zone
Quantity	1
Quantity @ time of WV	1
Operations Comments	<p>WV failed this veg point correctly as it affects two segments. The Viewpoint in question is not overhanging the segment it is clipped to, but it is overhanging the segment on it's East side, which is white and passed. VP_AY119-F03_1236953_2020. WV intended to fail this segment by failing this specific veg point, but when this WV inspection occurred there was not a question on the survey to denote overhang scope was not met.</p> <p>VP_AY119-F03_1236953_2020 is a work identified veg point and not passed, it is clipped to segment CIP_AY119-F03_691193 which is not passed and is currently a blue line segment "phase 1 &amp; 2 inspected".</p>
QV Recommendation	Findings stands. Operations' comments indicate Work Verification Algorithm Limitations per EVM V Responsibility one-pager.

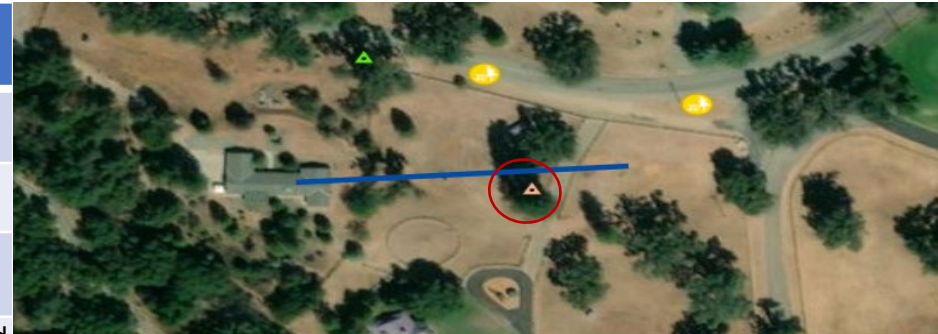
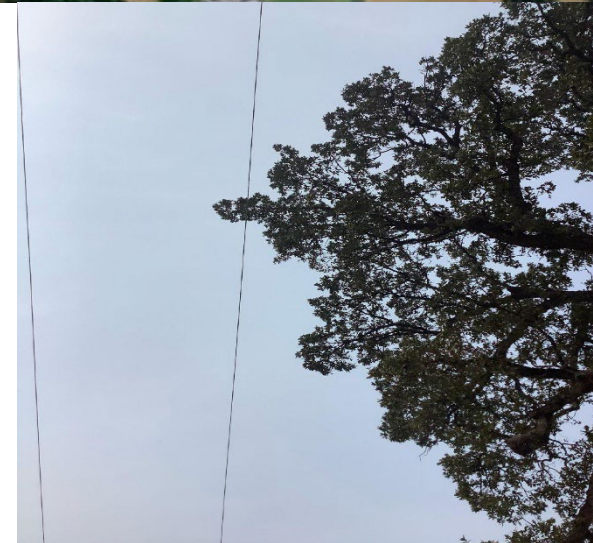
Details
QV Findings	Vegetation within the 4' overhang zone
Quantity	1
Quantity @ time of WV	1
Operations Comments	<p>The tree is a <b>work identified point failed by WV</b>, but snapped to another segment, but is overhanging the segment in question. <b>WV intended to fail this segment, but at this point in time there was no survey questions to denote overhang scope was not met.</b></p> <p>VP_BE126-C22_1492597_2020 is a work identified veg point that is not passed, it is clipped to segment <b>CIP_BE126-C22_621629</b>, which is currently a blue line segment "phase 1 &amp; 2 inspected".</p>
QV Recommendation	Findings stands. Operations' comments indicate Work Verification Algorithm Limitations per EVM V Responsibility one-pager.

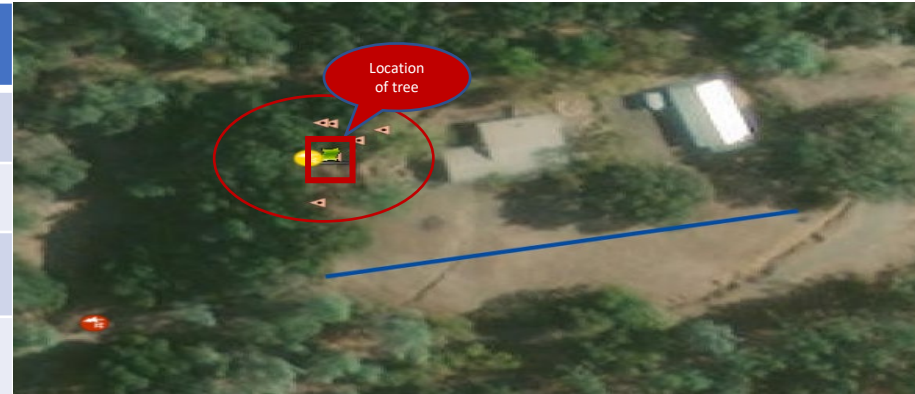
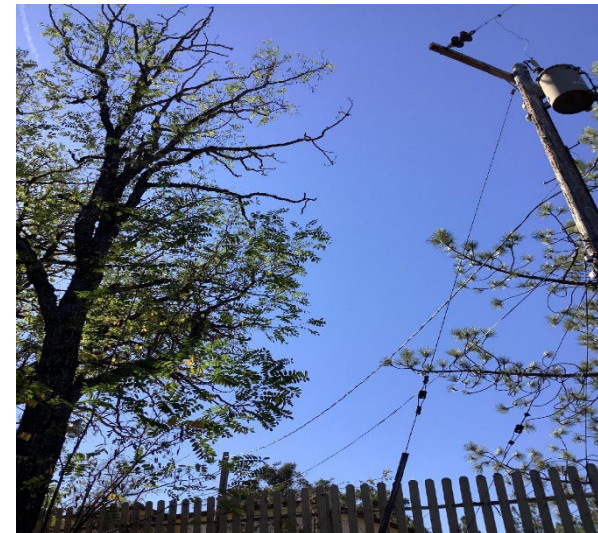
# CIP\_AK117-G11\_47313

Details
QV Findings	Hazard trees present with strike potential to primary
Quantity	1
Quantity @ time of WV	1
Operations Comments	<p>WV correctly failed veg points and segment survey. Due to GIS inaccuracies these veg points are clipped to neighboring segment. <b>This segment in reality is still failed.</b> WV survey data we received has comments that state "Work Identified".</p> <p>VP_AK117-G11_1359810_2020 is a work identified veg point that is failed, it is clipped to segment CIP_AK117-G11_47314, which is not passed and is currently a blue segment "phase 1 &amp; 2 inspected"</p>
QV Recommendation	Finding stands. Segment assessed per audit scope, as it was provided as a "Passed" location. Operations' comments states Work verification process issue. Tree in question is non-conformant for sample segment.

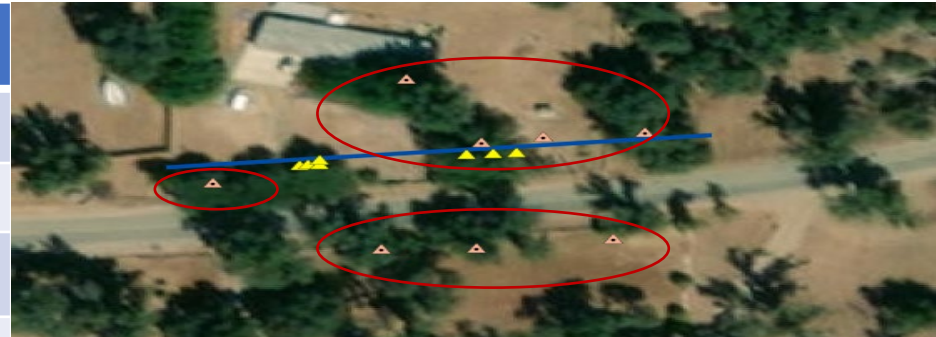
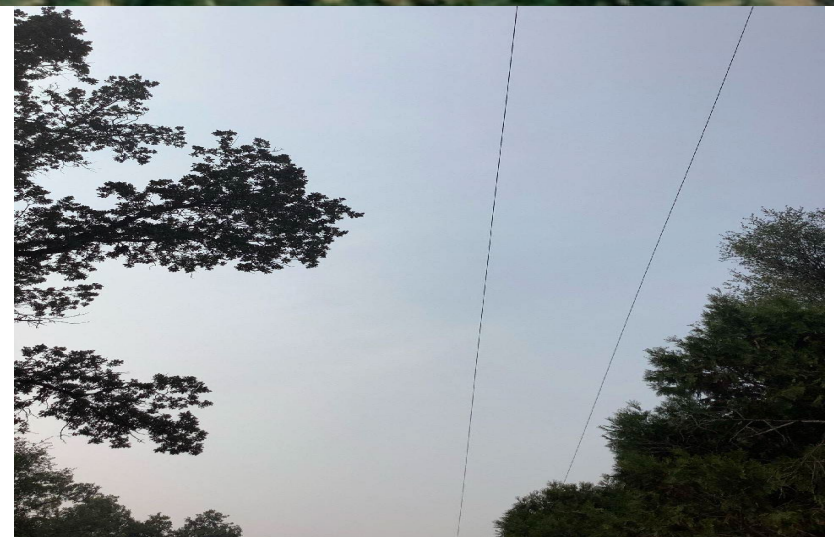
Details
QV Findings	Vegetation within the 4' overhang zone
Quantity	1
Quantity @ time of WV	1
Operations Comments	<p><b>Segment is not passed currently.</b> Did not review and field check since the segment is still in process of EVM and has not been work verified.</p> <p>Segment is blue "Phase 1 &amp; Phase 2 Inspected" Numerous in progress veg points with work prescribed.</p>
QV Recommendation	Finding stands. Segment assessed as per audit scope, was provided as a Passed segment.

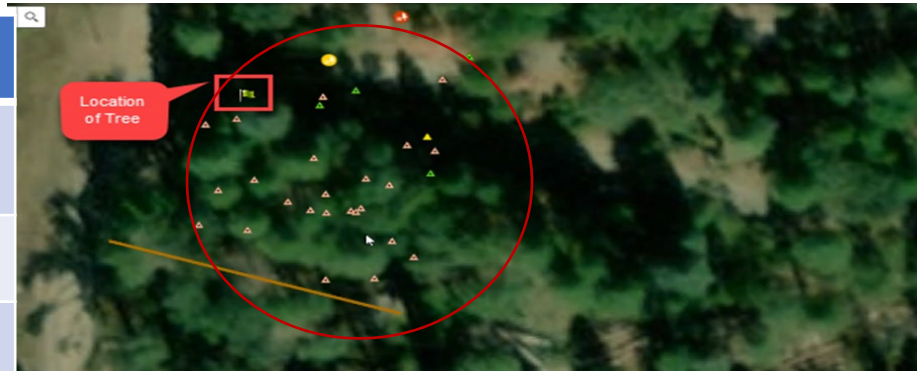
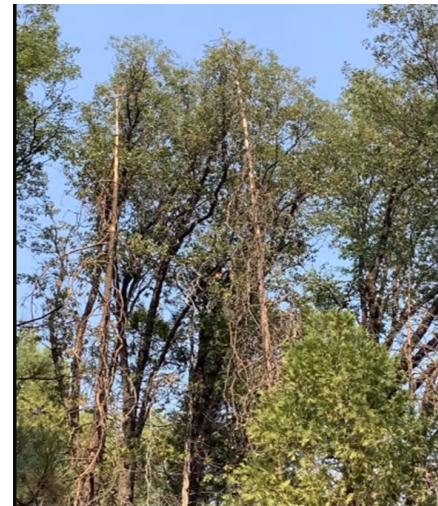
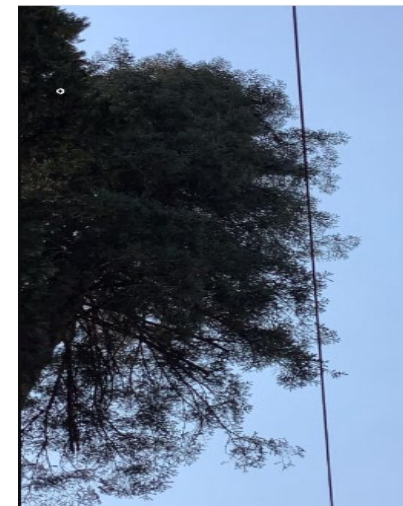
Details
QV Findings	<ul style="list-style-type: none"> <li>Hazard trees present with strike potential to primary</li> <li>Vegetation within the 4' overhang zone</li> </ul>
Quantity	1
Quantity @ time of WV	1
Operations Comments	<p><b>Segment is not passed currently.</b> Did not review and field check since the segment is still in process of EVM and has not been work verified. Segment is blue "Phase 1 &amp; Phase 2 Inspected" Numerous veg points with no status.</p>
QV Recommendation	Finding stands. Segment assessed as per audit scope, was provided as a Passed segment.

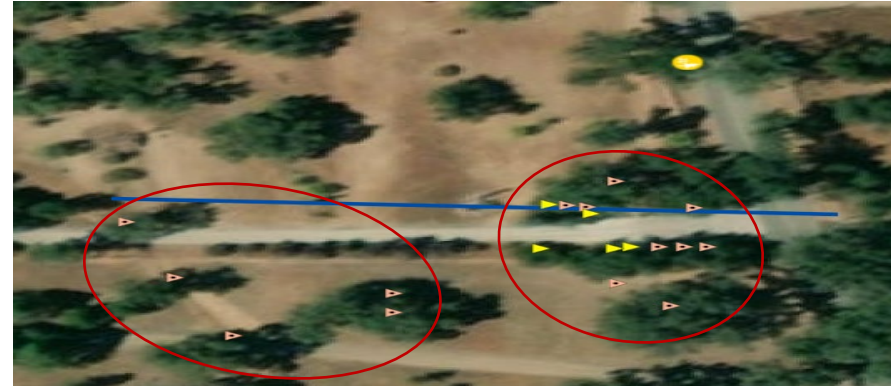
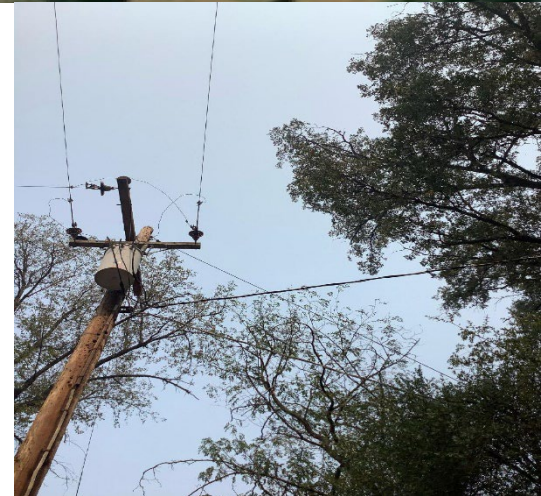
Details
QV Findings	Vegetation within the 4' overhang zone
Quantity	1
Quantity @ time of WV	1
Operations Comments	We disagree there was a WV error. Segment is not passed currently. Did not review and field check since the segment is still in process of EVM and has not been work verified. Segment is blue "Phase 1 & Phase 2 Inspected" Numerous in progress veg points with work prescribed.
QV Recommendation	Finding stands. Segment assessed as per audit scope, was provided as a Passed segment.

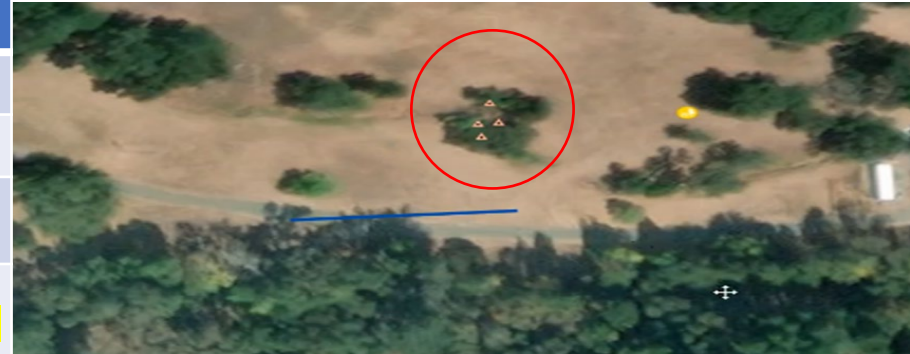
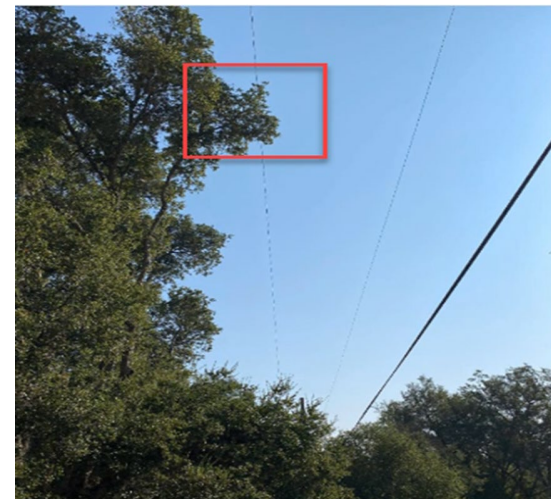
Details
QV Finding	Vegetation within the 4' overhang zone
Quantity	1
Quantity @ time of WV	1
Operations Comments	<p>WV survey data we received denotes this segment was failed by WV due to not meeting scope. <b>WV did not submit a passing survey for this segment</b> and survey shows non listed trees present with comments, "Oak roll between poles. Redwood behind corner pole. Fail." WV lead also disagrees with the QV findings.</p> <p>The tree in question ( VP_AL119-F20_1499502_2020 ) is a pending unit, in a different segment ( CIP_AL119-F20_77640 ) that has not passed WV.</p> <p>VP_AL119-F20_1499502_2020 is a work identified veg point not passed, it is clipped to segment CIP_AL119-F20_77640, which is not passed and is currently a blue "phase 1 &amp; phase 2 inspected" segment.</p>
QV Recommendation	Finding stands. Tree in question is non-conformance to sample segment.

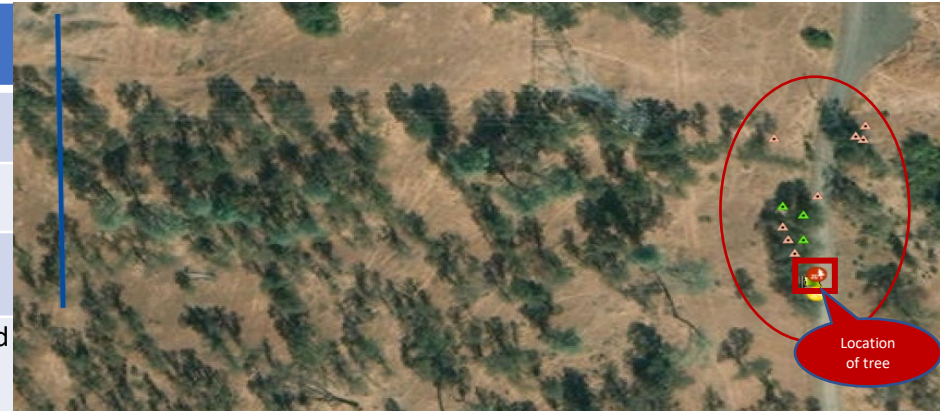
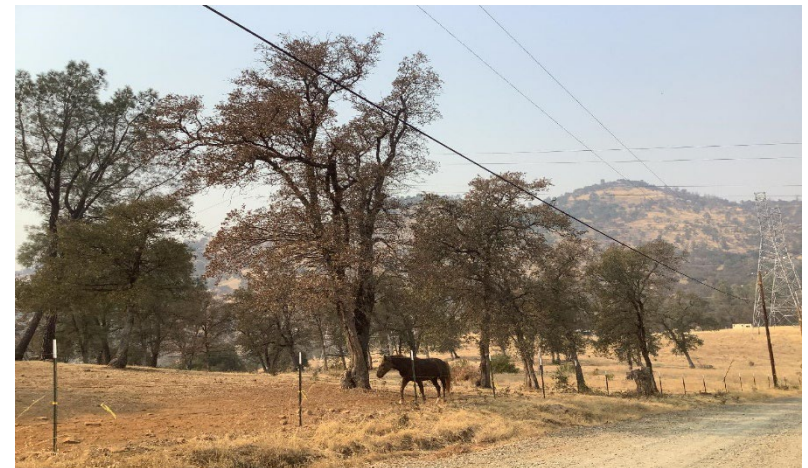
# CIP\_AS113-O20\_299472

Details
QV Findings	Hazard trees present with strike potential to primary
Quantity	1
Quantity @ time of WV	1
Operations Comments	The Veg Point in question has a minor defect that has healed over, and the holding wood is solid. The limb that is most likely to fail (however highly unlikely) is not tall enough to strike the line. It should also be noted that the VP in question (VP_AS113-P16_1315453_2020) is not tied to the segment QC sited but is tied to CIP_AS113-O20_299470. VP_AS113-P16_1315453_2020 passed on 7/6/20, segment it is clipped to is passed CIP_AS113-O20_299470
QV Recommendation	Finding stands. Tree meets Abate criteria (per TAT) and would impact sample segment.

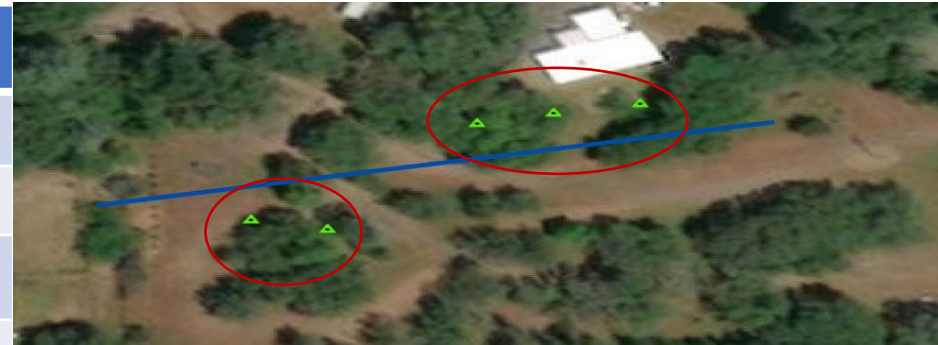
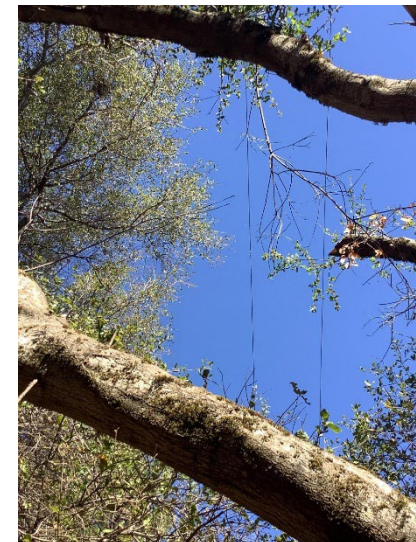
# CIP\_AT114-C09\_312631

Details
QV Findings	Vegetation within the 4' overhang zone
Quantity	1
Quantity @ time of WV	1
Operations Comments	The tree in question (VP_AT114-C09_1726880_2020) is not in this segment. VP_AT114-C09_1726880_2020 Passed on 8/14/20, segment it is clipped to is passed CIP_AT114-C09_312627
QV Recommendation	Finding stands. Tree in question is non-conformance to sample segment.

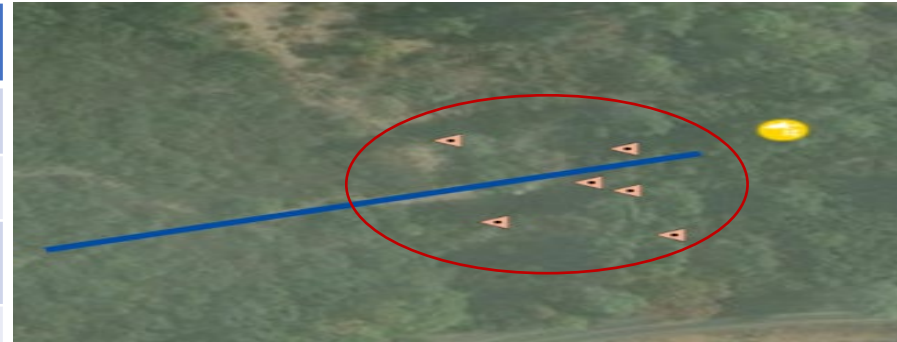
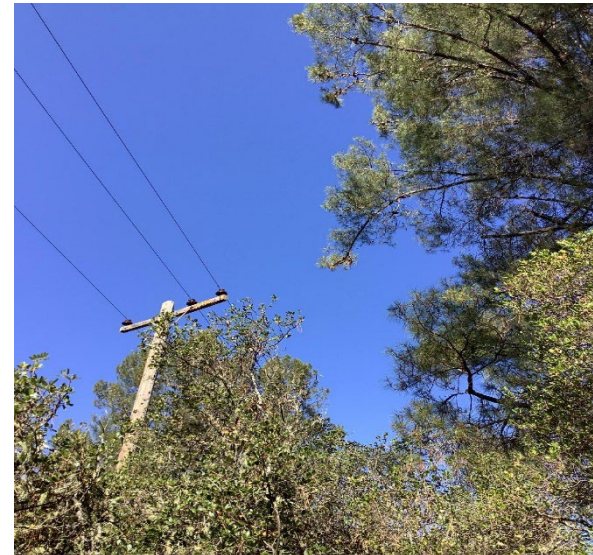
# CIP\_AK117-H23\_48140

Details
QV Findings	Vegetation within the 4' overhang zone
Quantity	2
Quantity @ time of WV	2
Operations Comments	<p>GIS is inaccurate would have caused a WV to pass this segment if they are looking at only their gps in relation to line segment on collector. This is a section of lines with only straight line segments in cross country area. There are no line &amp; buck poles or 3way poles/taps to refer to. We didn't have the pole layer on collector at this point in time so WV correctly passed this line segment based on in the field GPS location. The trees in question are clipped to neighboring segment and not this one. <b>This was before we had the support structure layer</b> on collector to see poles. The trees in question would make the neighboring segment fail scope and not this one.</p> <p><b>VP_AK117-H23_1352388_2020 is not passed currently</b>, and the segment it is clipped to CIP_AK117-H23_48139 <b>is passed currently</b></p>

QV Recommendation	Finding stands. Segment assessed per audit scope, as it was provided as a "Passed" location. Operations' comments states Work Verification process issue. Tree in question is non-conformant for sample segment.

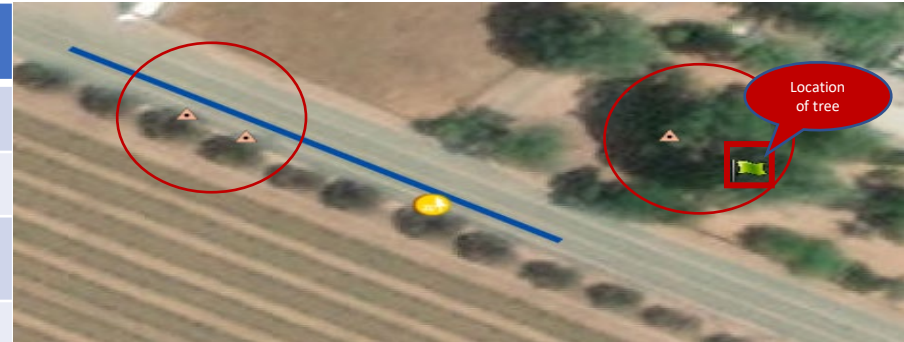
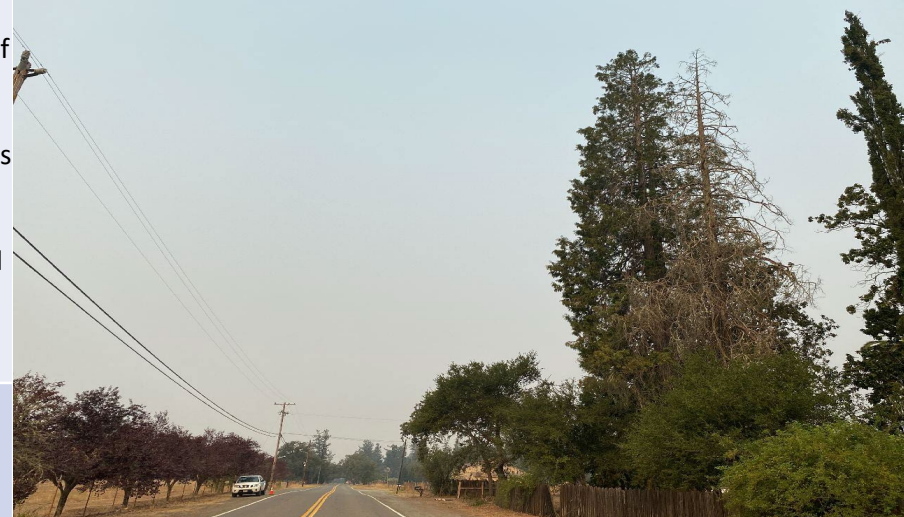
Details
QV Findings	Hazard trees present with strike potential to primary
Quantity	1
Quantity @ time of WV	0
Operations Comments	<p>Dead cedar tree is listed for work and the veg point is failed correctly by WV. Veg Point failed by WV on 5/8/20 by Abutla. WV intended to fail this segment. Tree is at border of 2 segments and wv correctly failed segment tree is clipped to and has more strike potential on due to lean that way. Tree has low likelihood of falling towards this segment that is passed, however both segments surveys should have been failed. Will coach WV inspectors on proper documentation. VP_AL119-C17_1405632_2020 is currently a work identified point not passed, the segment it is clipped to is VP_AL119-C17_1405632_2020 is not passed and is currently a blue segment "phase 1 &amp; 2 inspected"</p>
QV Recommendation	Tree is already identified as "Pass with Observation" as part of the original 11 "Pass with Observation" locations.

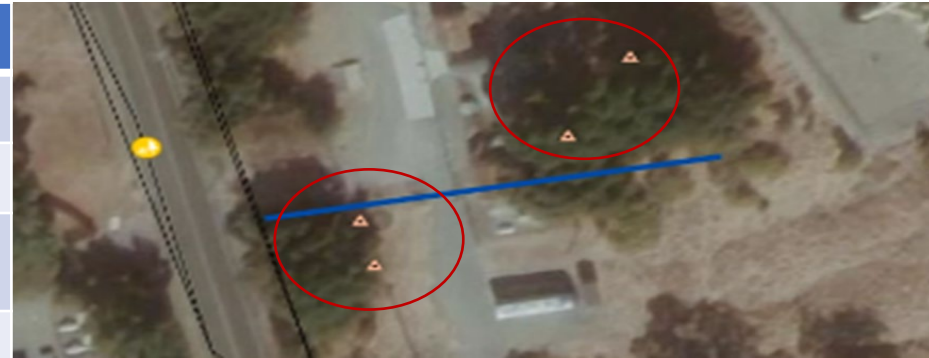
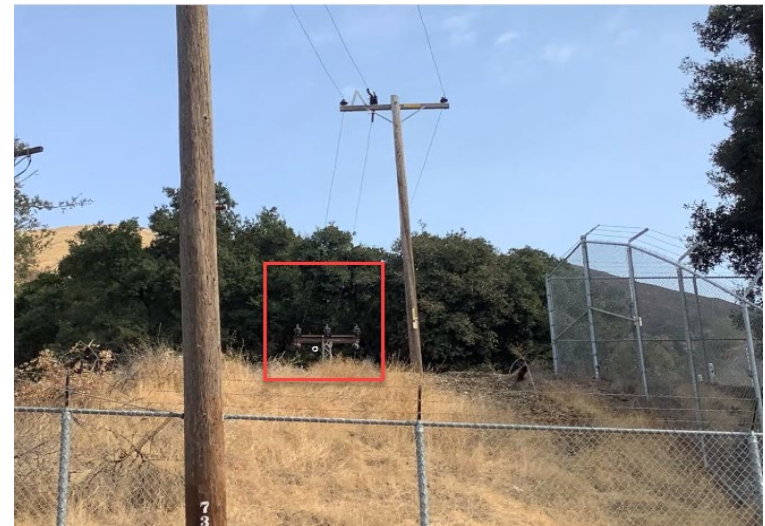
Details
QV Finding	Vegetation within the 4' overhang zone
Quantity	1
Quantity @ time of WV	1
Operations Comments	<p>QV auditor isn't looking at correct segment. This segment is not encompassing the end pole that does not meet overhang scope according to QV auditor. Qv auditor is looking at the wrong segment. This segment denoted on this spreadsheet stops 14 ft before the end pole. The last 14 ft of primary lines is an entirely different segment that encompasses the end pole with the overhang scope not met the QV auditor is referring to.</p> <p>That segment, which is CIP_AQ125-D22_234073, is correctly failed and is a green "inspection needed" line segment.</p>
QV Recommendation	<p>QV agrees that due to GIS data being unclear the overhang observed in the field in fact affects a segment adjacent to the sample segment. <b>This can be changed to "Pass with Observation"</b>.</p> <p>This one will be added to the 11 Pass with Observation to make it 12.</p>

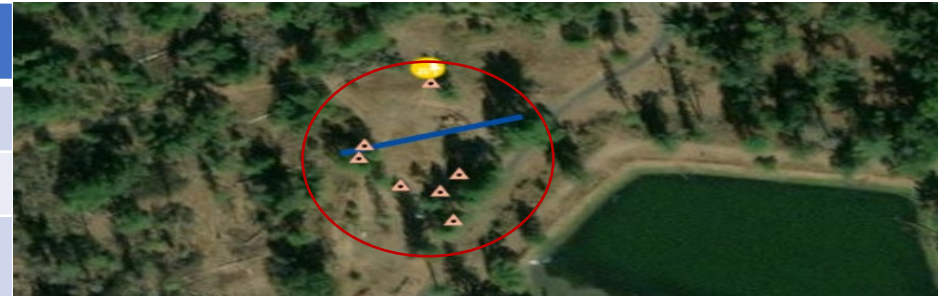
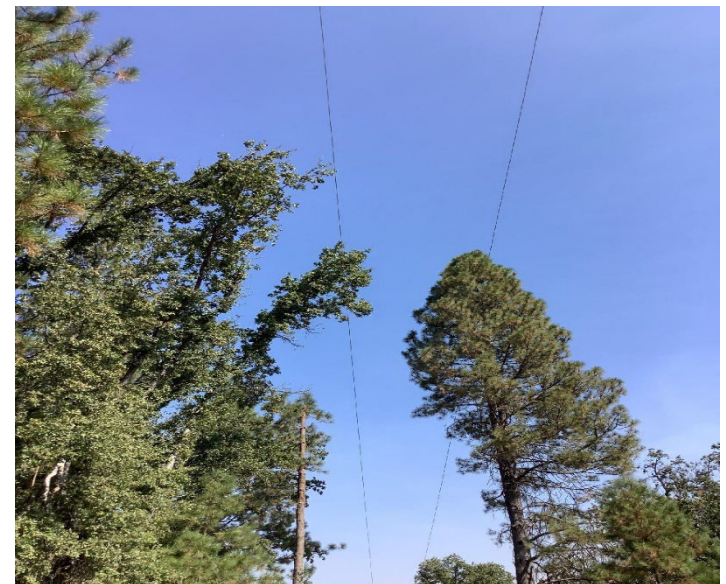
Details
QV Findings	Vegetation within the 4' overhang zone
Quantity	5
Quantity @ time of WV	5
Operations Comments	Segment was accurately passed. None of the overhanging trees are on this segment nor are their veg points snapped to it. No TAT double check needed, No Overhanging trees are on this segment and none of the veg points are snapped to it. QV looking at wrong segment and no hazard tree denoted.
QV Recommendation	Additional information needed from Operations to verify findings vs. Pass with observation status.
Ops Action	██████ to review and provide additional information to QV.

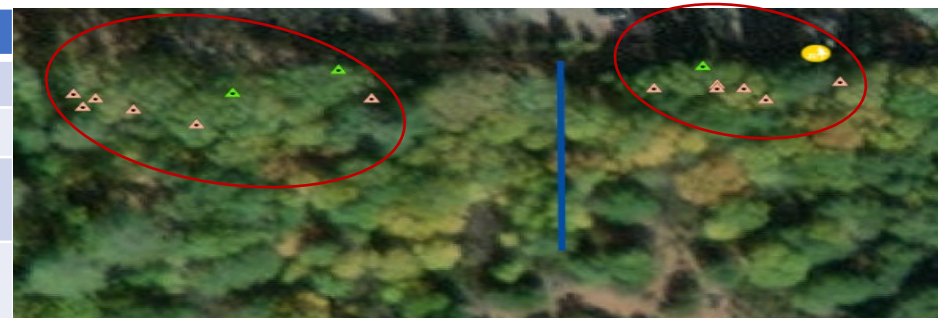
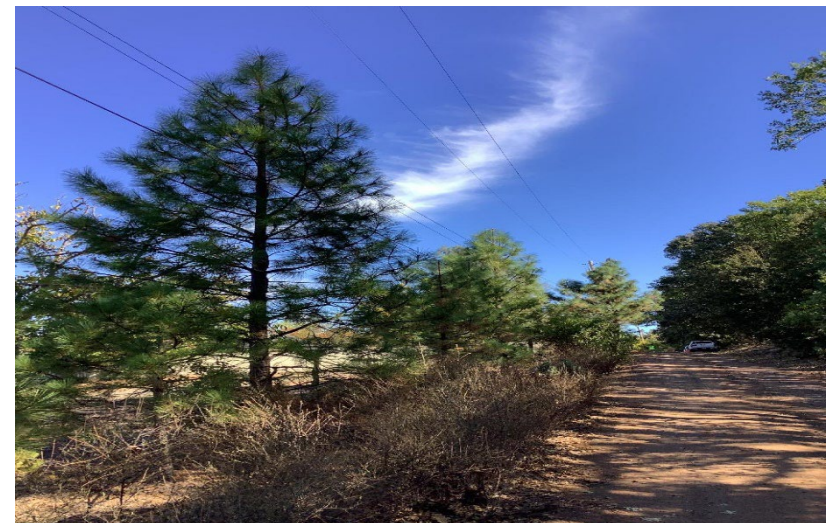
Details
QV Findings	Vegetation within 4 feet
Quantity	2
Quantity @ time of WV	2
Operations Comments	<b>These trees would have been breaking 4ft. at time of work verification.</b> QV auditor is looking at wrong line segment in reality and <b>this segment can pass WV due to GIS inaccuracies.</b> Wv correctly failed the line segment these trees actually fall on in reality in the field. These trees are currently right at 4 - 4.5ft. away and would not have been within 4ft at time of WV in February 2020. 1-1.5 ft of new growth since then. WV did everything correct here comments on survey even state two non listed trees need work referring to these trees. See collector map, QV is reading map wrong and is not looking at correct segment in the field. Need to use the GIS inaccurate line that was drawn in
QV Recommendation	Additional information needed from Operations to verify findings vs. Pass with observation status. Further explanation requested on statement that "segment can pass WV due to GIS inaccuracies".

Ops Action	██████ to review and provide additional information to QV.

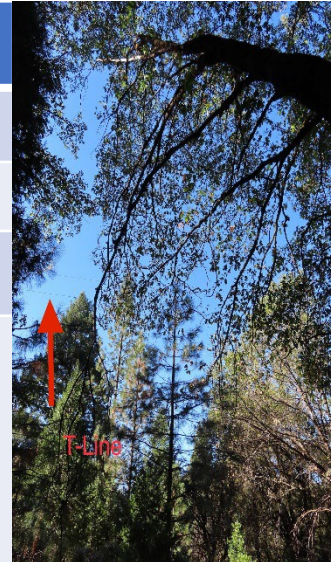
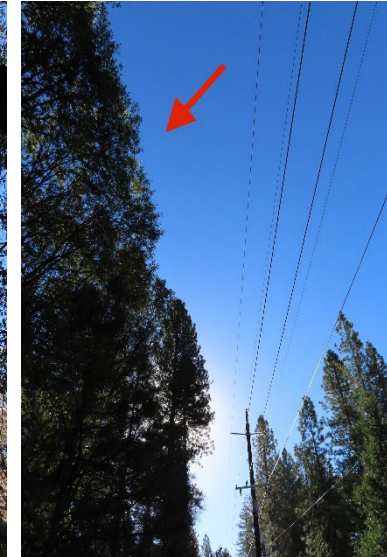
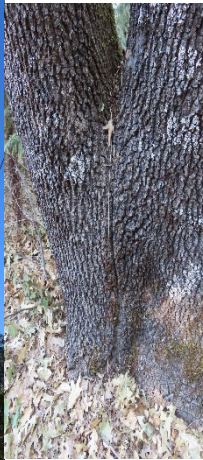
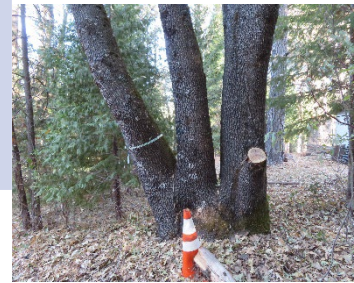
# CIP\_AW116-A04\_398509

Details
QV Findings	Hazard trees present with strike potential to primary
Quantity	1
Quantity @ time of WV	1
Operations Comments	The Veg Point in question (VP_AW116-A04_1327971_2020) is not a hazard tree, or a threat to the power lines at this time. the holding wood is solid with no signs of rot, and union between the stems in question is health. The QV comment of lean toward the line is natural growth toward the sun & ROW and has self corrected, also the base of the tree is not leaning or uprooting
QV Recommendation	Finding stands. Tree in question received an EVM PI HTRS rating of 3,3; which was work verified in 6/2020. QV SPM performed follow up TAT assessment on 10/28/2020, resulting in "Abate", which affirmed prior QV field tech result. No significant condition change would have likely occurred since work verification date.

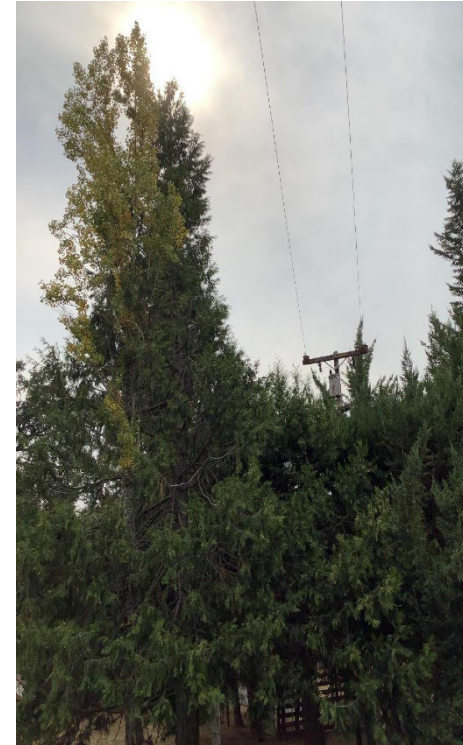
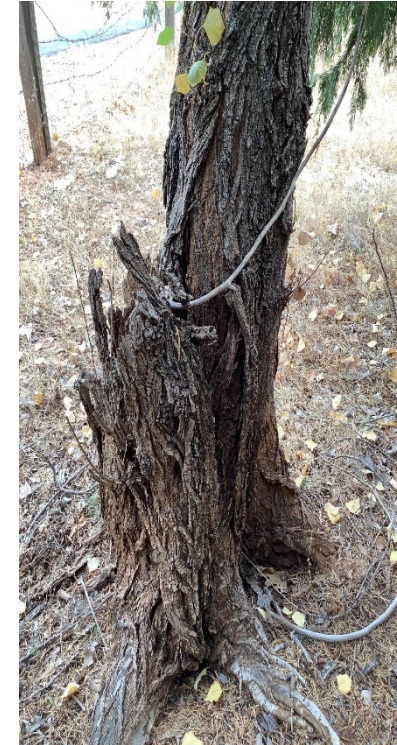
# CIP\_BA122-G21\_719302

Details
QV Findings	Hazard trees present with strike potential to primary
Quantity	1
Quantity @ time of WV	1
Operations Comments	Tree has lean away from line and will fail away from the facilities.
QV Recommendation	Finding stands. Tree in question received an EVM PI HTRS rating of 3,4; which was work verified in 1/2020. QV SFT, QV FT and QV Supervisor together performed a TAT assessment on 10/8/2020, resulting in "abate." No significant condition change would have likely occurred since work verification date.

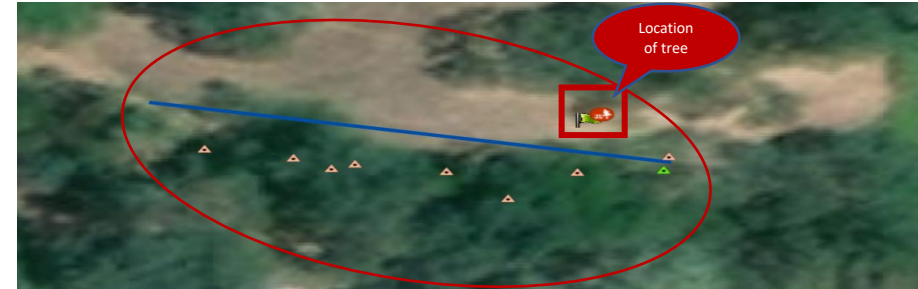
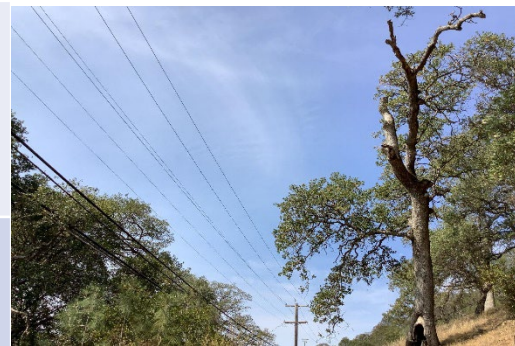
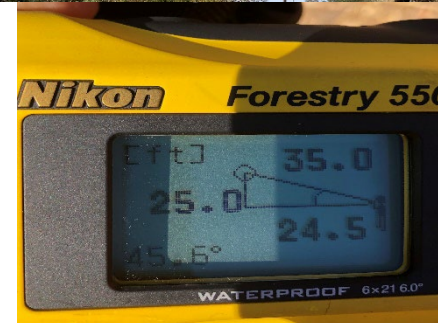
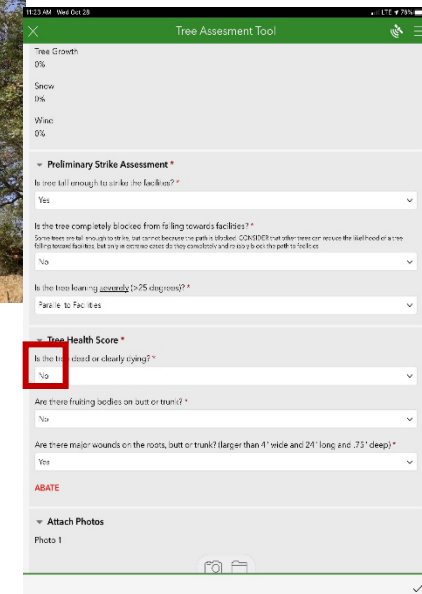
# CIP\_AL116-N23\_63661

Details
QV Findings	Hazard trees present with strike potential to primary
Quantity	1
Quantity @ time of WV	1
Operations Comments	Tree in question has significant lean parallel with lines and is not tall enough to strike facilities. If the tree fails at base with the amount of lean and weight of canopy parallel to lines it will miss all facilities. Tree does have a large cavity at base of trunk, however, will not strike any facilities if it were to fail.
QV Recommendation	Finding stands. No prior Veg point exists for tree in question. Location was work verified in 1/2020. QV SPM performed a TAT assessment on 10/28/2020, resulting in "abate", which affirmed prior QV field tech result. No significant condition change would have likely occurred since work verification date.

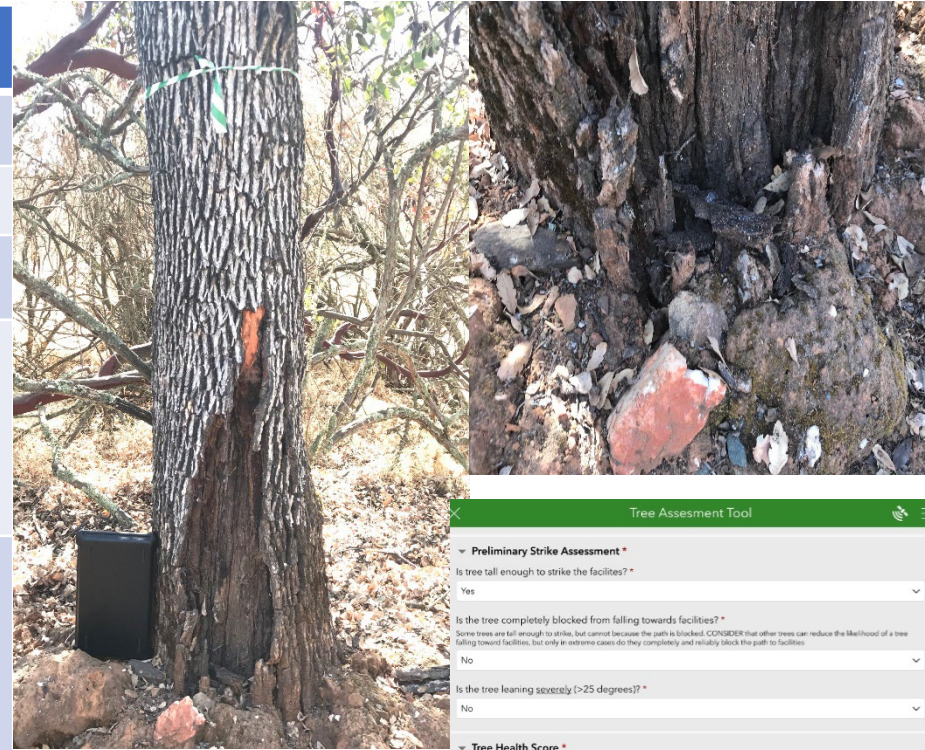
# CIL\_AW120-C25\_72912

Details
QV Findings	Hazard trees present with strike potential to primary
Quantity	1
Quantity @ time of WV	1
Operations Comments	The tree in question has holding wood is solid, minor wound is healing over well, the tree is vertical with no lean towards the line, and 70% of the weight is away from the line.
QV Recommendation	Finding stands. Tree in question received an EVM PI TAT result of "Do not Abate"; which was work verified in 6/2020. QV SPM performed a TAT assessment on 10/28/2020, resulting in "abate", which affirmed prior QV field tech result. No significant condition change would have likely occurred since work verification date.
