OFFICE OF ENERGY INFRASTRUCTURE SAFETY

~~DRAFT~~ ANNUAL REPORT

PACIFIC GAS & ELECTRIC COMPANY

2020 WILDFIRE MITIGATION PLAN

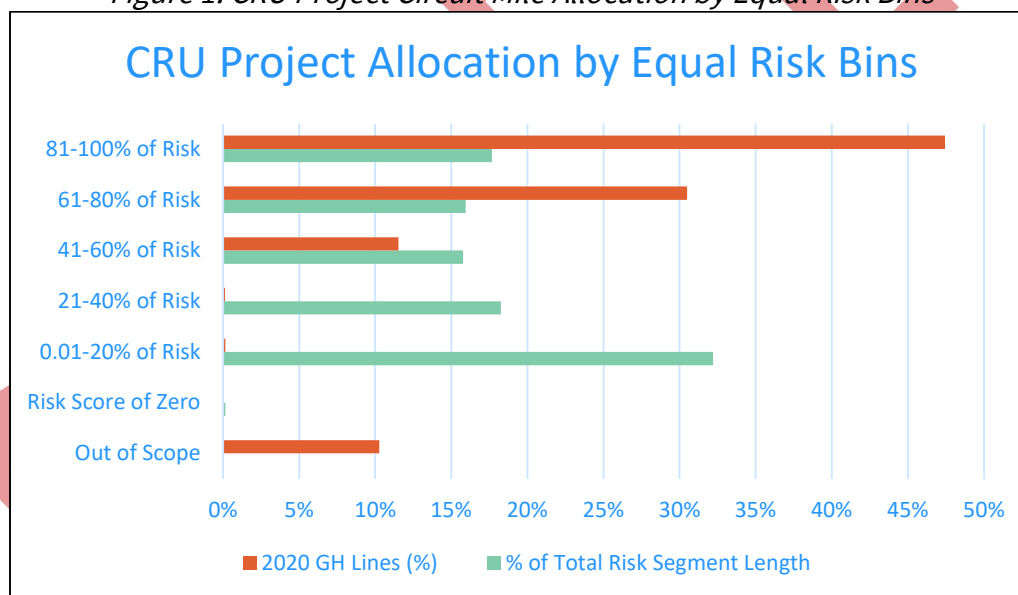
Figure 1: CRU Project Circuit Mile Allocation by Equal Risk Bins

As shown in Figure 1, 10% of the CRU projects completed by PG&E in 2020 were out of the scope of this analysis. While PG&E completed nearly half of its CRU projects in its highest risk bin, as discussed above, the 61-80% and 41-60% risk bins contained more risk per circuit mile. Given the amount of CRU projects completed in 2020, more risk may have been reduced for the same number of miles completed had there been more work allocated in the 61-80% and 41-60% risk bins.

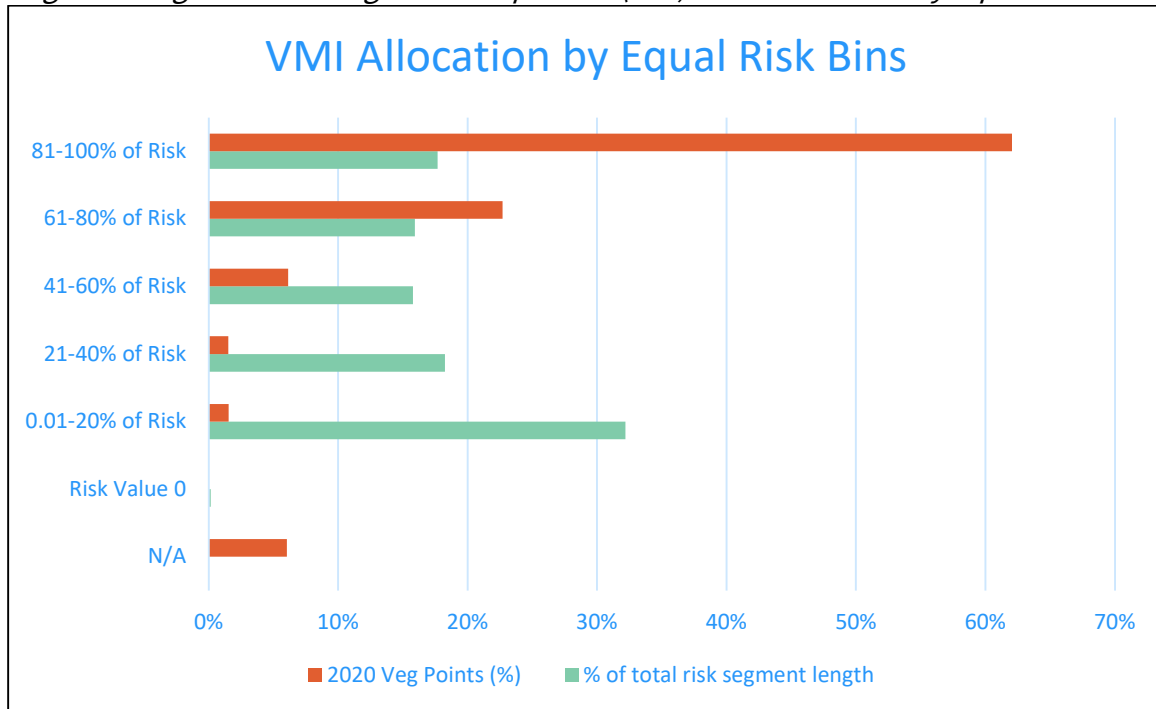
Figure 2: Vegetation Management Inspection (VMI) Point Allocation by Equal Risk Bins

PG&E completed approximately 90% of its non-routine VMI near risk segments that make up 60% of its distribution risk.¹⁵² While PG&E completed over 60% of its VMI work in its highest risk bin, as discussed above, the 61-80% and 41-60% risk bins contained more risk per circuit mile. Given the amount of VMI completed in 2020, more risk may have been reduced for the same volume of VMI work completed had there been more work allocated in the 61-80% and 41-60% risk bins.

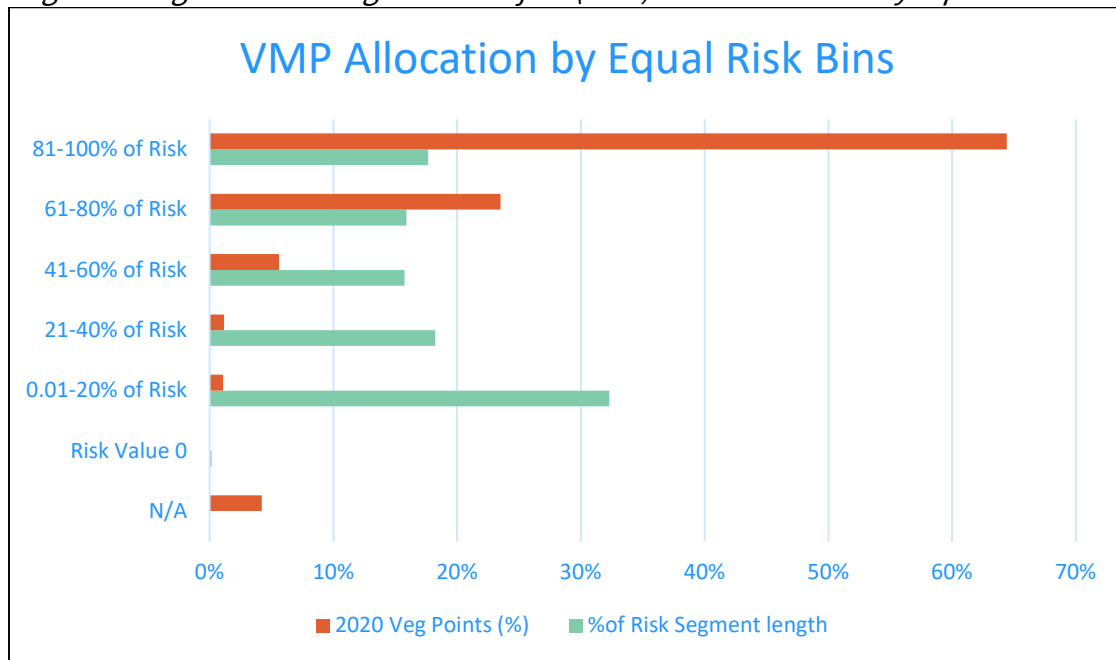
Figure 3: Vegetation Management Project (VMP) Point Allocation by Equal Risk Bins

PG&E completed 88% of its non-routine VMP near risk segments making up the top 40% of riskiest segments.¹⁵³ While PG&E completed over 60% of its VMP work in its highest risk bin, as discussed above, the 61-80% and 41-60% risk bins contained more risk per circuit mile. Given the amount of VMP work completed in 2020, more risk may have been reduced for the same volume of work completed had there been more work allocated in the 61-80% and 41-60% risk bins.

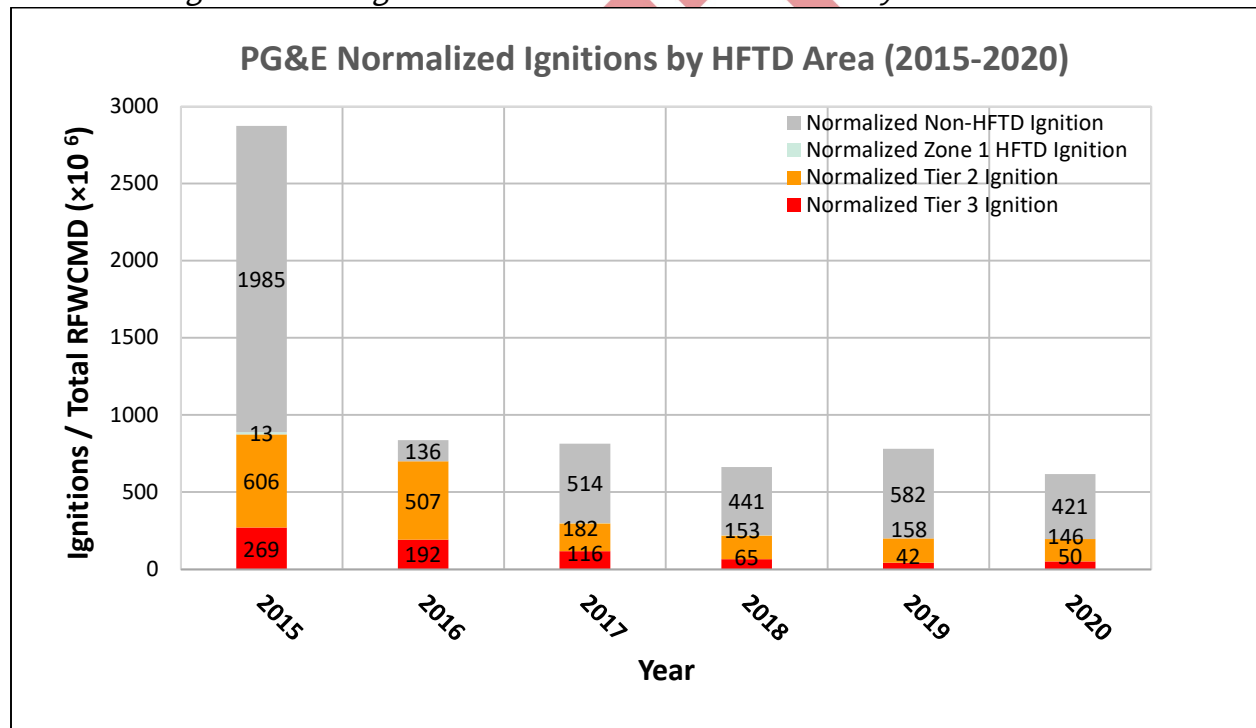
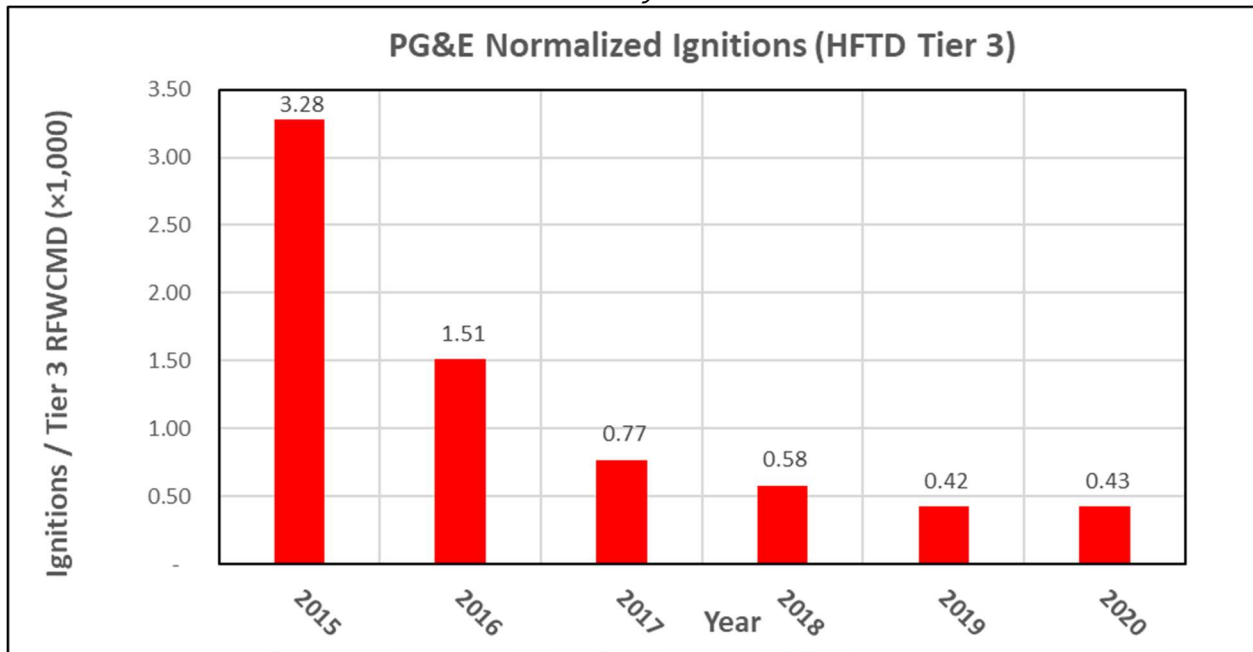
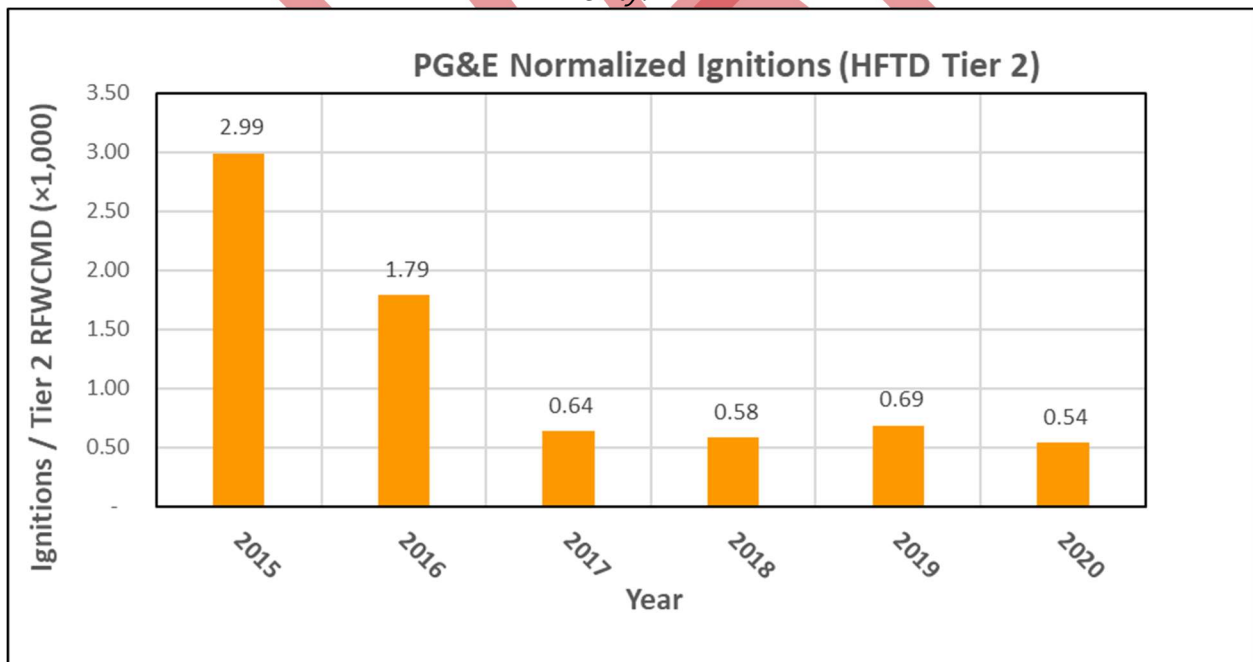
As can be seen in the three figures above, PG&E's normalized ignitions decreased during the 2015-2020 period. There is a general downward trend in ignitions across PG&E's service territory, as well as in Tier 2 and Tier 3 HFTD areas specifically.

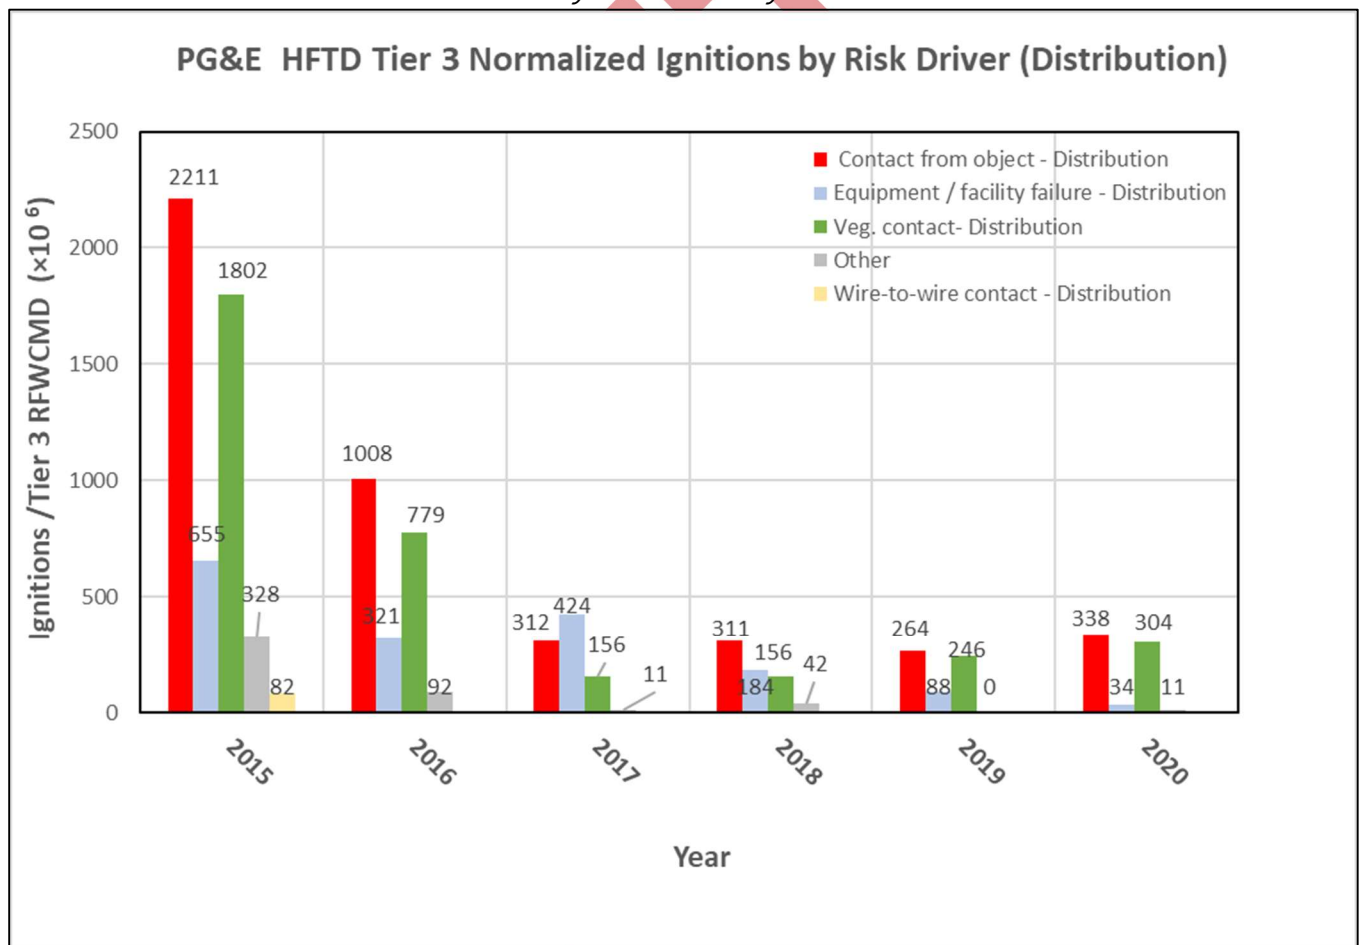
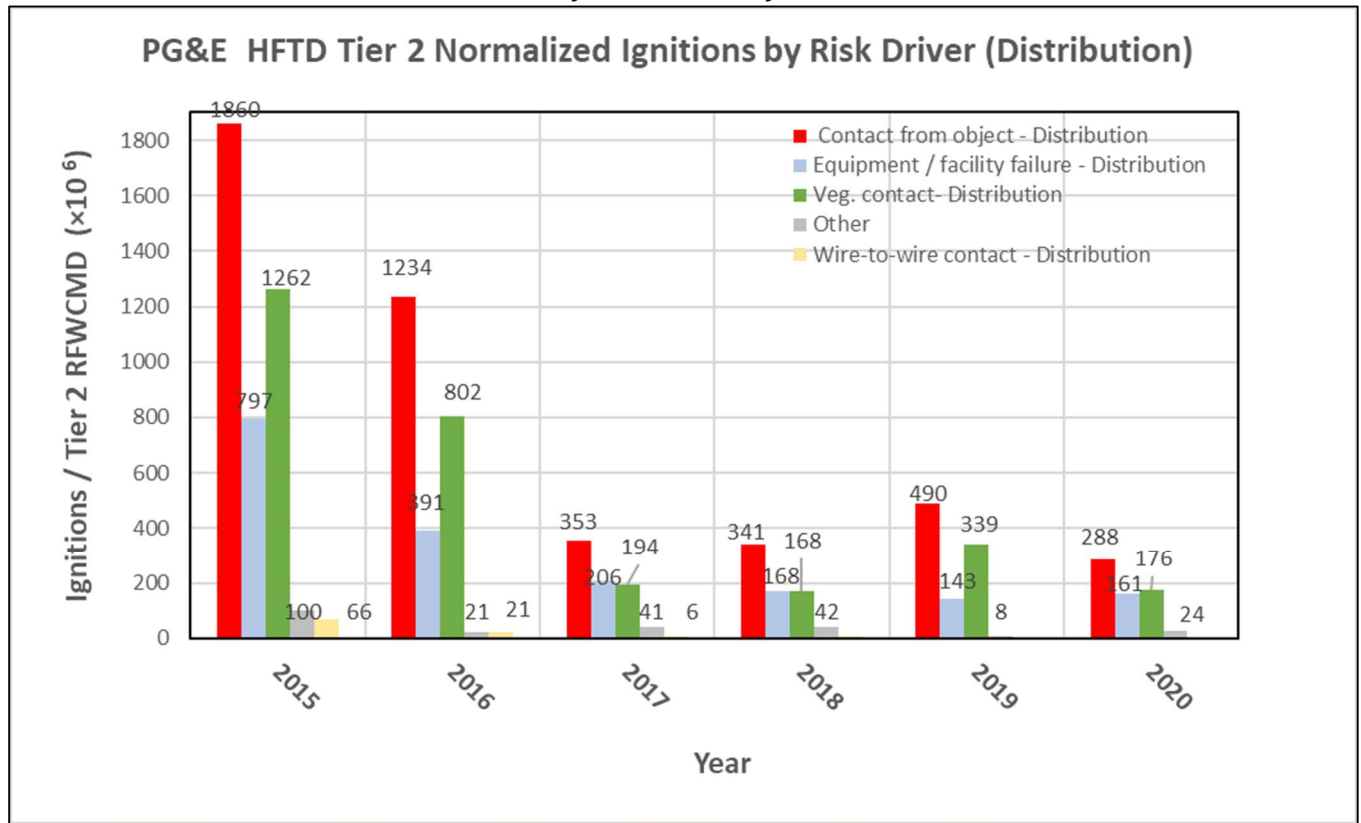
As can be seen from the figures above for the distribution system, the primary drivers of ignition are object contact and vegetation contact followed by equipment or facility failure.

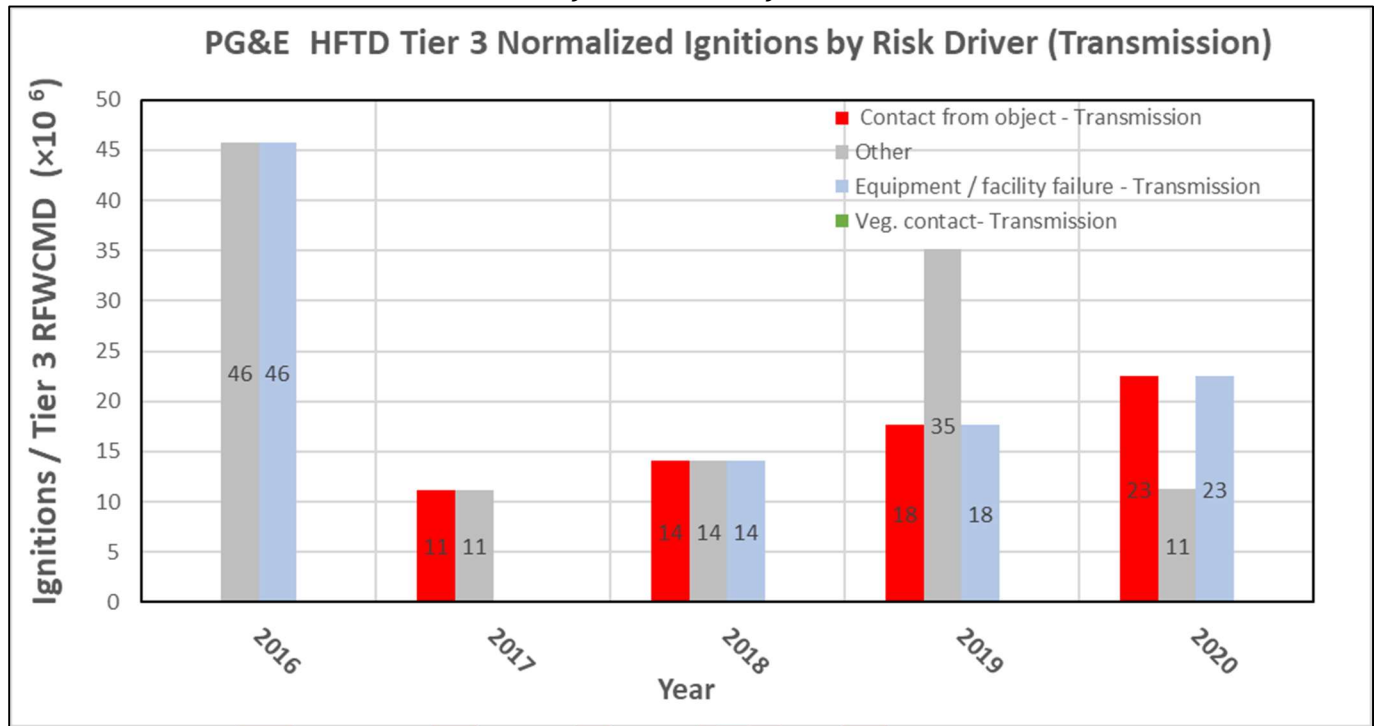
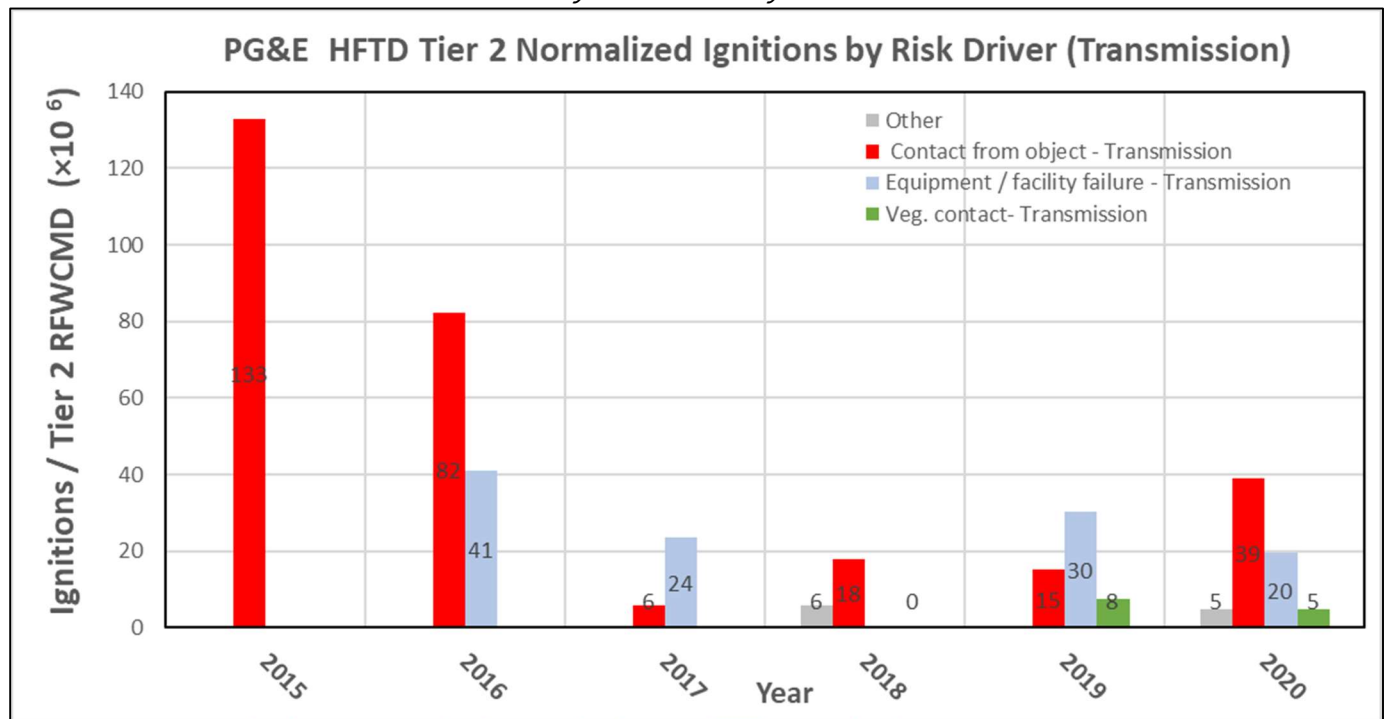
On the transmission system, the primary ignition drivers are object contact and equipment or facility failure, although HFTD Tier 3 ignitions are notably driven by drivers in the “other” category.¹⁷⁵

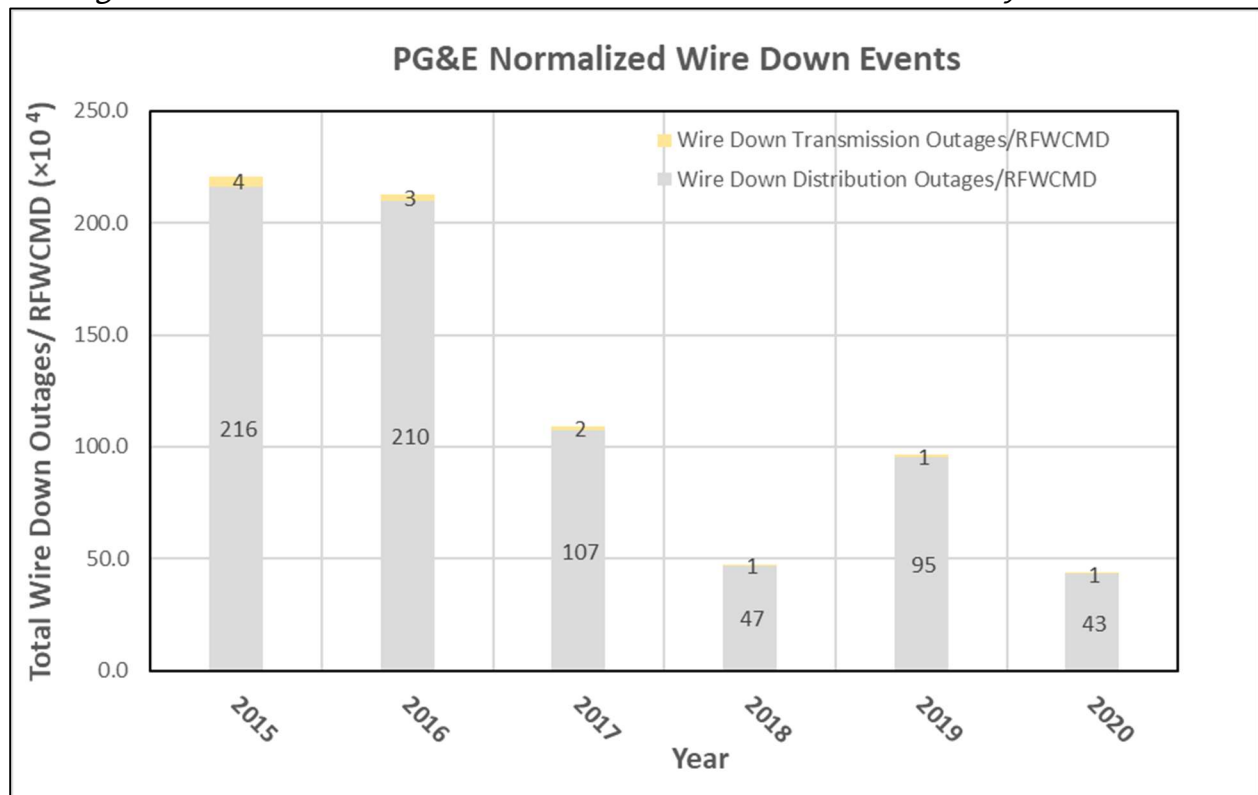
Figure 12: PG&E Total Wire Down Events from 2015-2020 Normalized by RFWCMD.¹⁷⁶

Although there was an uptick in 2019, normalized wire down events trended lower over the 2015-2020 timeframe.

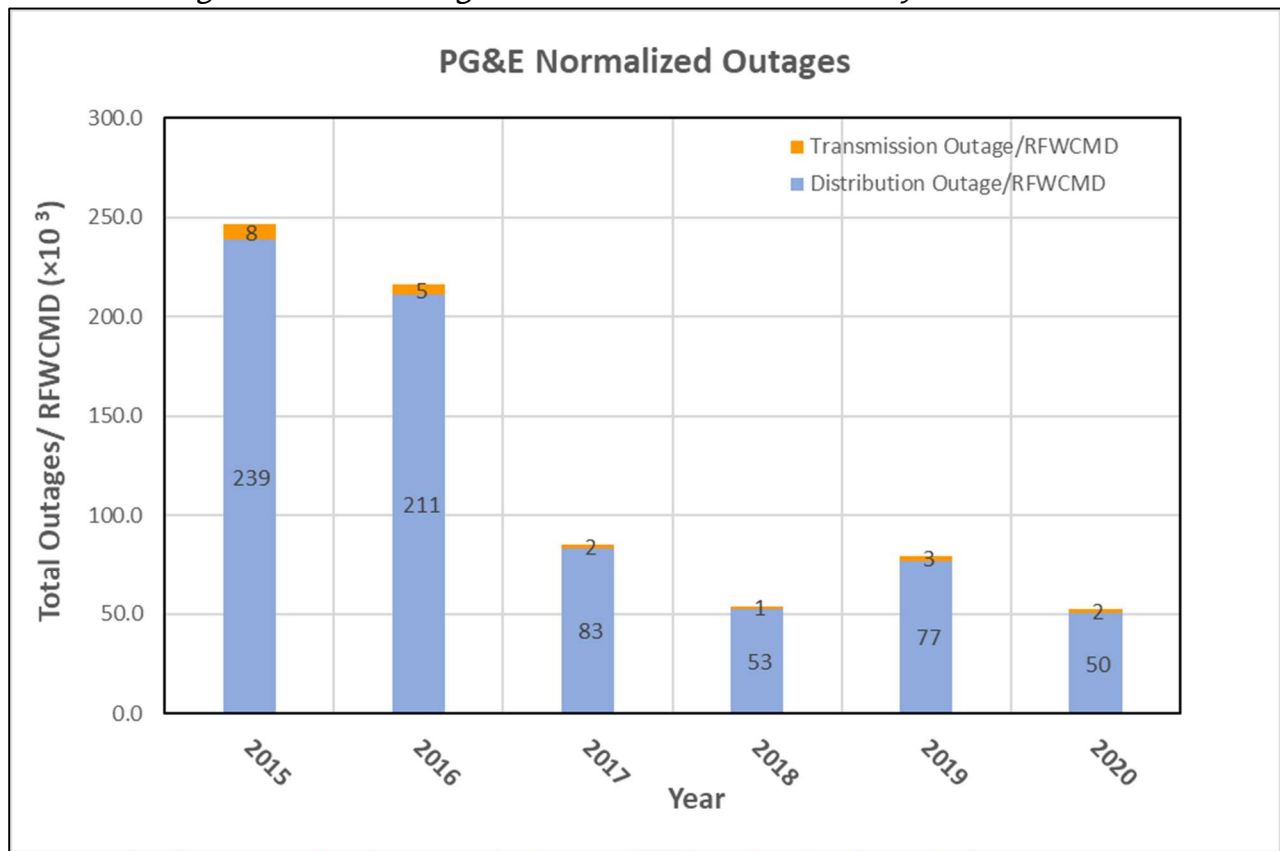
Figure 13: PG&E Outages from 2015-2020 Normalized by RFWCMD.¹⁷⁷

Although there was an uptick in 2019, normalized total unplanned outages trended lower over the 2015-2020 timeframe.

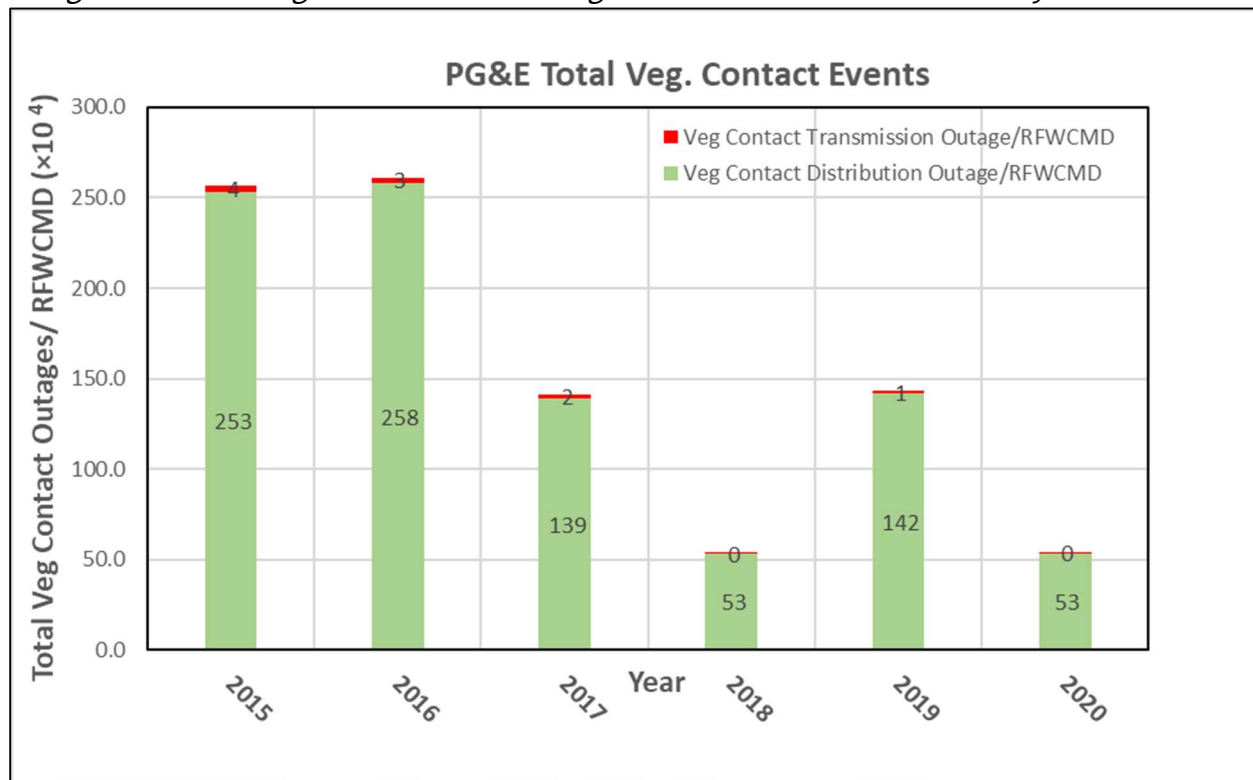
Figure 14: PG&E Vegetation Contact Outages from 2015-2020 Normalized by RFWCMD.¹⁷⁸

Although there was an uptick in 2019, normalized outages due to vegetation contact trended lower over the 2015-2020 timeframe.

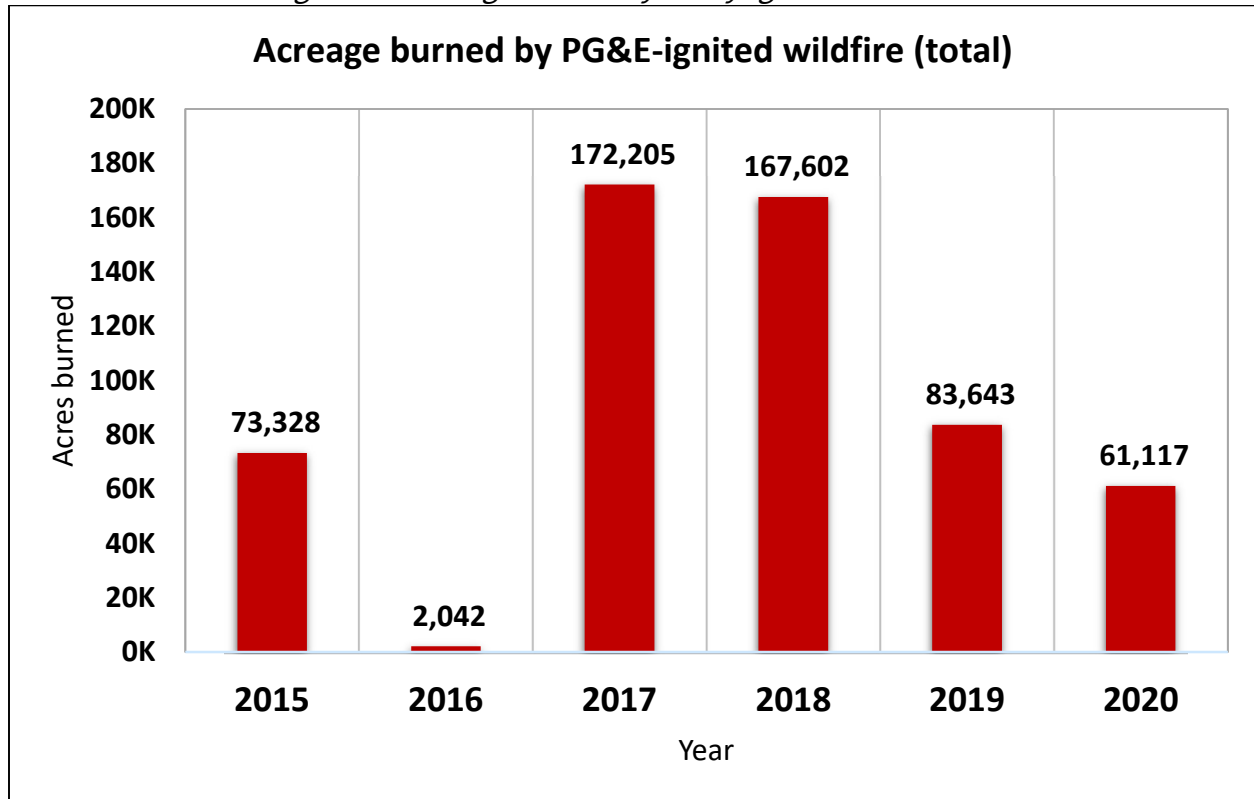
Figure 20: Acreage burned by utility-ignited wildfire.¹⁹³

As shown above, the acres burned from wildfires ignited by PG&E's infrastructure over the six-year reporting period generally follows a normal distribution and indicates a decline since 172,205 acres burned in 2017.

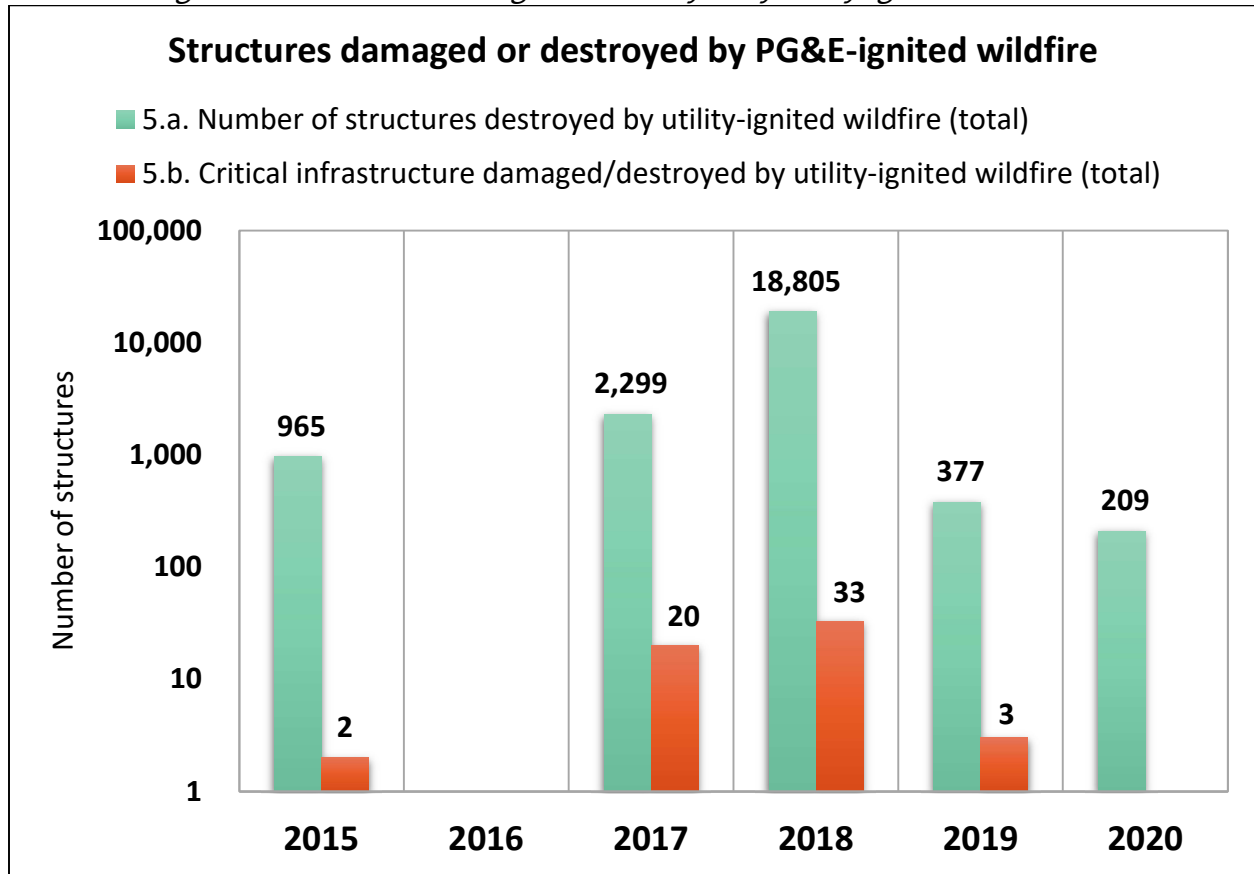
Figure 21: Structures damaged or destroyed by utility-ignited wildfire.¹⁹⁴

The number of structures and critical infrastructure damaged or destroyed from wildfires related to PG&E's electrical lines and equipment decreased in 2020 compared to the 5-year average from 2015-2019 (4,489 structures and 12 critical infrastructure).

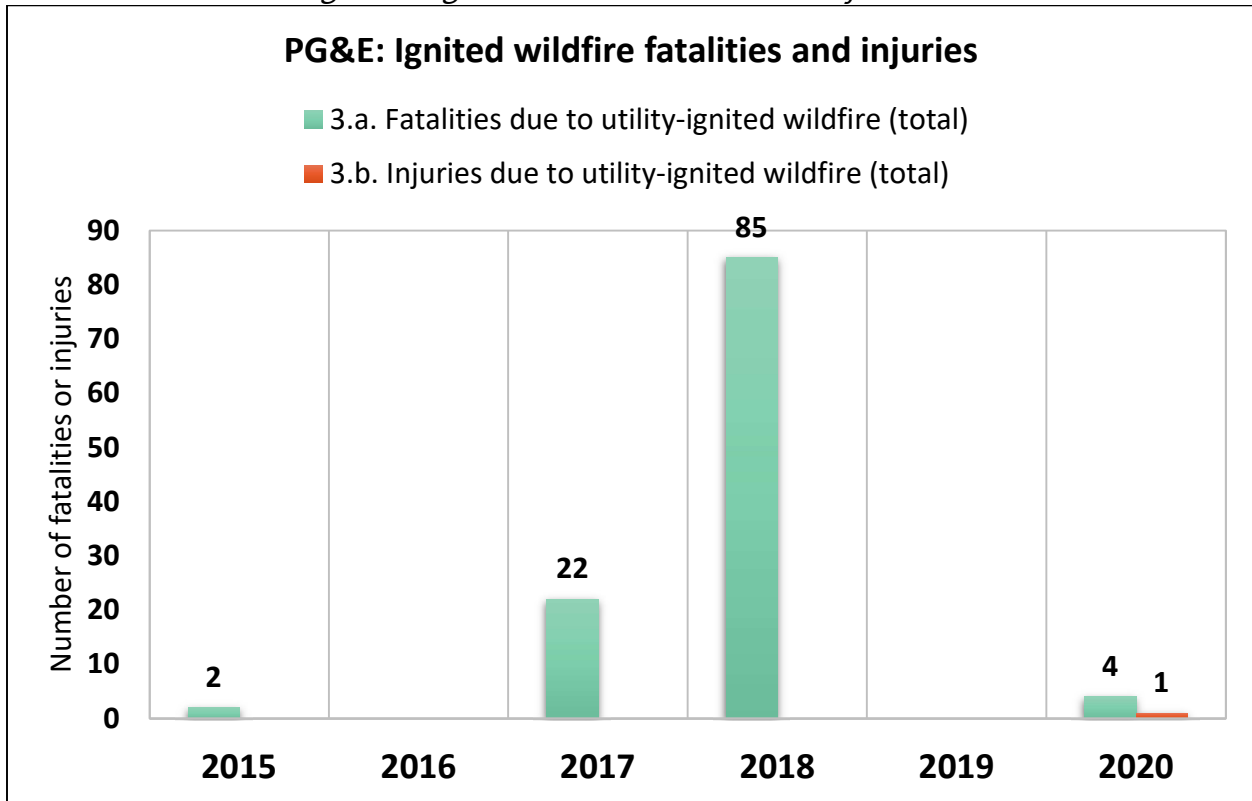
Figure 22: Ignited wildfire fatalities and injuries.¹⁹⁵

Following the significant loss of life from PG&E-ignited wildfires in 2017 and 2018 that claimed the lives of 107 individuals, a reprieve from such loss of life in 2019 was temporary as there were four fatalities and one injury attributable to PG&E-ignited wildfires in 2020.

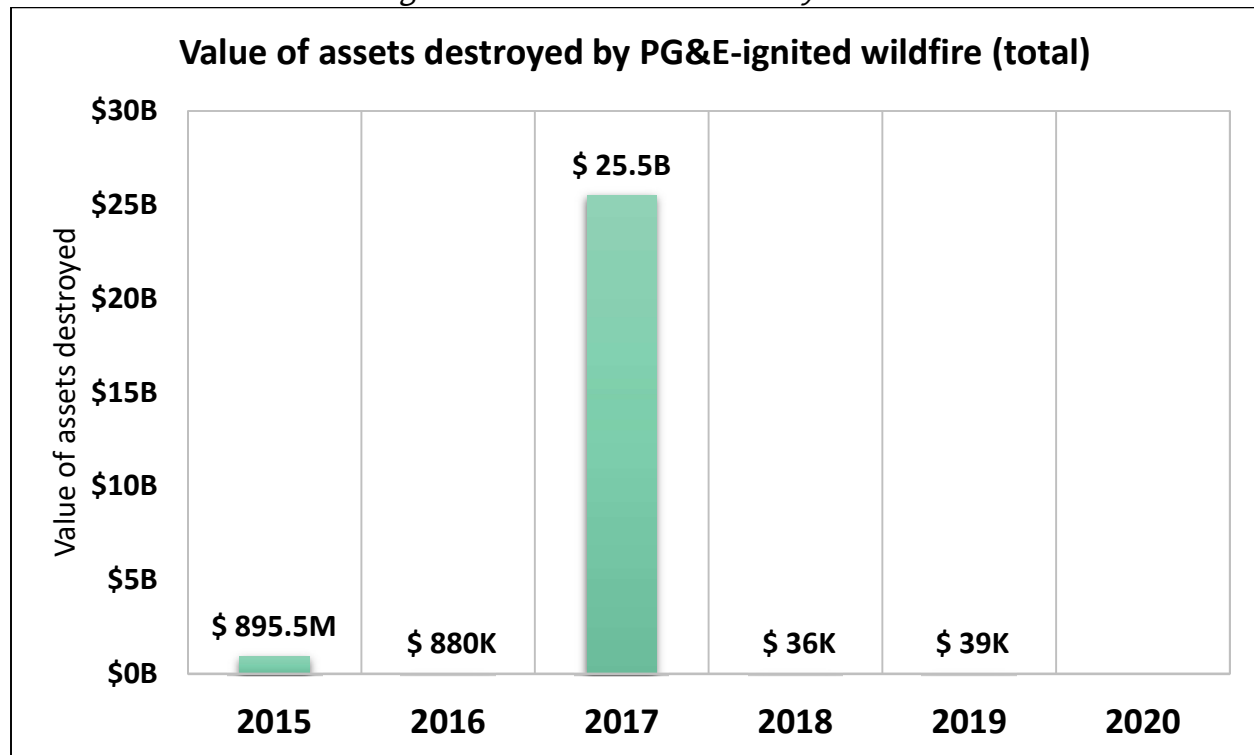
Figure 23: Value of assets destroyed.¹⁹⁶

The value of assets destroyed in 2020 was reported as \$0. Although it is unlikely that there was \$0 in damage given the volume of structures damaged or destroyed, Energy Safety relied upon the data as reported by PG&E in its 2021 Q1 QDR.
