April 25, 2022

Reference: Energy Safety Record ID: NOD_MJ4_PGE_20211207_01
Notice of Defect: Government Code § 15475.2 and the California Code of Regulations, Title
14, Section 29302(b)(1)

This letter is in response to the March 11, 2022, Office of Energy Infrastructure Safety (Energy Safety) Notice of Defect (NOD) from an inspection occurring on December 7, 2021, of grid topology improvements and system hardening work in Santa Cruz, Santa Cruz County. The NOD alleges two (2) types of defects which include vegetation contacting the guy wire above the insulator and excessive splicing in a single span.

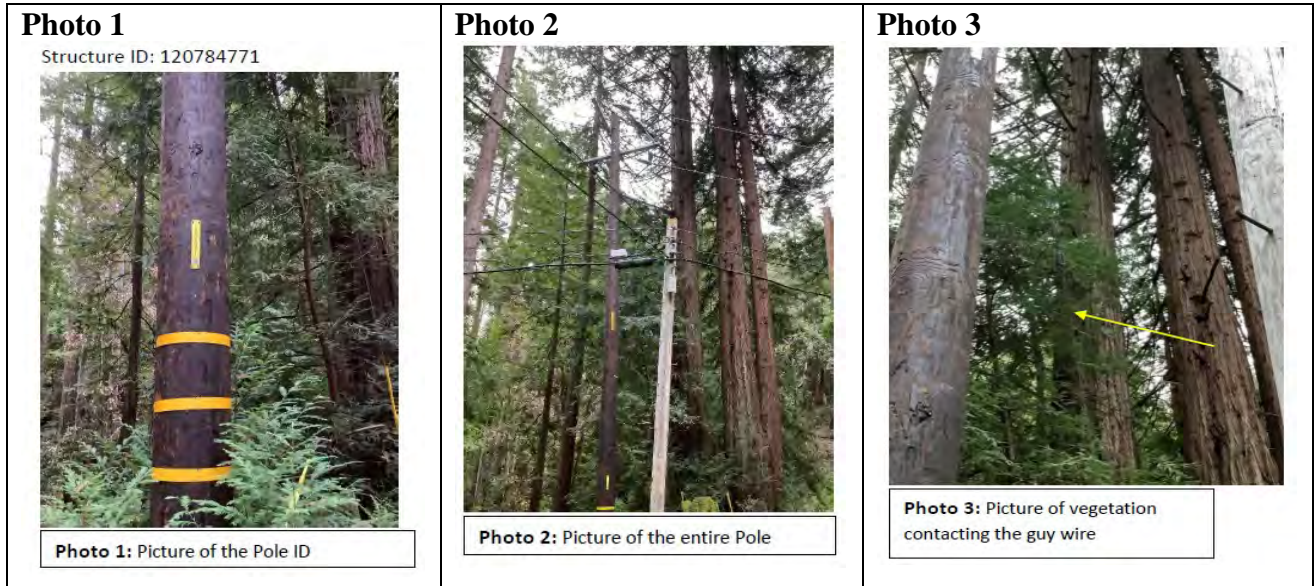
Before:

Regarding Defect 1, pole 120784771, vegetation contacting guy wire above the insulator, we agree with the finding. On March 23, 2022, we performed a field inspection and observed minimal new vegetation growth contacting the guy wire above the insulator. The vegetation was trimmed on the same day of the field visit; please see Attachment 1 for photos.

Defect 1: Pole 120784771

Disposition: Agree with Defect Finding - Vegetation contacting the guy wire above the insulator.

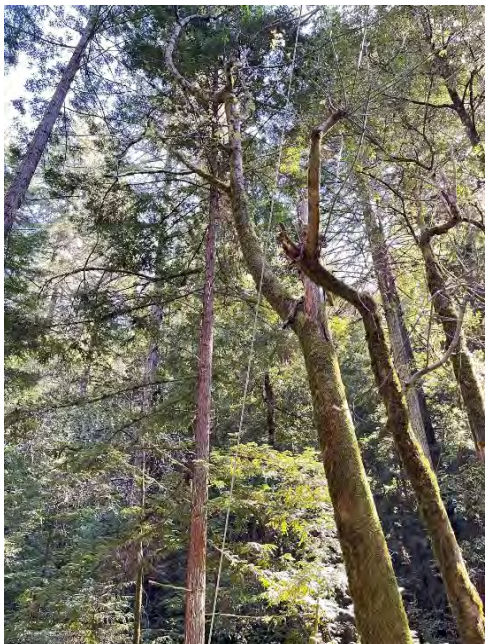
Photo 1

Defect 1: Pole 120795203

Disposition: Defect not Found - No vegetation found contacting the guy wire above the insulator during field verification.

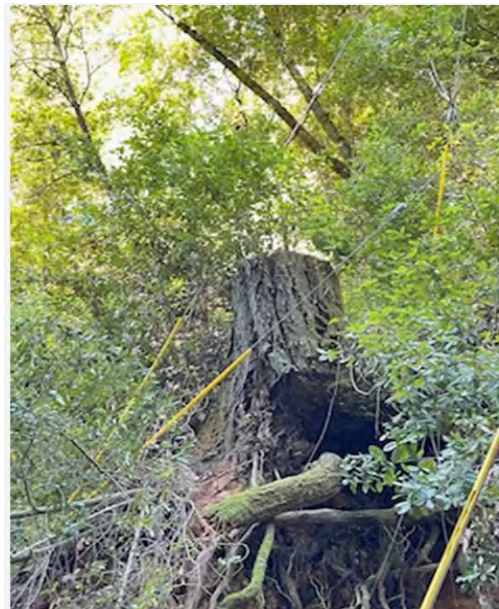
Photo 1

Defect 1: Pole 120786270

Disposition: Defect not Found - No vegetation found contacting the guy wire above the insulator during field verification.

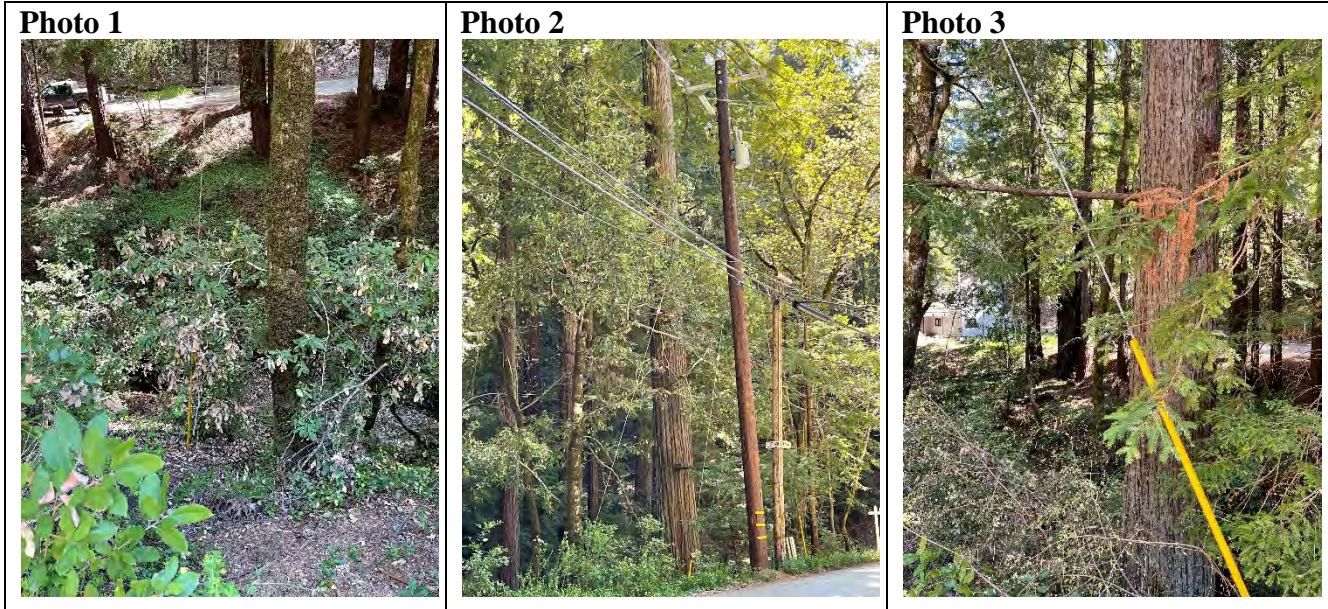
Defect 1: Pole 120786268

Disposition: Defect not Found - No vegetation found contacting the guy wire above the insulator during field verification.

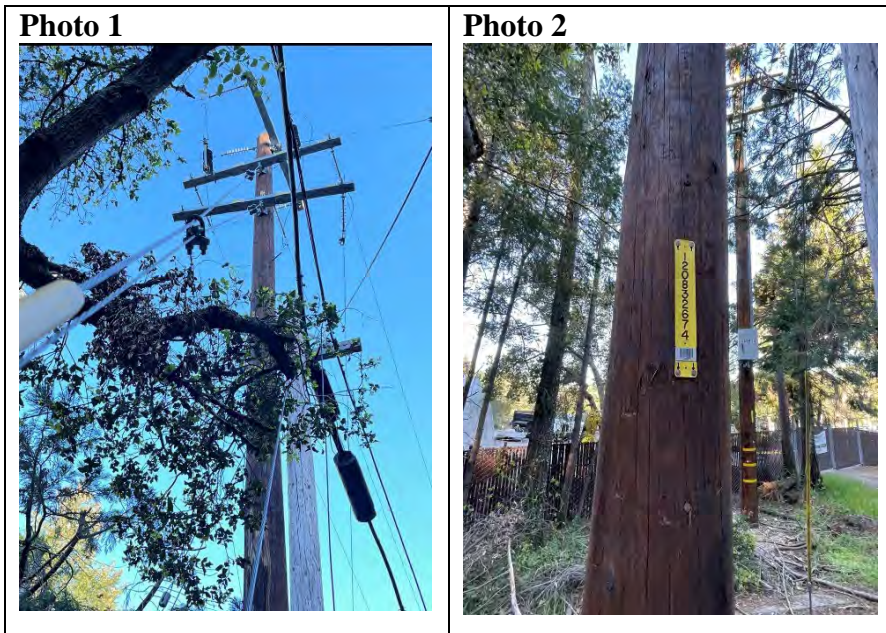
Defect 1: Pole 120832674

Disposition: Defect not Found - No vegetation found contacting the guy wire above the insulator during field verification.
