# Asset Failure Analysis

## Ignition Extent of Condition Report

Index # 450 | Alleghany-1101

Report Date: April 30, 2022 | Rev 01

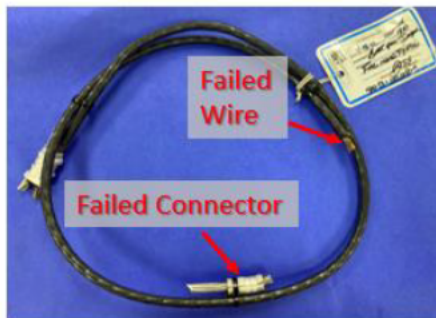
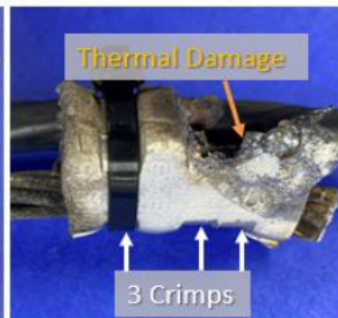
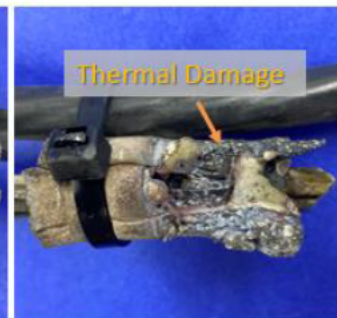
### As-Received Photos

The jumper failure within the compression connector appears to be at least partially attributed to a fatigue fracture. There was little to no deformation observed on fracture surface on three of the copper strands. Workmanship may have also contributed to the failure as the connector had one less crimp than required per 041010 page 6 note 2 for the Hmac OB-101 connectors. The broken strands and/or workmanship could contribute to localized arcing and thermal damage within the joint.

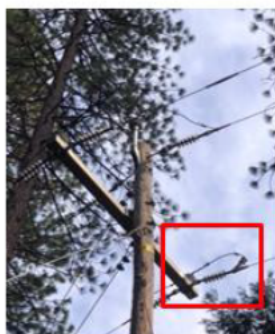
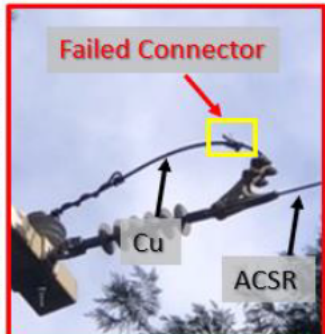
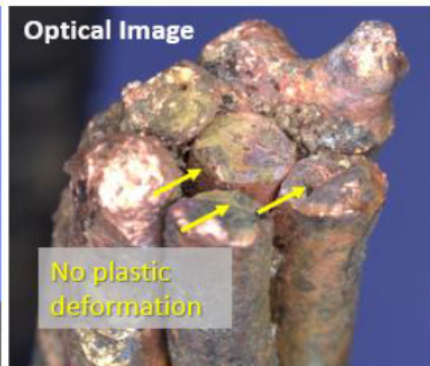
### Field Photos

No, there was one less crimp than required per 041010, Additionally, it was noted that a 'no-oxide' (corrosion inhibitor) applied and may have corroded internally due to signs of heat damage observed, as indicated in [TD-2907P-01](#) "Installing Overhead Conductor Splices".

- Roadside connector failed and caused jumper burnt
  - i. REPLACED 6 CONNECTORS
  - ii. 2 JUMPERS
  - iii. INSTALLED HIGH SIGNS.
