Index 450 ALLEGHANY 1101 Connector, Summary

Date Identified: 4/18/22
Fire Index: 450, Tier 2

Circuit: ALLEGHANY 1101
City: Sierra City
Division: Sierra

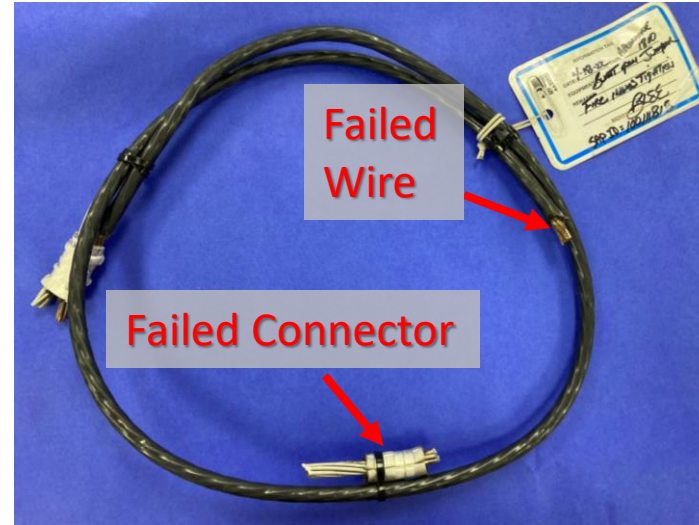
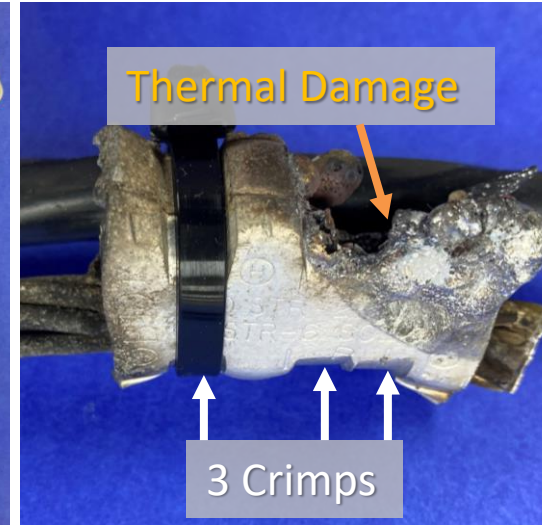
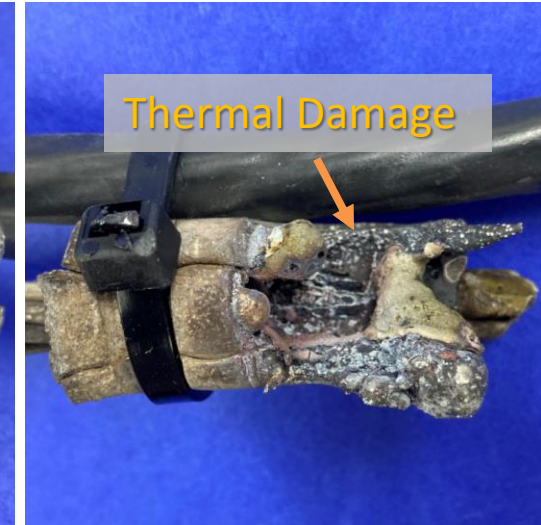
As-Received Photos

The jumper failure within the compression connector appears to be at least partially attributed to a fatigue fracture. There was little to no deformation observed on fracture surface on three of the copper strands. Workmanship may have also contributed to the failure as the connector had one less crimp than required per 041010 page 6 note 2 for the Homac OB-101 connectors. The broken strands and/or workmanship could contribute to localized arcing and thermal damage within the joint.

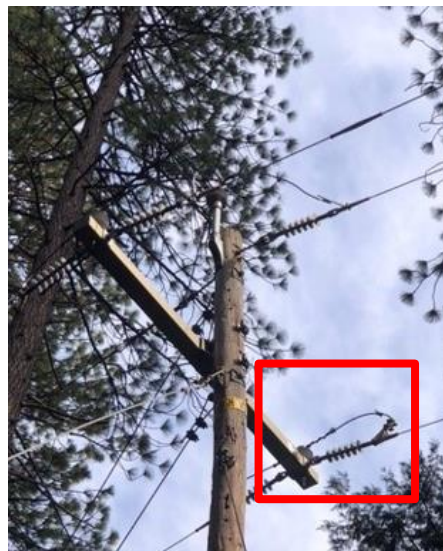
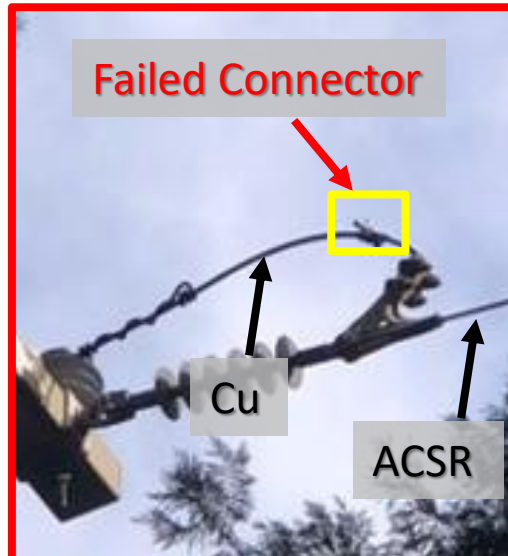
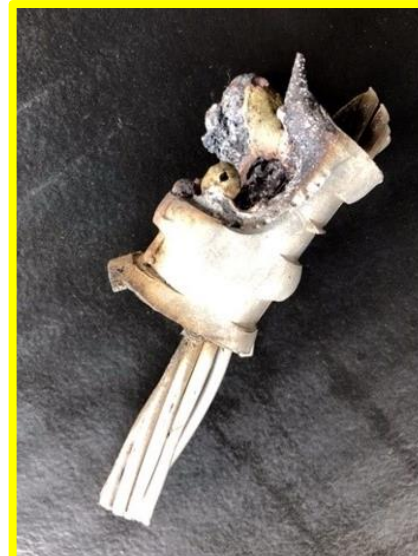
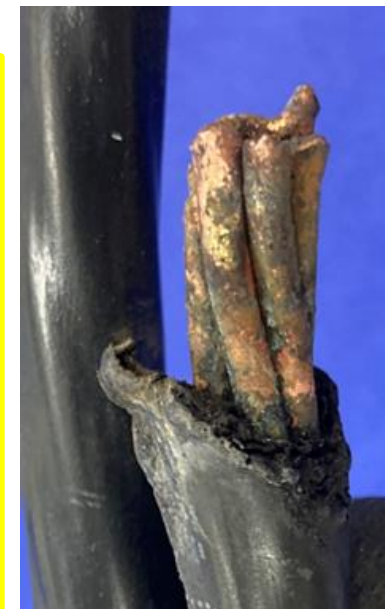
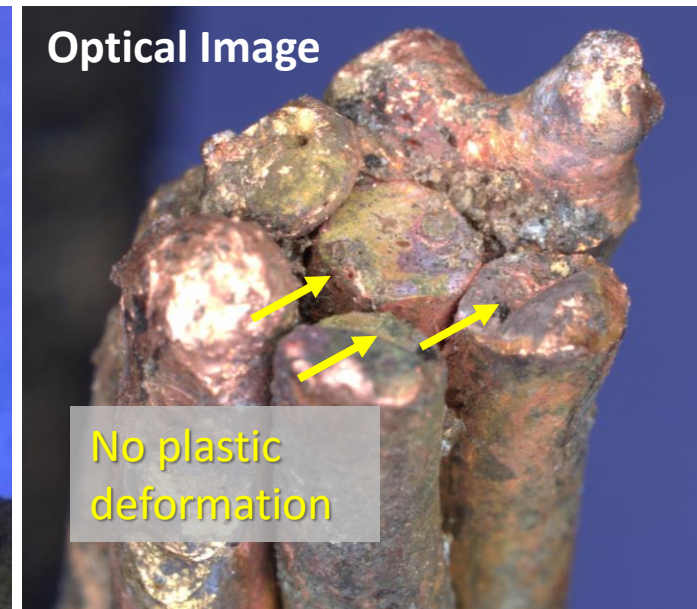
Field Photos

On April 18, 2022 at 18:17 hours, a PG&E Troublemaker was dispatched to the Alleghany 1101, a 12kV Distribution Circuit near State Highway 49, 1.80 miles East of Forest Route 93 in Sierra City in response to an area outage. Upon entering the rural area, the Troublemaker was met by Fire Department on the side of the road requesting his assistance. He then realized this was more than an area outage. Initial analysis indicates equipment failure caused the ignition. Once the Fire Department made the scene safe and allowed PG&E to enter, the Troublemaker began his assessment and found the connector had failed at the aluminum to copper connection. This failure caused the ignition that was .25 acres in size. The fire was suppressed by Sierra City Fire Department. This incident led to an outage affecting 604 customers. Due to the remoteness of the area, and a one way feed, the town was fed by a generator through the night. A PG&E Crew, along with the responding PG&E Troublemaker returned to the site on April 19, 2022 to replace the connector and re-energize electricity to the impacted area.
